NEWTOWN URBAN CONSERVATION STUDY. - 'C' CITATIONS. Ref: 133

Richard Peterson Architect & Conservation Consultant. Daniel Catrice Historian 1996.

ADDRESS: 15 Pleasant Street

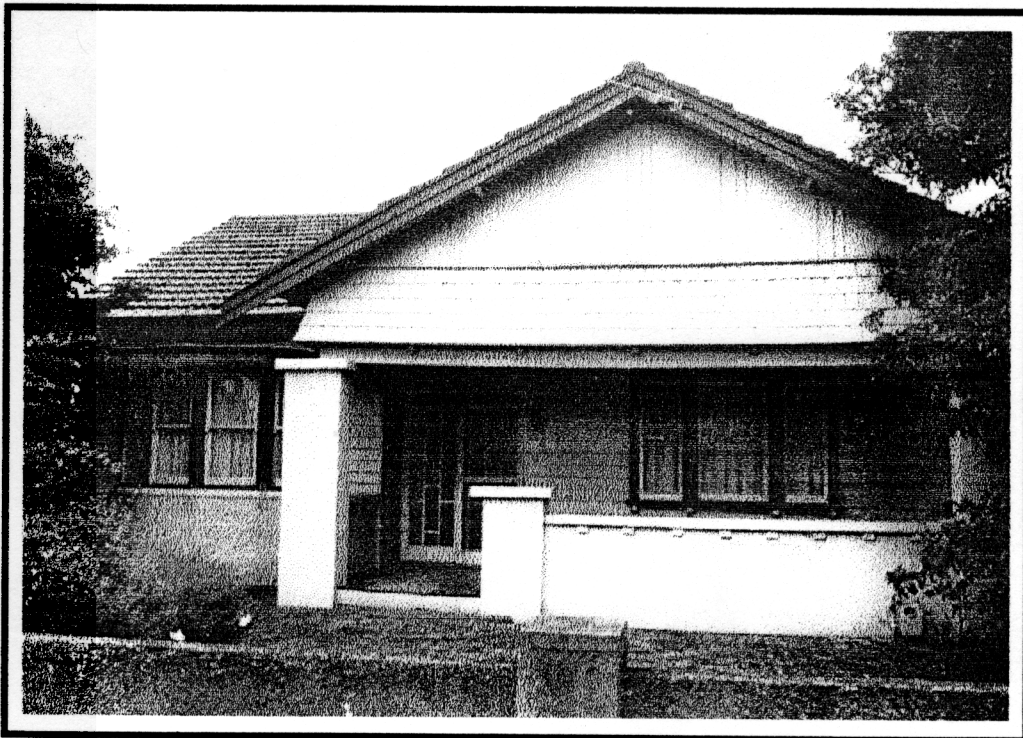
INTACTNESS: Fair only. Brickwork is painted, grand level is too high. Roofing is replaced by glazed Marseilles terracotta tiles.

CONDITION & THREATS: Good. There is no front sub-floor ventilation, enabling rotting of floors.
