NEWTOWN URBAN CONSERVATION STUDY. - 'C' CITATIONS. Ref: 134
Richard Peterson Architect & Conservation Consultant. Daniel Catrice Historian 1996.

NAME: Lemea		
ADDRESS: 19 Pleasant Street.		
USE: House		
CONSTRUCTION DATE: 1925 SOURCE: Visual & 1		
ALTERATIONS/ADDITIONS: DATE: 1990s SOURCE: Visual & 1		
DESIGNER: — BUILDER: —		
CRITERIA: H1, Ar1, Ar3. HISTORIC THEME: 2.3		
DESCRIPTION: STYLE: Bungalow STORIES: 1 DETACHED.		
MATERIALS: WALLS Brick ROOF Iron STRUCTURE Stud		
CONDITION: Very good INTACTNESS: Excellent. THREATS: —		
SIGNIFICANT INTACT ELEMENTS: * MATERIALS. Tuckpointing & sandstone cills. FORM. FACADE. VERANDAH. ROOF FORM. VERANDAH DECORATION. CHIMNEY. DOOR. WINDOWS. PAINTWORK SCHEME. UNPAINTED FINISH.		
SIGNIFICANCE:		
TYPE: HISTORICAL. ARCHITECTURAL.		
LEVEL: LOCAL.		
DESIGNATION EXISTING: PLANNING SCHEME.		
RECOMMENDED CONTROL: PLANNING SCHEME.		
GRID REF:	SURVEY: RP	DATE: 23.5.96. NEGS: 6.19

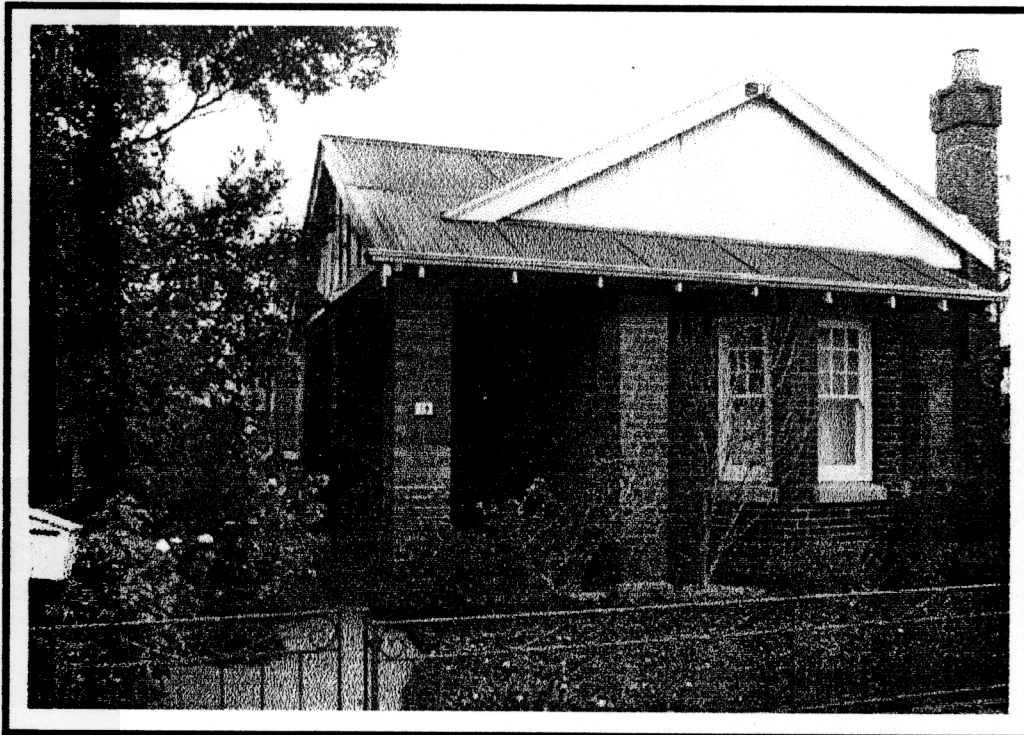
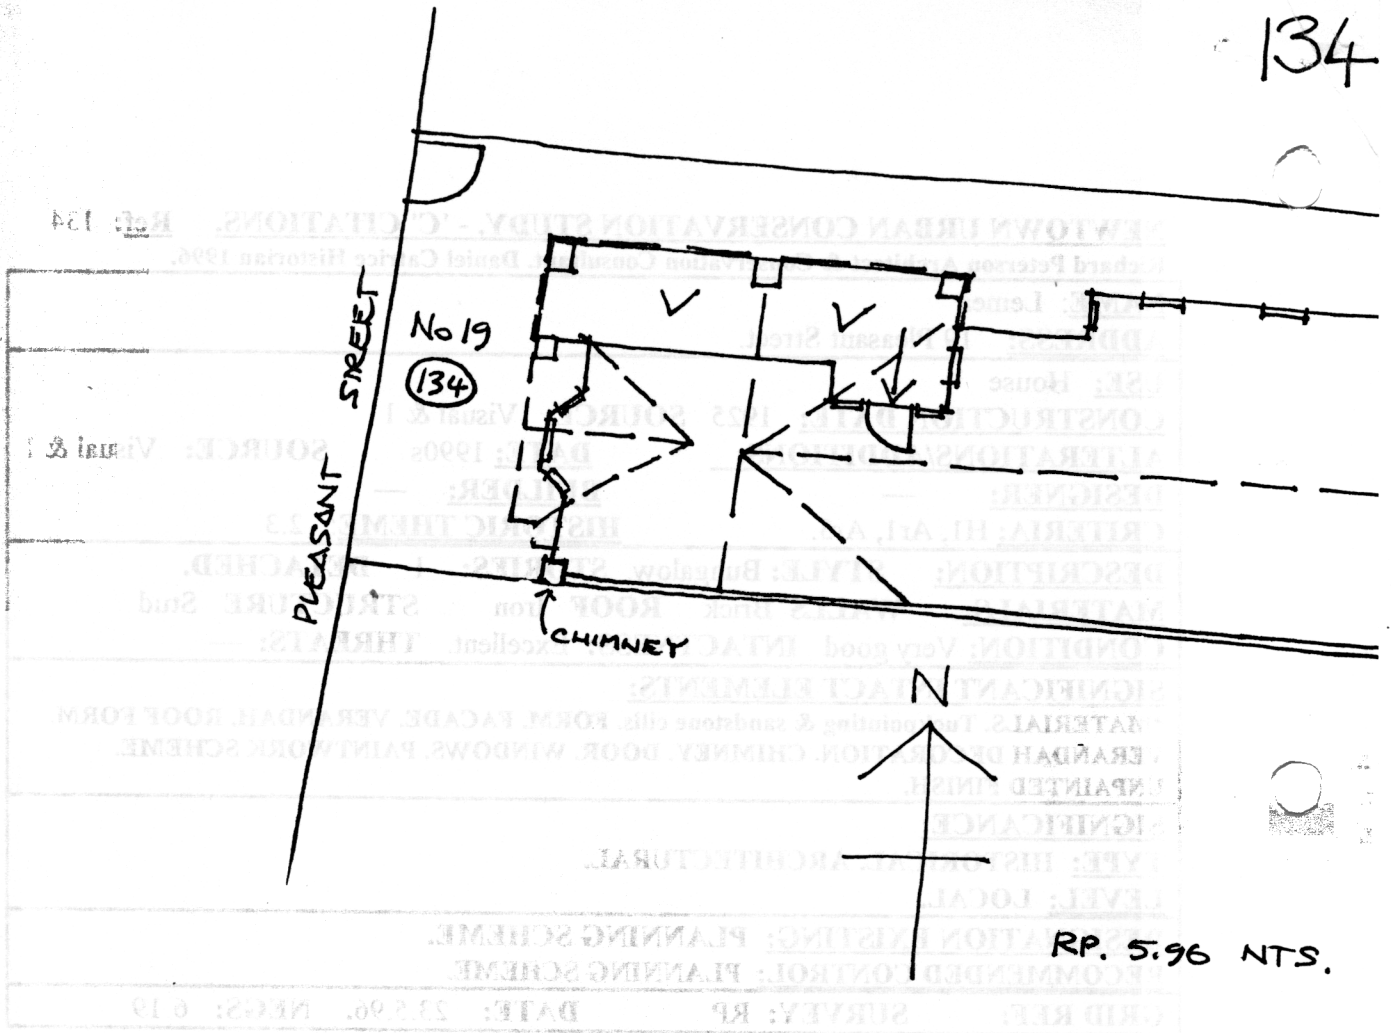
CONDITION & THREATS: Very good, but there may be rising damp damaging the tuckpointing. Closer inspection is needed.
