CITY OF GEELONG WEST

URBAN CONSERVATION STUDY: BUILDING IDENTIFICATION FORM

BUILDING ADDRESS **23 Candover Street** Type **residence** Original Use **residence**

CONSERVATION AREA Name **Ashby**

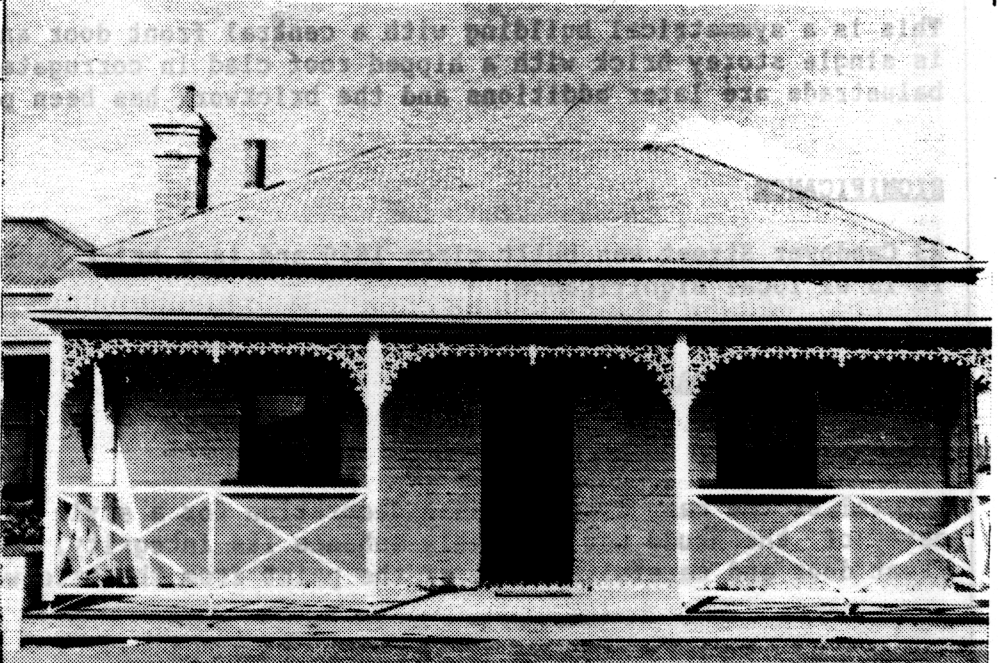
This is a symmetrical building with a central front door and a window each side. It is single storey brick with a hipped roof clad in corrugated iron. The verandah and balustrade are later additions and the brickwork has been painted.

23 Candover Street was built circa 1860 and is a brick house typical of that period. It is of local significance.

Removal of the cast iron verandah decoration for a style more appropriate for the date of the house would greatly enhance its integrity, as would a more appropriate front door and careful removal of the paint from the brickwork.
