CITY OF GEELONG WEST

URBAN CONSERVATION STUDY: BUILDING IDENTIFICATION FORM.

BUILDING ADDRESS *87 Clarence Street* Type *Residence* Original Use *Residence*

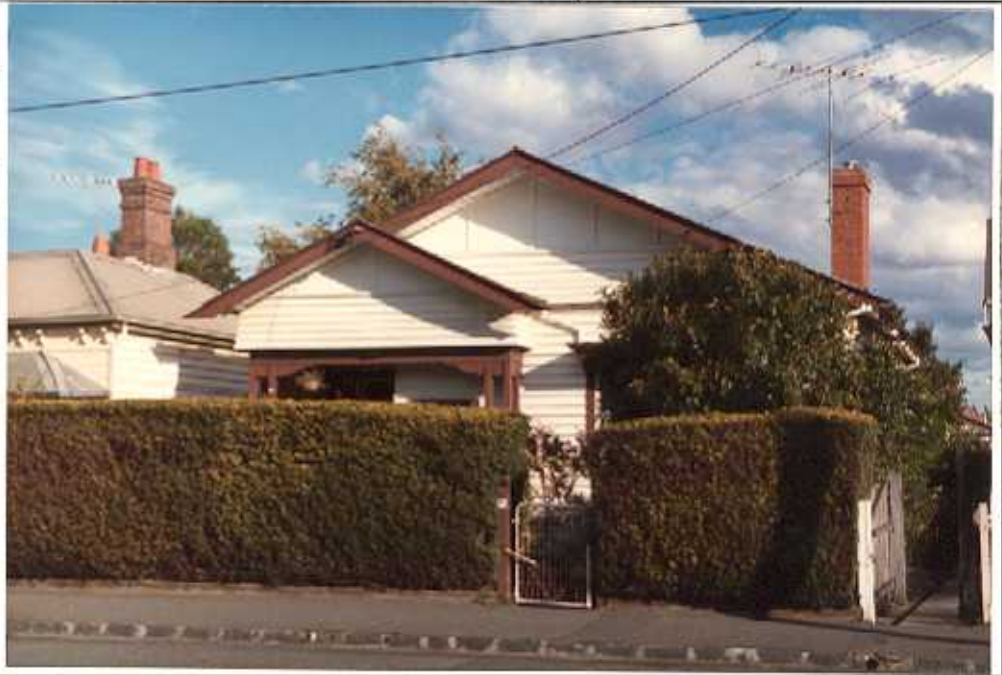
Description: A single-storey building with weatherboard walls and a corrugated iron roof. The simple gable roof is complemented by a projected gable porch. Decorative elements are few but include timber fretwork on the verandah porch and vertical pilaster strips in the gable ends. The wire fence and gate is supported by timber posts with decorative caps; much of this is concealed by a hedge.

The integrity of the building is excellent.
