BUILDING IDENTIFICATION FORM

RICHMOND CONSERVATION STUDY

BUILDING ADDRESS *83 BENDIGO ST*

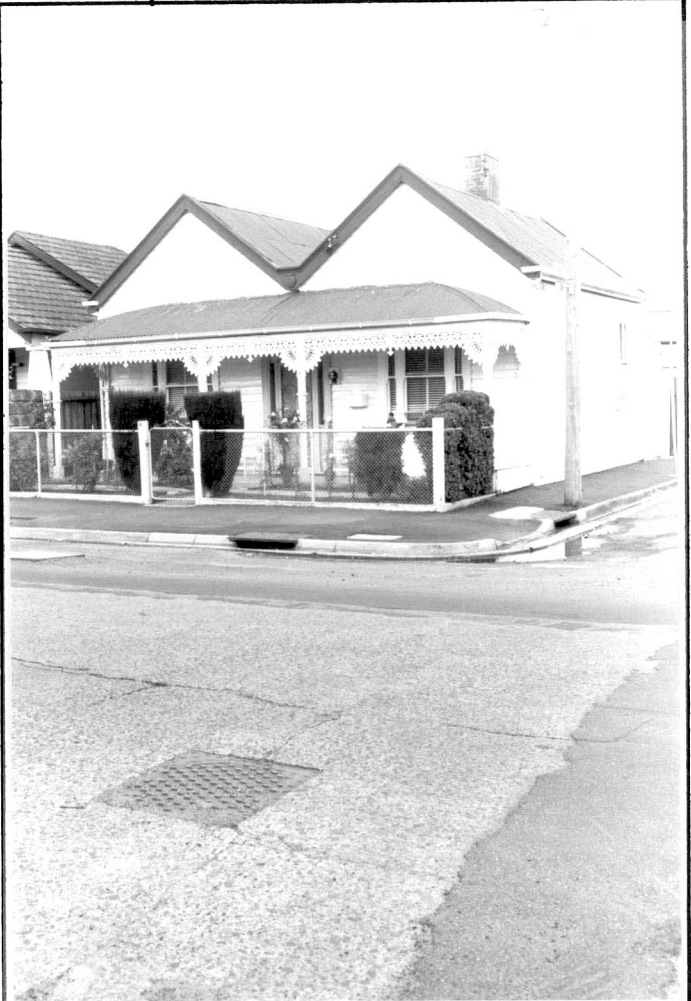
No.	Sympathetic	S.G.	Inappropriate	S.G.	Extremely Inappropriate	S.G.
			<i>FENCE</i>	<i>S</i>		
			<i>CHIMNEY</i>	<i>S</i>

COMMENTS
Unusual double gable corner building, with convex verandah roof.
