<b>Site:</b>	Fairfield Park	<b>Significance:</b>	B
<b>Address:</b>	Fairfield Park Drive, Fairfield	<b>Map Ref:</b>	30 112
<b>Access:</b>	Unrestricted	<b>Survey Date:</b>	8/5/98

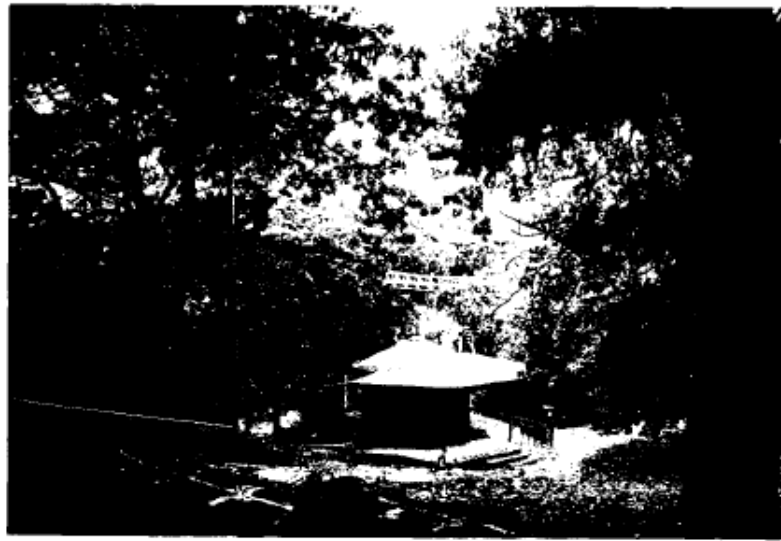
The water main and associated bridge is prominent within the park. The terracing established by 1914 appears to be largely intact, and has been augmented by a recent amphitheatre complex immediately to the east of the Swimming Clubhouse.

Butler (1982) has noted that there has been a noticeable loss of certain trees, principally the Cypress border on Heidelberg Road, but the character of the place has generally been maintained. Further removal of mature trees and failure to replace them with the same species will adversely effect the heritage character of the place. Introduction of new species to the site, particularly inappropriate native species will further erode the heritage character of the site.

The site requires the preparation of an overall Master Plan and Management Plan that would seek to reinforce the strong heritage character of the area. It should outline appropriate strategies for the replacement of senescent plant material and the introduction of new species, particularly in relation to restoration projects, such as the old rockeries. Guidelines for appropriate hard landscaping and detailing should also be included.
