BUILDING IDENTIFICATION FORM

RICHMOND CONSERVATION STUDY

BUILDING ADDRESS 517 SWAN ST

BUILDING ADDRESS 517 SWAN ST (NE COR BENDIGO ST)

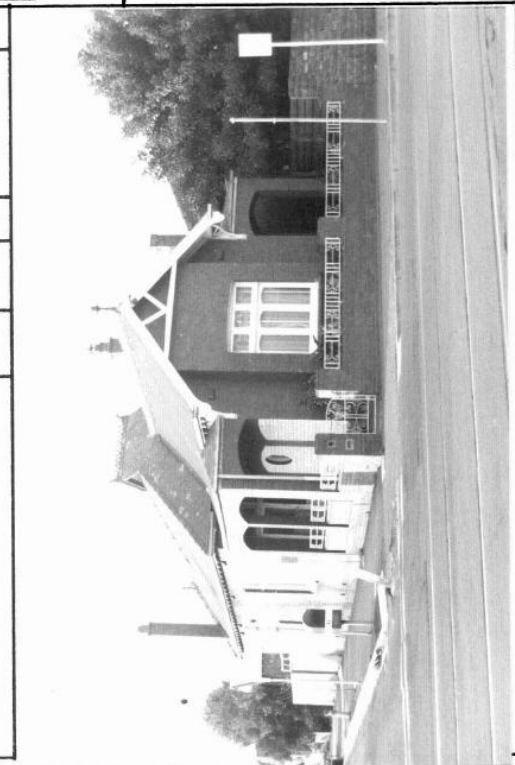
COMMENTS
Edwardian corner dwelling, with notable brick verandahs flanking the central gable and verandah roofs are formed from a change in roof pitch

O = reinstate original designs S = reinstate sympathetic alternative R = remove RAM = Remove by approved method
