## 3.0 PHYSICAL SURVEY

### 3.3 Hard Landscape Features

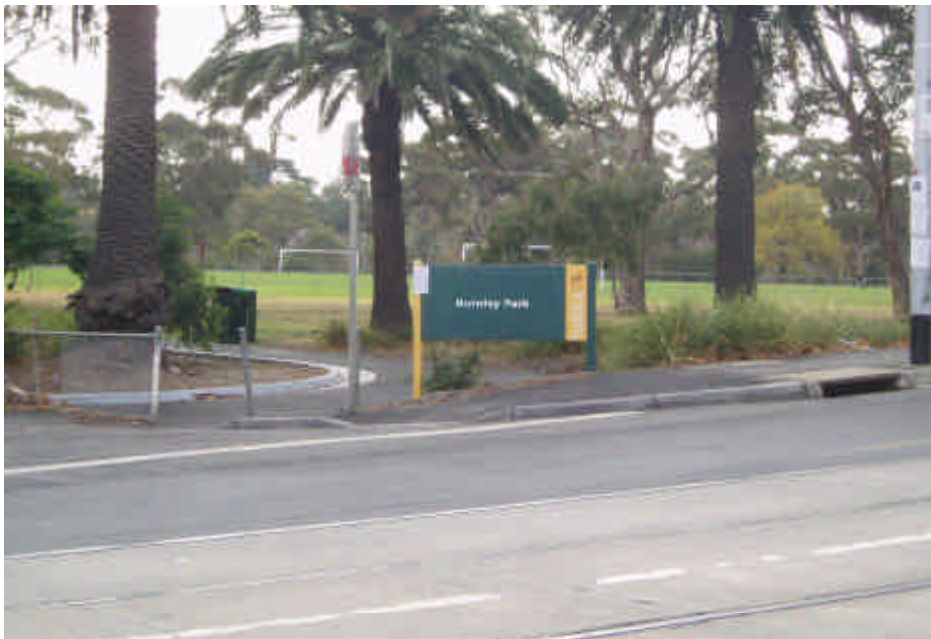
Richmond Park pedestrian entrance on the corner of Swan Street and Park Grove.

The southern pedestrian entrance to the site features the park name sign, and asphalt bike path extending from the Yarra Boulevard with a concrete kerb garden bed and a cyclone wire fence with steel pipe posts and rail, following the Park Grove boundary.

The pedestrian entrance on the corner of Swan Street and Park Grove is of no significance.

Retain or redevelop as required.

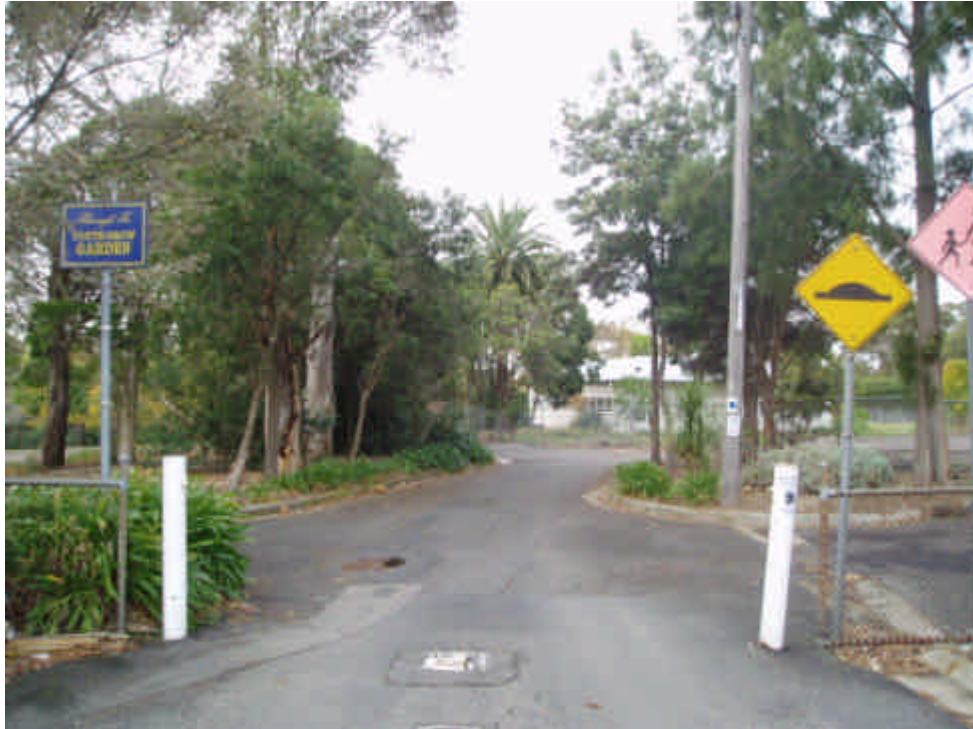
Richmond Park vehicle entrance.

The vehicle entrance is on the western boundary of the park. It is accessed from Bellevue Street, and leads to the car park in front of the Caretaker's Cottage.

The vehicle entrance is of no significance.

Retain or redevelop as required.

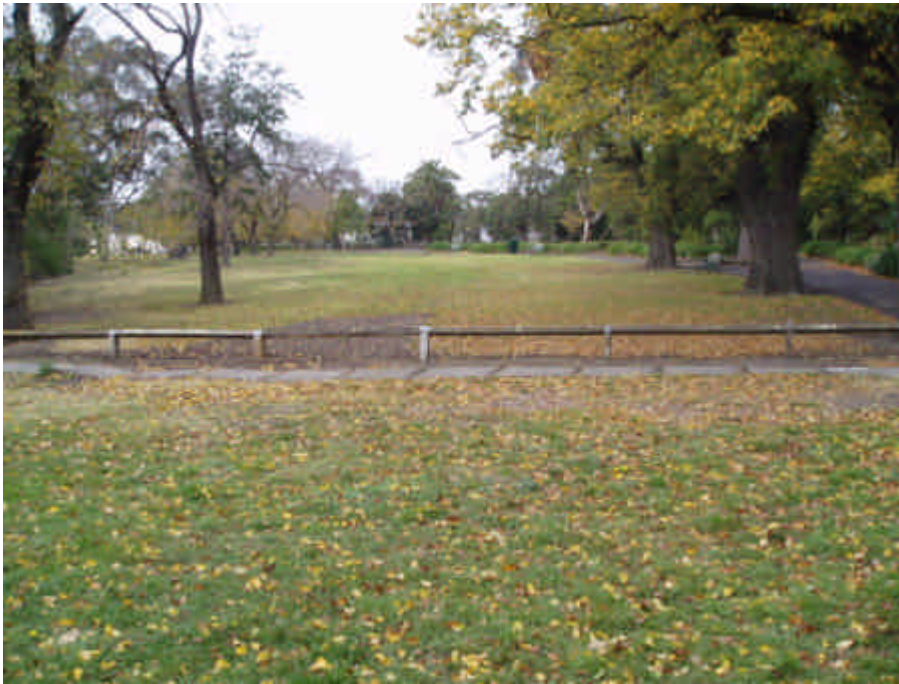
Richmond Park pedestrian entrance on Yarra Boulevard.

This fence was considered to be of primary significance by McPhee and Andrews as being demonstrative of an early (1920-1930s) type of fencing used in Richmond Park. Judging by the physical condition of the fence, some parts may be original, while others are probably replacements. The fence is assessed as being of contributory significance because of its ability to demonstrate a type of historical park infrastructure.

The Richmond Park pedestrian entrance and fence on Yarra Boulevard should be retained, although there may be scope for alteration and adaptation.

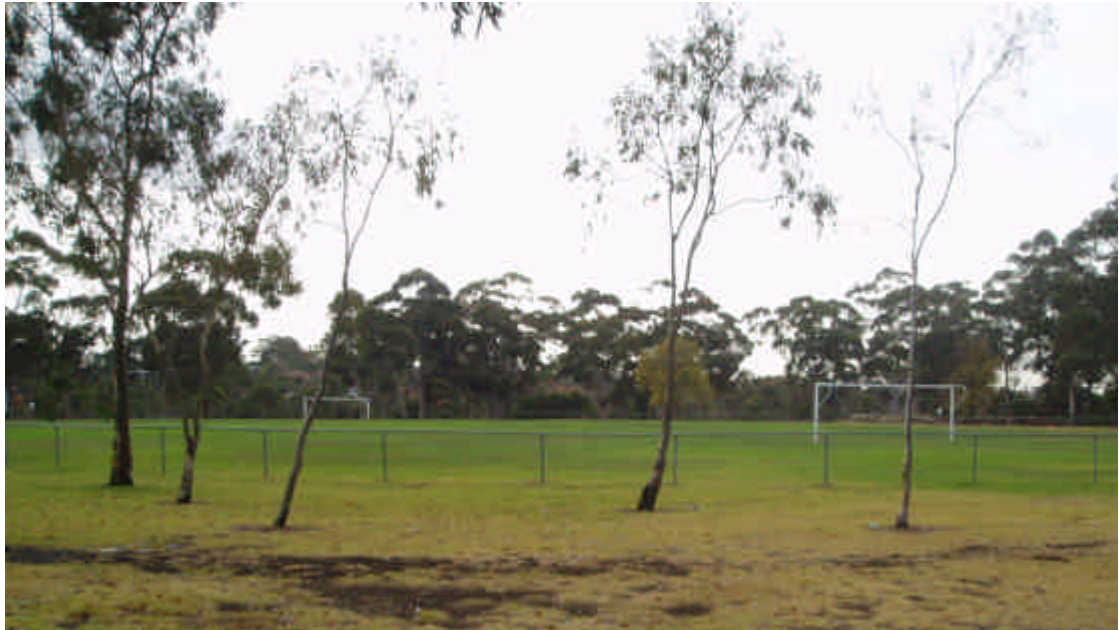
Burnley Oval.

The Burnley oval is of contributory significance because of its ability to demonstrate a continued use of the Park since the late nineteenth century. The Burnley Oval soccer goals are of no significance.

The Burnley Oval should be retained, but the soccer goals may be retained or removed as required.

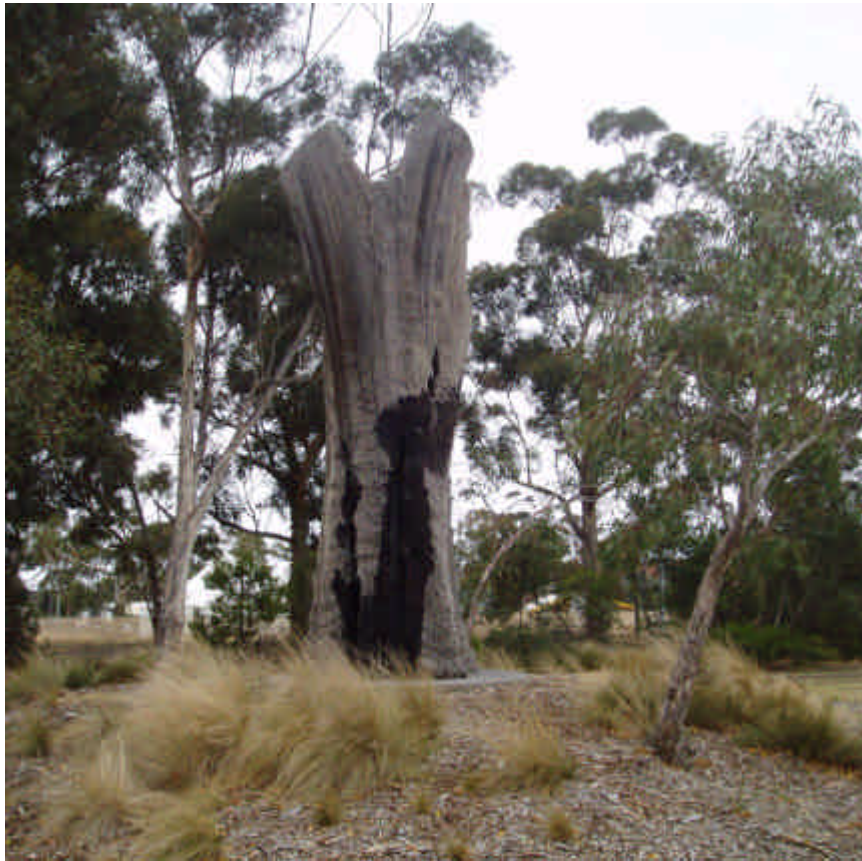
The Corroboree Tree stands as a singular element in the in the south eastern corner of the park. The Tree is set on a concrete foundation, presumably as a treatment for pedestrian traffic, that is causing deterioration at the base of the tree because of inadequate water drainage.<sup>10</sup> The tree is dead, and retained more as a monument or historical marker.

The Corroboree Tree is of Primary significance.

Investigate another pavement treatment to reduce the potential for further deterioration at the base of the tree, and repair deterioration if possible. Install interpretative signage.

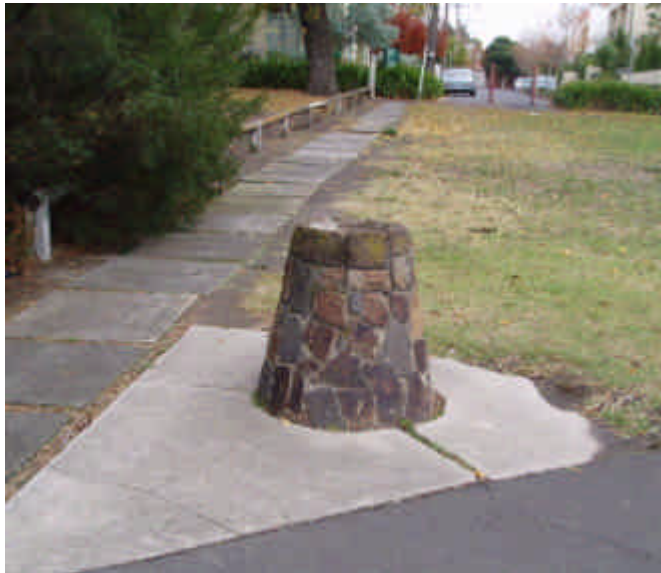
A former drinking fountain is situated immediately adjacent to the northern perimeter of the park. It is constructed of crazy slate, with an intact basin, but no tap. It is set on a concrete slab.

The drinking fountain may be of contributory significance.

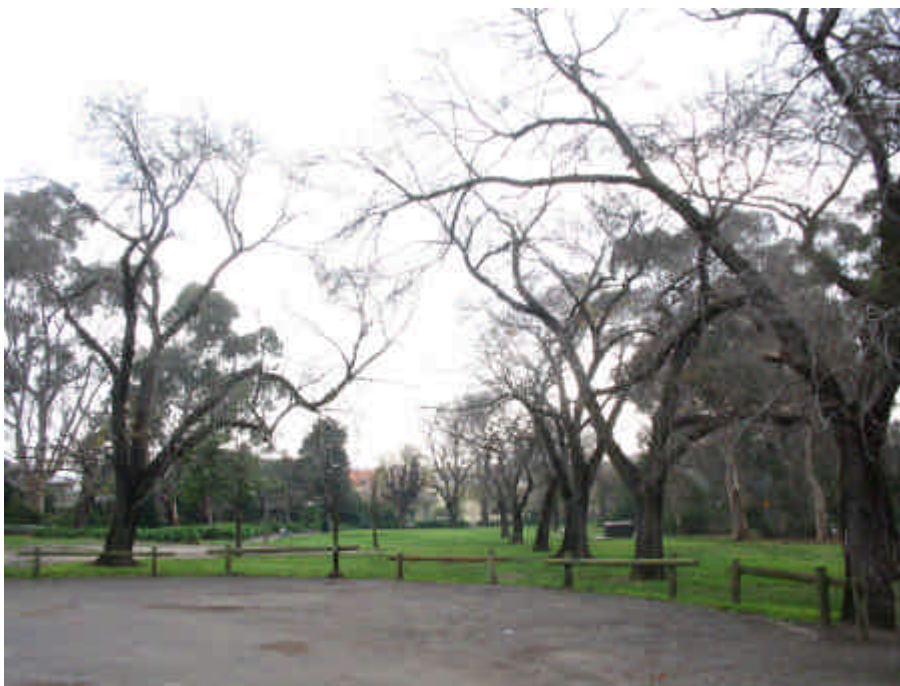
The Elm Avenue consists of three main sections. The trees at the northern end that were incorporated into the Boulevard are very large, mature specimens. A number have recently been removed and replaced with juvenile specimens of the same taxa.

There are two remnant trees in the far southern section near the railway line, isolated from the balance of the avenue. The enormous gap between these two trees and the balance of the Avenue illustrates how many trees were removed during the brief relocation of Burnley Primary School to the Park in the late 20<sup>th</sup> century.

Consider re-planting both sides of the missing section of the Avenue that was removed for the temporary re-location of Burnley Primary School, from the old Park Keepers Cottage to the two remnant trees in the southern section of the Park.

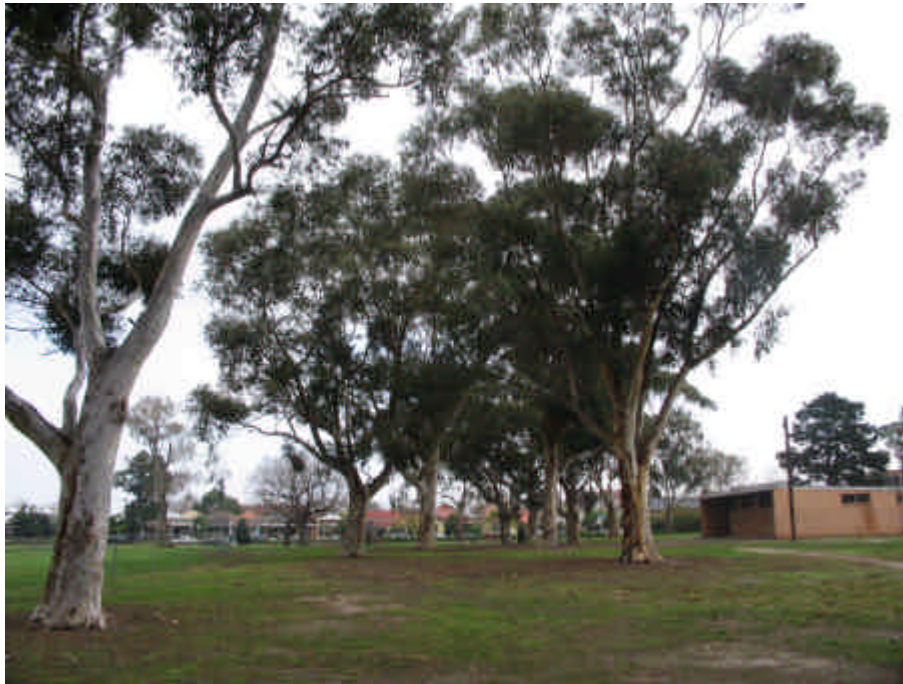
The Burnley Oval Eucalypt Plantations are located on the northern and southern sides of the playing field, converging to the east near the railway reservation. Many of the trees are senescent, or require ameliorative works to ensure their ongoing amenity or to address public safety issues.

The Burnley Oval Eucalypt Plantations are of primary significance as substantially intact plantings dating from the turn of the 20<sup>th</sup> century. They offer considerable amenity value and are amongst the most characteristic of plantings in the southern section of the park.

Manage and replace the trees, as required, as part of a tree management plan for the entire Park.

Investigate the exact alignment of the associated path system with the view to possible reconstruction of this early element of Burnley Park.

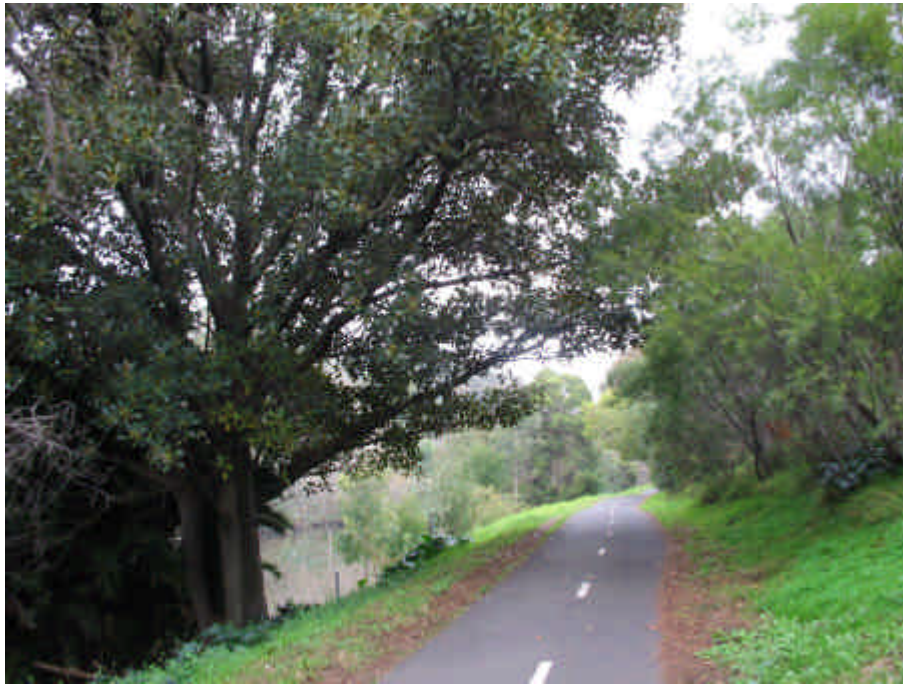
This section, as a discrete element within the broader Burnley Park precinct, is not considered to be of significance.

Implement a weed control and revegetation program throughout the area, as appropriate. Consider replacement of non-indigenous native specimens with locally indigenous trees, particularly the Mahogany Gums, which have a limited useful amenity lifespan due to their susceptibility to borer within the Melbourne region, and resultant propensity for massive limb drop.

Manage the large River Red Gum as part of a Tree Management Plan for the entire site. Consider its use as a seed source for revegetation activities within this area.

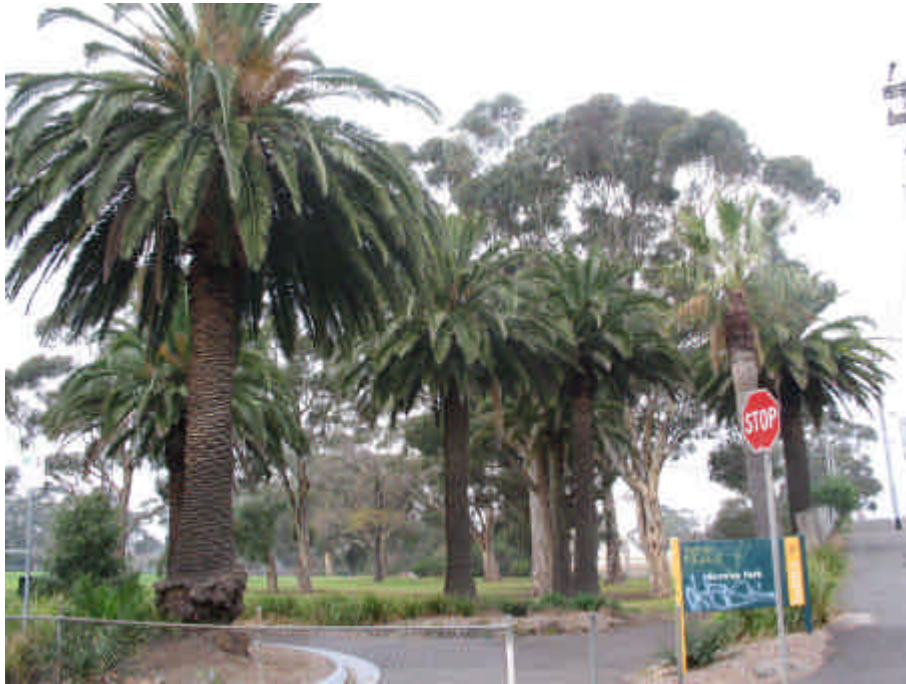
*Palm copse at Swan Street entry.*

Trees within Burnley Park of mid-20<sup>th</sup> century origin include a Palm copse at the south western Swan Street entry. Whilst these specimens are in generally good health and indeed form a fine feature to this entry point, there is evidence of partial soil coverage over the base of two trees on the Swan Street boundary that could affect their long-term health.

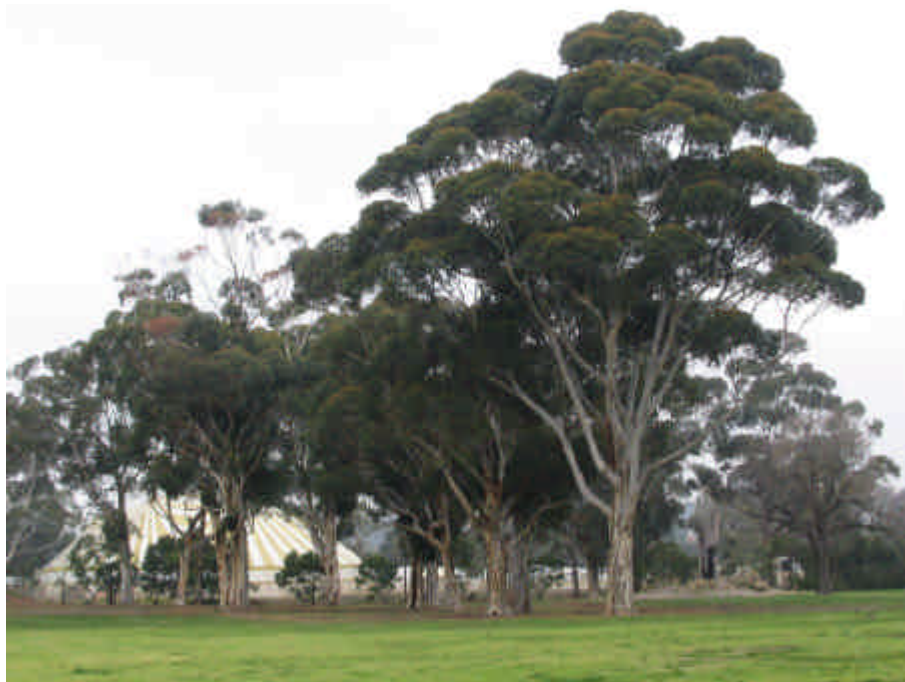
*Mature Eucalypts adjacent to the railway line*

The bulk of mature trees within Burnley Park are mature Dutch Elms (*Ulmus x hollandica*) and Eucalypts (*Eucalyptus cladocalyx*, *E. camaldulensis*). These trees date from the mid-19<sup>th</sup> century to the early 20<sup>th</sup> century. The individual health of these trees varies enormously, and is noted in Appendix 1, *Tree Survey*. There is evidence of poor pruning practice on many of these trees, some of which are senescent and require replacement.

Manage the trees identified as of significance as part of an overall Tree Management Plan for the site, including replacement strategies for over-mature and senescent specimens.
