Manningham Heritage Garden & Significant Tree Study

Significant Tree Information Sheet

Tree Identification No.: 25
Botanical Name: *Eucalyptus cinerea*
Common Name: Mealy Stringbark
Location: Anglican Church
 106-118
 Church Road, Doncaster

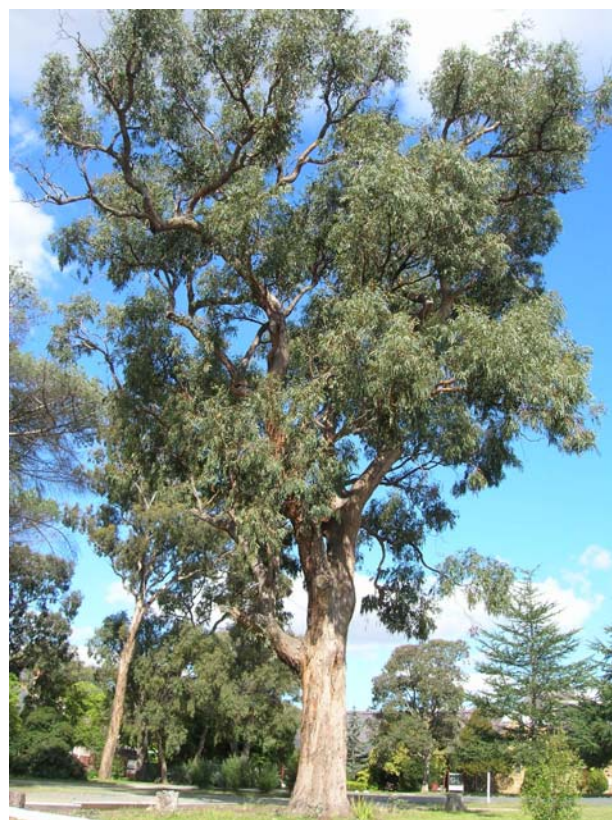
Other/Notes: Deadwood present.

Threats/Risks to Tree: Damage to the trunk from lawn mowers

Other/Notes: Tree has lost some limbs (some large) and has a warning sign attached stating such. Some dieback is present in pruning points and there are co-dominant leaders in the canopy. The tree is also bifurcated with there possibly being damage at this point.

Tree requires a safety assessment by a qualified arborist as soon as practically possible with deadwood removed and any other necessary maintenance work carried out.

The tree should be assessed every one to two years by a qualified arborist, carrying out works as required. The area under the tree has had some trees and shrubs etc. planted. This practice should be expanded with additional native grasses and strappy plants. These will not dominate the form of the tree while still restricting the access of pedestrians under the canopy. The carpark should also be moved so that it is not under the canopy of the tree, with these measures helping to reduce the risk of damage to the public when limbs fail.
