## Manningham Heritage Garden & Significant Tree Study

### Significant Tree Information Sheet

**Tree Identification No.:** 5  
**Botanical Name:** *Eucalyptus sideroxylon*  
**Common Name:** Iron Bark  
**Location:** 43 Harold St, Bulleen

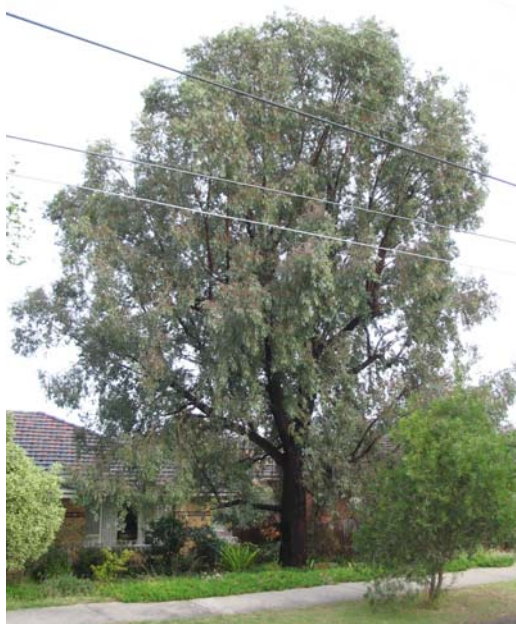
**Other/Notes:** Tree was generally in good health at the time of inspection.

**Other/Notes:** Tree was lopped and now has a canopy made up mostly of epicormics. Co-dominant leaders also present.

**Structure Rating:** 4

The procedure of lopping the top off the tree has led to a canopy comprised of structurally unsound epicormics. Therefore the tree must have regular (twelve month intervals) inspections and remedial work carried out by a qualified arborist until the tree is more structurally sound; at which time the frequency of inspections and maintenance work can be reduced.

**Works Required & Priority:** Tree should be subject to an inspection by a qualified arborist as soon as practically possible in order to determine safety and stability of epicormics and large branches,

as well as to carry out required maintenance works. This should be carried out as a matter of urgency in order to preserve the safety of people moving around and under the tree.
