Conservation Management Plan
Fernlea
75 Tuckers Road, Clyde, VIC 3978

17 SEPTEMBER 2020 – FINAL DRAFT

Prepared for Verve Projects Pty Ltd on behalf of the Owners of Fernlea

GJM Heritage

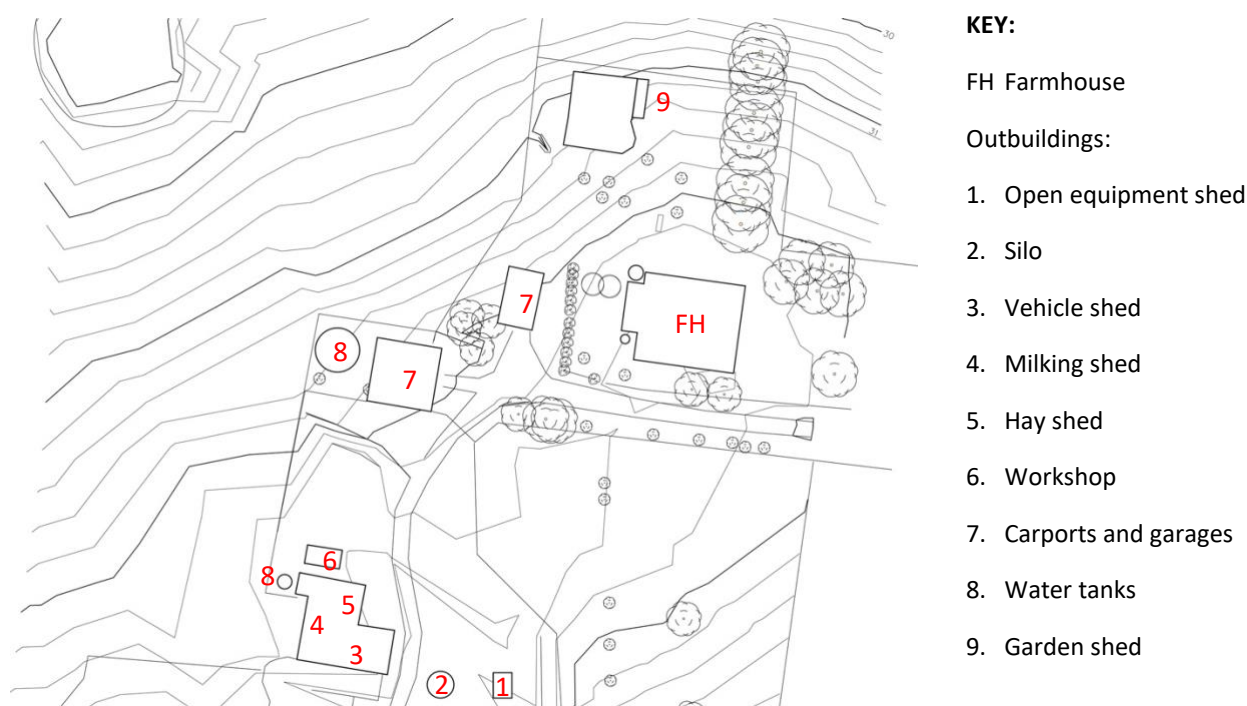
Site Plan showing structures (adapted from drawings prepared by Leah Lloyd-Smith Architect)

The Farmhouse is generally in a fair condition. The following dilapidations were observed to the exterior fabric:

- Warping and lifting of short-length painted corrugated metal roof sheets – it is presumed the sheets were overpainted due to surface rusting or failing galvanic coating;
- Flaking and peeling paint to underside of verandah roof sheeting;
- Replacement of cappings and flashings of variable visual match;

- Local depressions to non-original quad profile eave gutter;
- Variable deterioration of paint coating integrity to external walls (the underlying ashlar tooling in the render is masked by paint) with erosion or water-damp deterioration evident below and the quality and compatibility of substrate is variable;
- Eroded profile of rendered dressings, especially to chimneys, which are further masked by paint coat application;
- Local cracking to render, especially openings;
- Cracking to concrete verandah;
- Raised ground levels and installation of the concrete verandah floor has compromised the wall vents, building damp-proof course and is thought to be contributing toward rising damp deterioration to wall faces and building movement;
- Select panes of sash window glass broken; and
- Splits, checks, wear and mechanical damage to external timber frame joinery elements.

The following dilapidations were observed to the interior spaces:

- Variable loss of timber integrity to soffit and lining boards and cornices, select trims missing;
- Flaking, blistering and peeling paint to various plaster surfaces, presumed to indicate rising damp deterioration to select wall faces;
- Variable cracking and de-bonding to plaster especially about openings or at low-level;
- Modification of fireplaces and fire-settings, including removal of fire-boxes;
- Loss of vent grilles to ceiling roses;
- Covering of early floor surfaces including timber floorboards; and
- Unsympathetic previous repair or alteration.

The open equipment shed (Outbuilding 1) was inspected externally and internally and is in poor condition. The following dilapidations were observed:

- extensively warped, discoloured/ rust staining to cladding and capping (of like material), with corrosion at sheet ends;
- ogee profile eave gutter is disengaged or missing and the roof free drains;
- several wall cladding sheets are loose, disengaged or have holes and there is water staining; and
- weathering to all timber frame members to a varying degree with interiors unlined.

The silo (Outbuilding 2) was inspected from the exterior only and is in fair condition. The following dilapidations were observed:

- discoloured/ rust staining to cladding (wall and roof) and fixings (of like material), with corrosion sheet ends;
- extensive rust staining to door hinges; and
- mechanical damage to ladder.

The vehicle shed (Outbuilding 3) was inspected externally and internally and is in very poor condition. The following dilapidations were observed:

- warping, discolouration/rust staining and holes to corrugated cladding, fixings and rolled capping with corrosion sheet ends;
- extensively discoloured/ rust staining to flat cladding and fixings;
- a free-draining ogee profile eave (box) gutter with rust staining and spot corrosion;
- several wall cladding sheets that are loose or have holes (some patched) and display water staining;
- visible weathering to all timber frame members to a varying degree, several roof frame members are split or disengaged, and;
- splits or growth-ring delamination of timber poles.

The milking shed (Outbuilding 5) was inspected externally and internally and is in very poor condition. The following dilapidations were observed:

- warping, discolouration/rust staining and holes to corrugated cladding, fixings and rolled capping with corrosion sheet ends;
- a free-draining ogee profile eave gutter with visible cupping and inadequate falls;
- missing, loose or holed wall cladding sheets (select patches);
- missing timber whalers at select locations to the cattle lot (south) elevation; and
- weathering to all timber frame members to a varying degree, several frame members are split.
