**Lal Lal Estate Stables
313 Yendon Egerton Road
Lal Lal 3352**

Heritage Report

Wendy Jacobs FRAIA, M.ICOMOS
Architect and Heritage Consultant

May 2015
Revised 7 September 2015

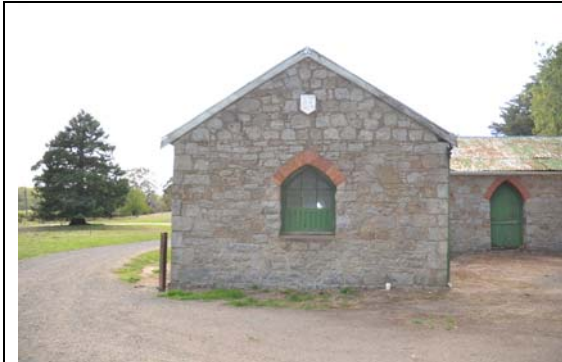
Photo 1 West gable end

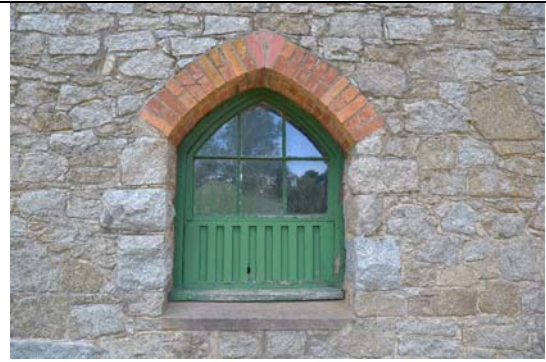
Photo 2 Detail of window, west gable end showing timber vent in lower section

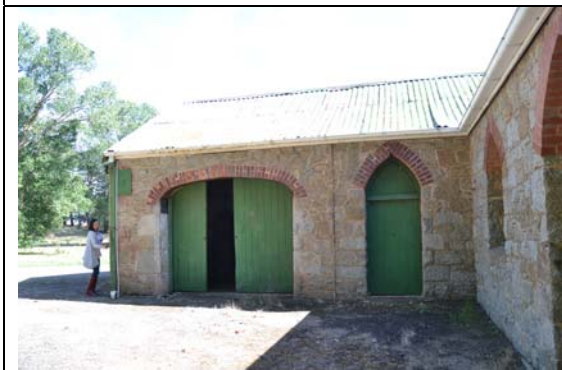
Photo 3 South face of west gable showing swing doors converted to sliding doors.

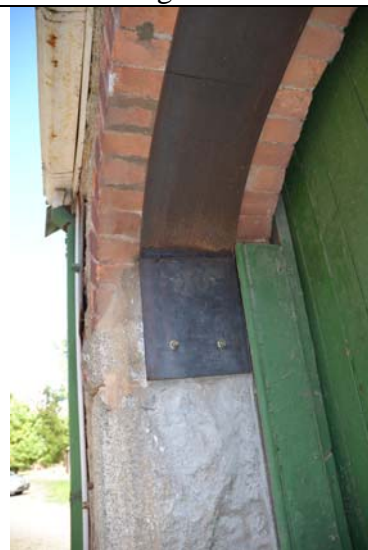
Photo 4 South face of west gable showing detail of door reveal showing curved stonework indicating earlier swing doors. Note introduced metal lintel.

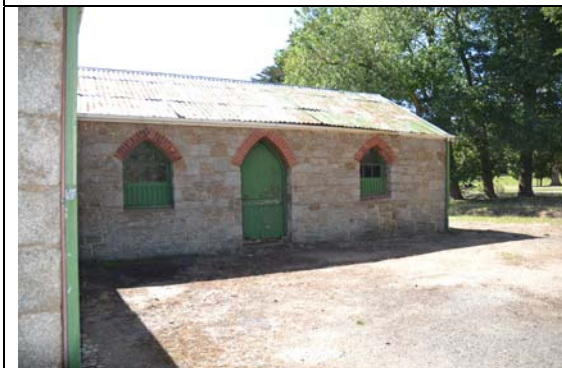
There is a rectangular downpipe that has suffered mechanical damage on the south end of the wall. This discharges into a pit edged with introduced twentieth century bricks. The pit appears to have silted up and not drain.

Photo 5 West wall of main gable.

Guttering and downpipes – There is evidence of rust in the gutter and downpipes and there has been noted some mechanical damage to downpipes. I recommend that the gutters and downpipes be replaced. I suggest that the current quad profile gutter, while mid twentieth century is acceptable. I would retain the rectangular profile for the downpipes. Ensure that any new guttering and downpipes are of galvanised steel to be compatible with the existing roofing. Do not use zincalume or Colorbond.

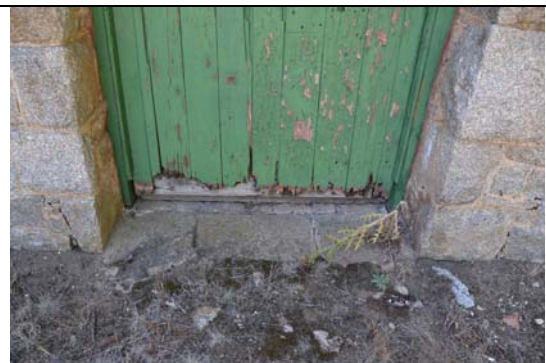
There is a central pedestrian doorway with the door (D5) clad in vertical boards and divided horizontally into two sections. On each side is an arched window similar to the window in the gable end. The three openings have pointed arched heads with introduced twentieth century brick voussoirs. The door has damage to the base of the lining boards.

Photo 6 West wall door showing damage to base.

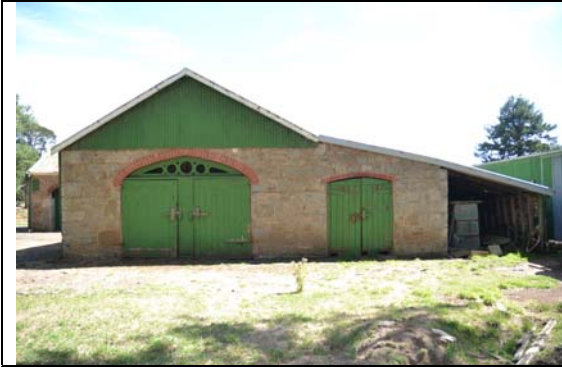
Photo 7 South face of stables showing doors to loose boxes and extension of skillion to form store area

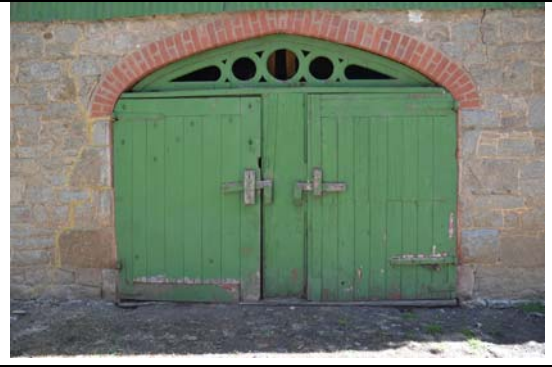
Photo 8 South face of stables showing doors to loose boxes

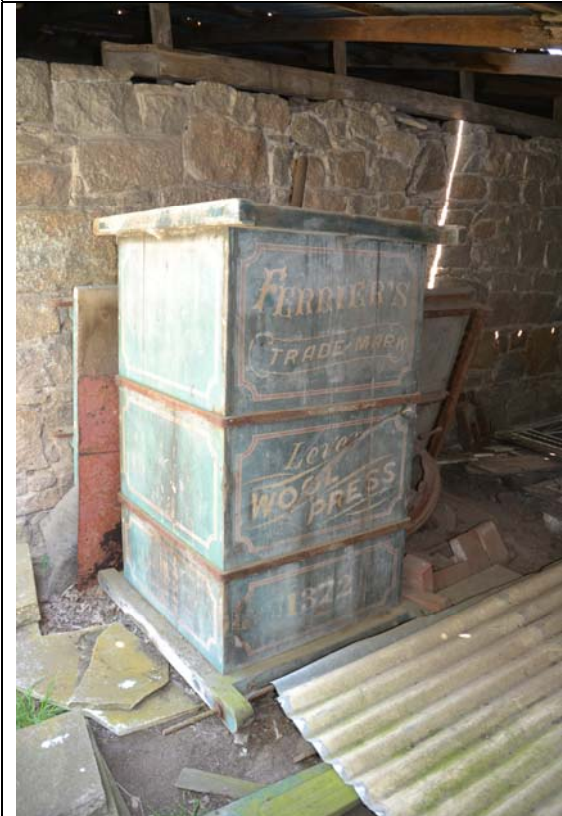
Photo 9 Part of early woolpress

retained and assessed for display or to assist with the interpretation of the building.
The retained Ferrier wool press is of interest.

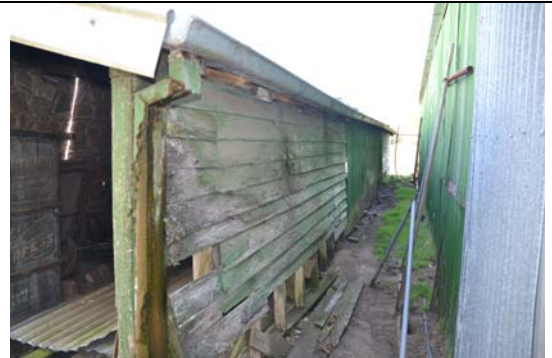
The east wall of the building is now adjacent to the new steel clad shed. The early wall of the east skillion was roughly coursed stones with no openings. The skillion roof was extended and a covered area created further to the east. This has a timber stud frame east wall with timber square edged weatherboard cladding for the south and north sections and vertically hung corrugated steel sheet cladding in the central section. The covered area is divided into north and south sections by an internal timber stud frame wall with weatherboard cladding now partly removed in the central section. There is a twentieth century quad gutter and rectangular downpipe on the south end of the wall.

Photo 10 East wall of open store

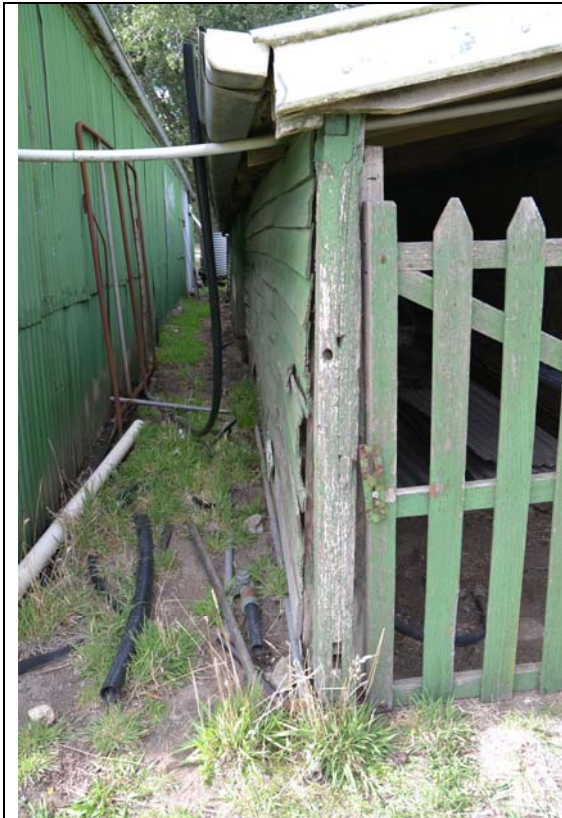
At the east, the covered area is open with a timber picket gate. The post at the east corner appears to have been cut down from the posts which once separated the horse stalls in the stables area as it has stop chamfered corners. The main wall is roughly coursed stonework with the corners having more squarely worked stones and slightly squarer stones used around the two doors and window. The skillion roofed section covering the store has a central flat arched opening with a pair of timber framed doors clad in vertical timber boarding. The brick voussoirs in the arch have been replaced in the twentieth century. To the east of the hipped and gabled section is a large double door opening to the stables. This has a flat brick arch with the brick voussoirs having been replaced in the twentieth century. The timber framed doors have vertical timber cladding. The stone reveals have been shaped with curves to allow for the swing doors. There is a narrow window to the groom's room to the west of the doors. There is a plain timber fascia with a twentieth century quad gutter.

Photo 13 detail of post showing stop chamfering

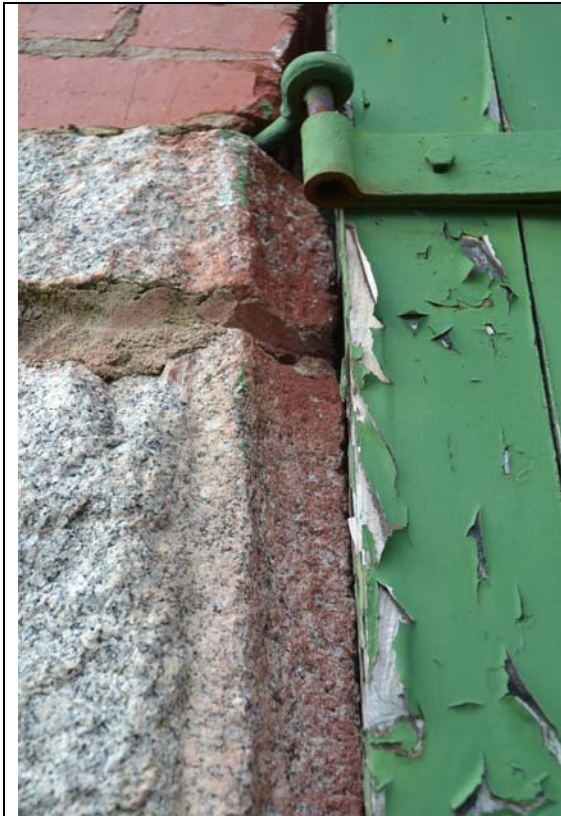
Photo 17 North wall, detail of curved stone to allow for door swing

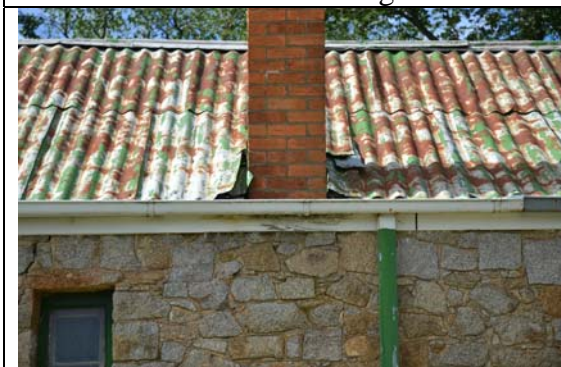
Photo 19 North wall, detail of chimney showing flashing problem.

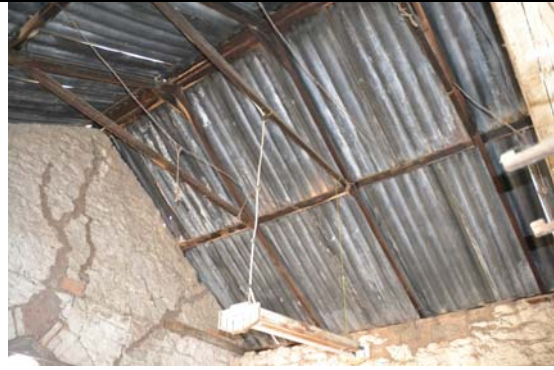
Photo 21 Interior of Tack Room (Room 1) looking north east showing roof structure and cladding

Currently the roof is unlined. This is the original finish but leads to difficult internal conditions on hot and cold days. It is possible to line the roof with a sandwich board which provides thermal insulation and install this between the roof rafters to allow them to be exposed to some extent. If these are painted a light grey colour similar to the colour of the galvanised steel roof cladding, this can provide a better thermal environment with little loss of character of the place.

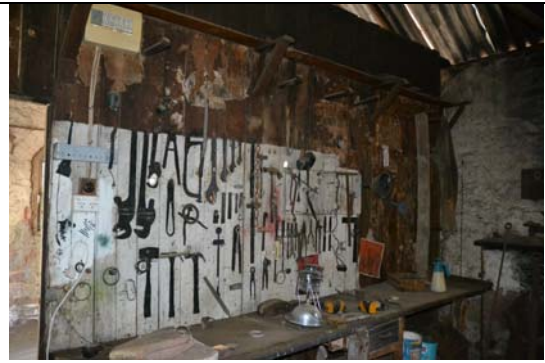
Photo 26 Groom's Room (Room 2) looking west to timber partition wall marked out for hanging tools.

I suggest keeping as much of the original fixtures and fittings as possible and using as part of the fit out for any new use. I would retain the basic layout of spaces. The timber floors for Rooms 1 and 2 can be retained and repaired. The cobbled floors of spaces 3 and 4 may be more of a challenge. The rough nature of the cobblestones and the drainage channels are essential to the character of the place but may not be suitable for a proposed new use. Retaining the floor and sheeting over it with timber to produce a smooth surface may require some changes to door openings to comply with current regulations. The alternative is to close off doors and just use the larger openings for access. There may be some need for step ramps to comply with accessibility issues depending on the use of the place. In the main stable area (Room 3) I suggest retaining the last remaining post which indicates the stall divisions and the existing boarded up wall openings which interpret the stall layout in the area. In Room 2, I would retain the wall with the painted outline of the tools to indicate this use of the room.

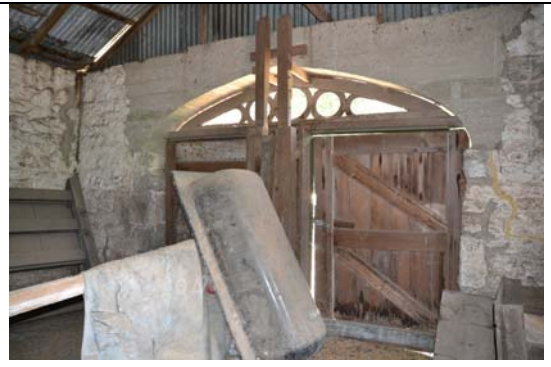
Photo 38 Loose Boxes (Room 4) Looking south to doorway showing introduced concrete in wall

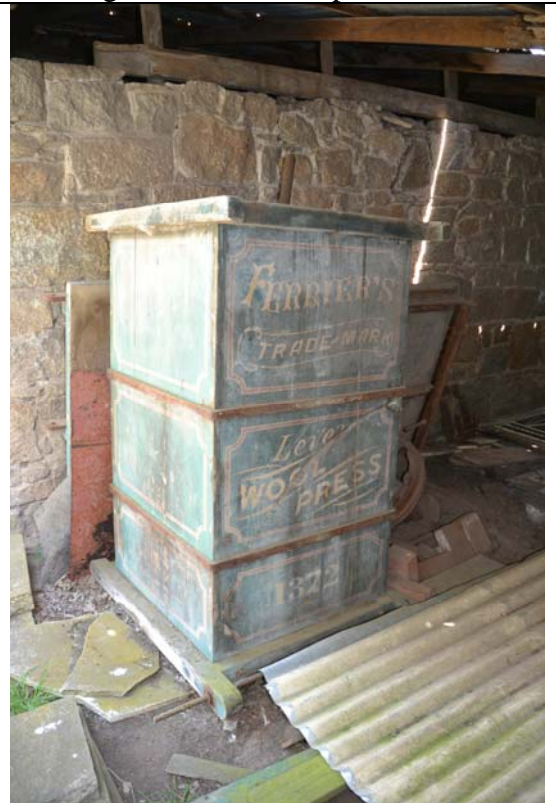
Photo 48 Covered Area (Room 6) showing base of early wool press in store.
