Ballarat Mining Exchange

12 Lydiard Street North, Ballarat

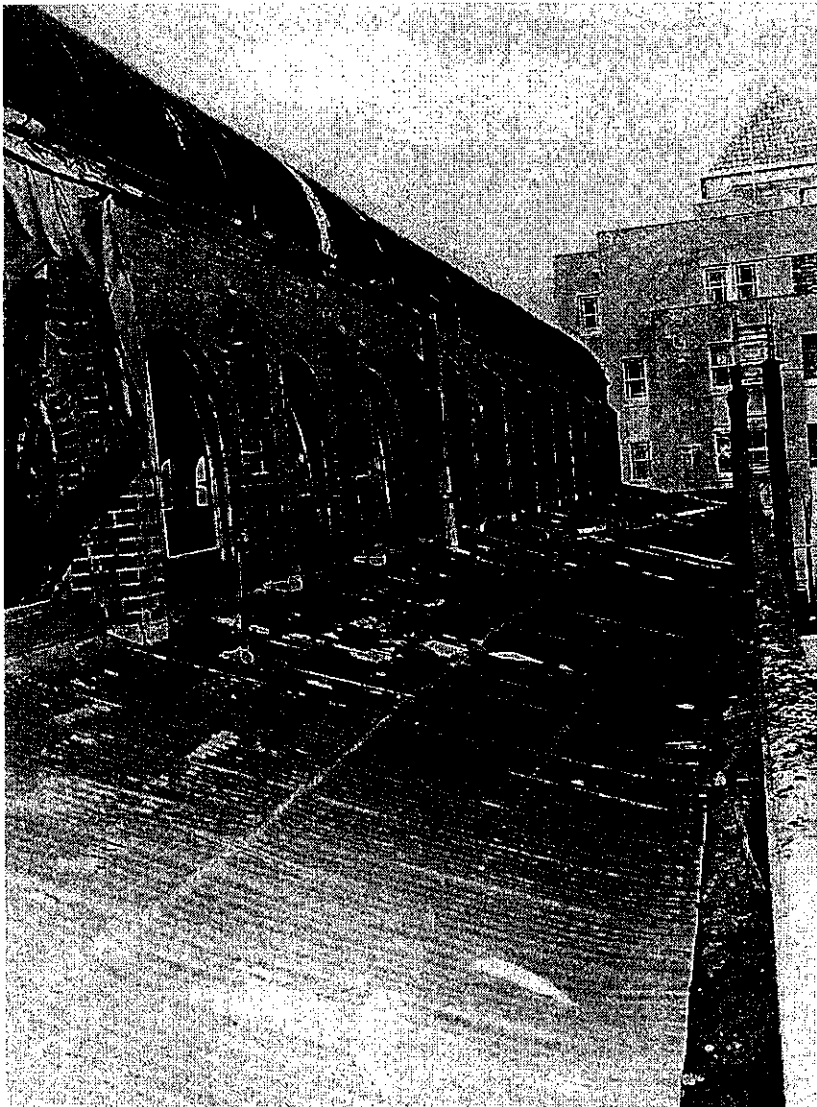
Figure 2.14: Exterior detail of Exchange hall clerestory windows, north elevation, c.1974. Note the damage/deterioration of the windows at that time. Source: City of Ballarat files..

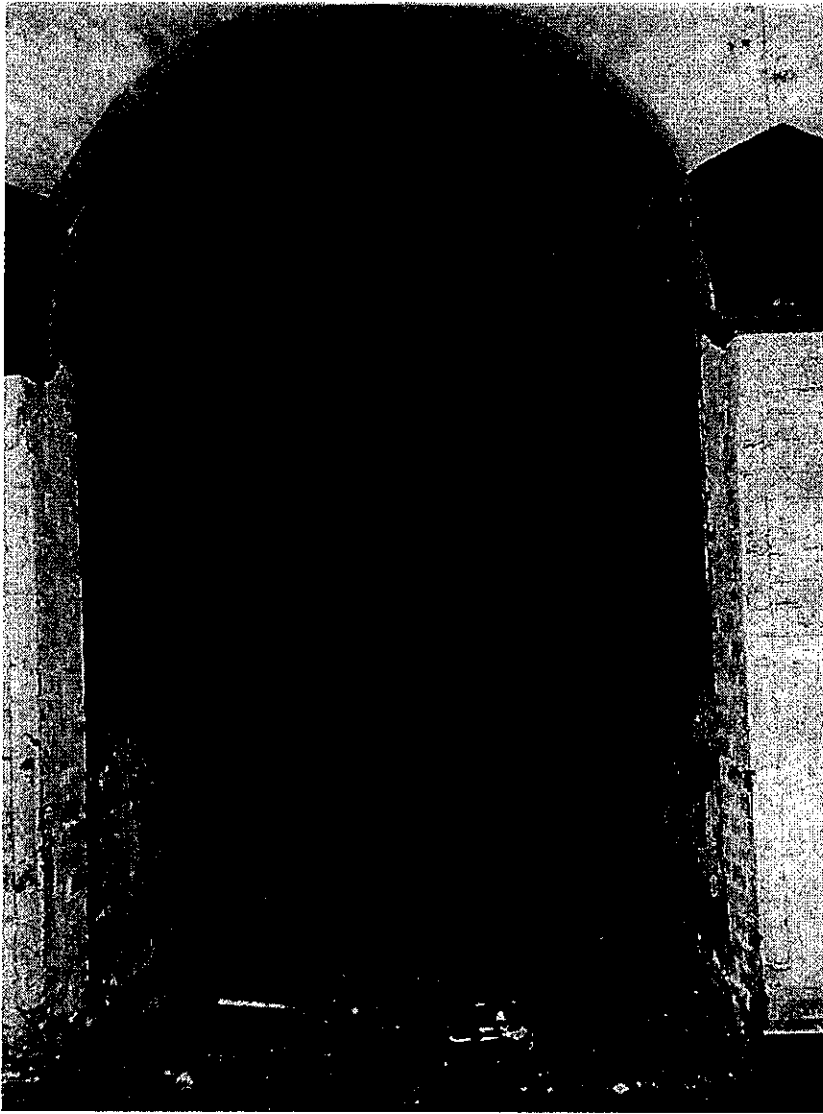
Figure 2.15: Interior detail of broker's booth off the Exchange hall, c.1974. Note the considerable deterioration in the plastered walls and timber floor caused by significant falling and possibly rising damp. Source: City of Ballarat files.

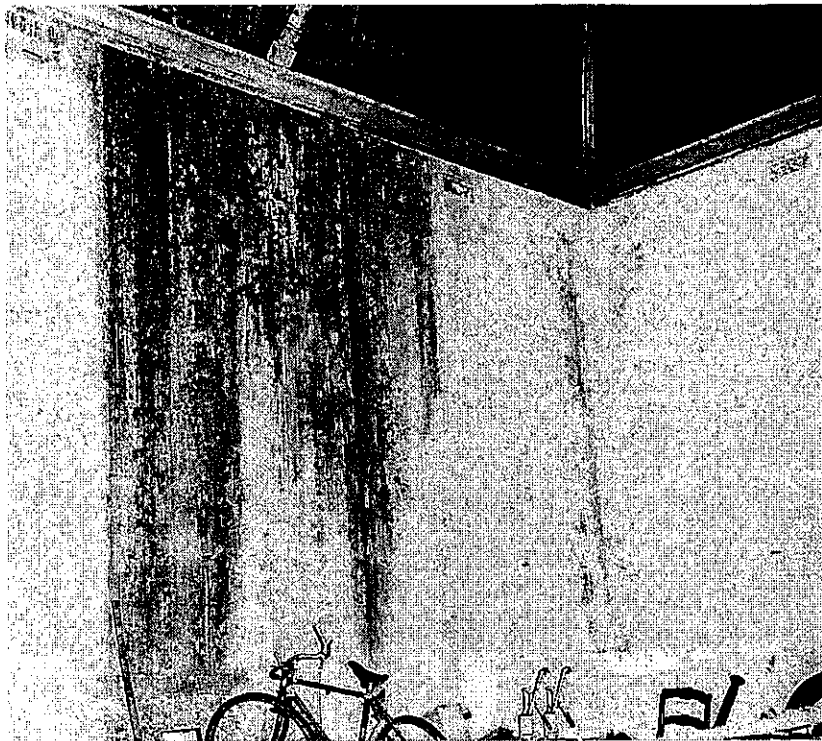
Figure 2.16: Interior detail of the Call Room, c.1974, showing evidence of substantial falling damp and deterioration in the coved timber ceiling. Source: City of Ballarat files.

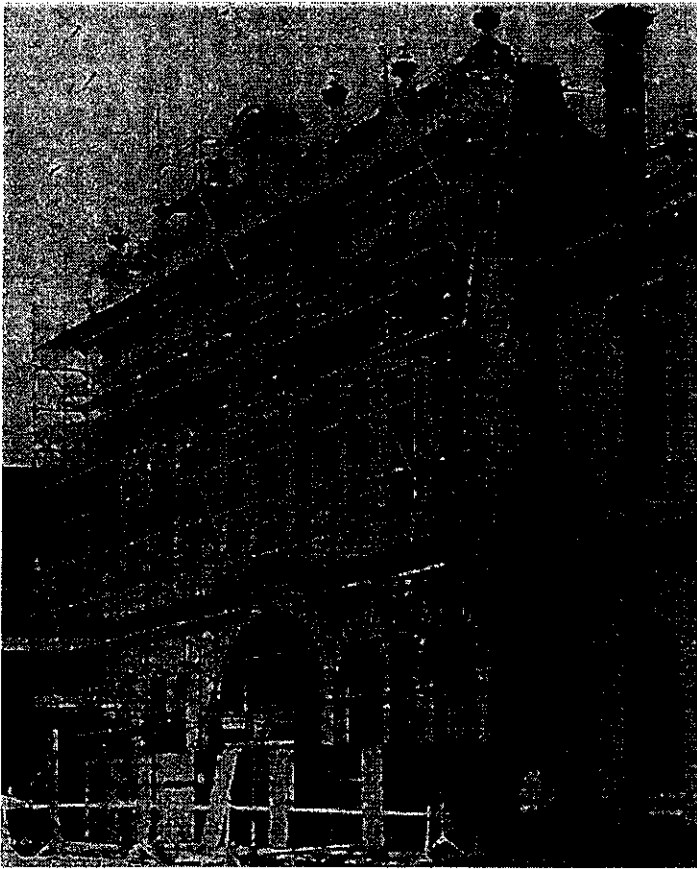
Figure 2.17: Scaffolding erected as part of the restoration of the Lydiard Street façade, September 1983. Source: *The Courier* newspaper, Ballarat, 22 September 1983 in National Trust of Australia (Victoria) file no. B3565.

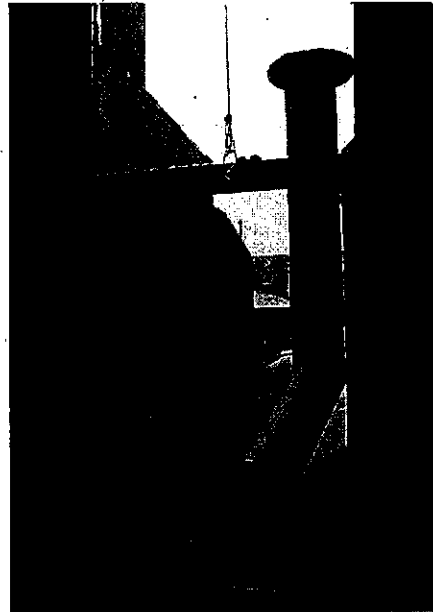
Photo 3.16: Exterior, Exchange Hall, north elevation (clerestorey level), west end showing introduced zincalume ventilation stack which is causing rusting at the junctions of the base cladding and the roof cladding.

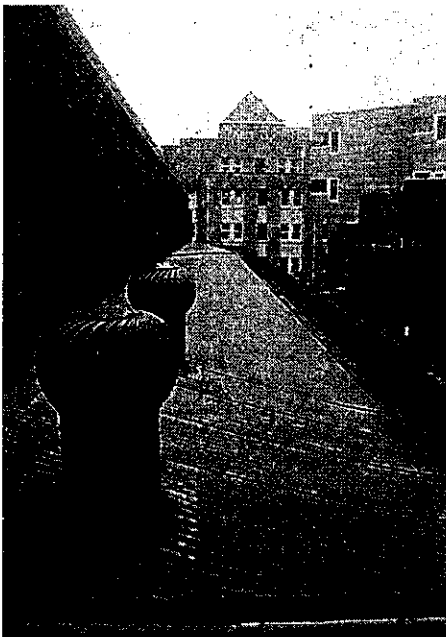
Photo 3.17: Exterior, Exchange Hall, south elevation (clerestorey level), west end, showing galvanised ventilation stacks.

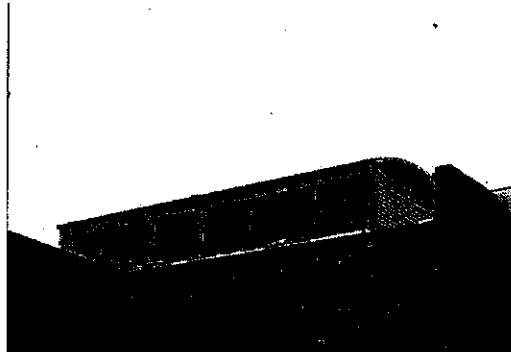
Photo 3.18a: Exterior, Call Room, south elevation showing deteriorated framing and cladding of lantern light.

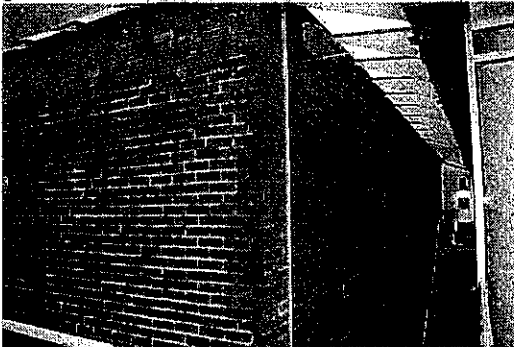
Photo 3.18b: Exterior, Call Room, view of north and east elevations now largely enclosed by the new University of Ballarat building.

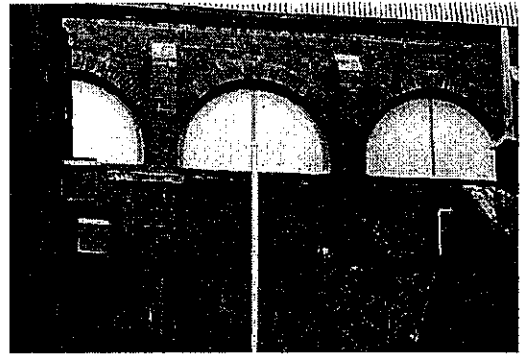
Photo 3.20: Exterior, Exchange Hall and Toilet Wing (part north & west elevations respectively). Note the deteriorated rendered capping to the parapet of the lower north façade of the Exchange hall.

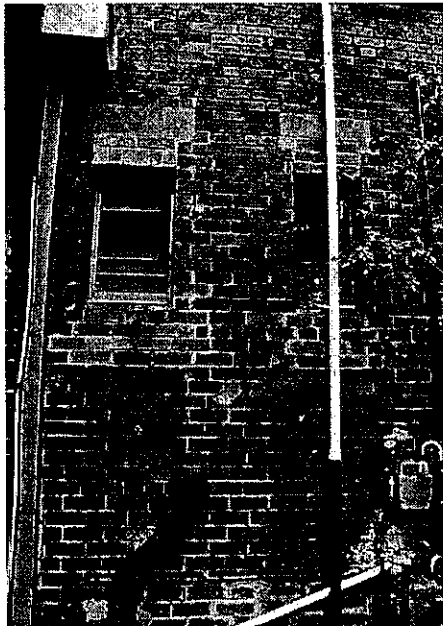
Photo 3.21: Exterior, Exchange Hall, part lower north elevation showing introduced toilet windows of ladies' toilets.

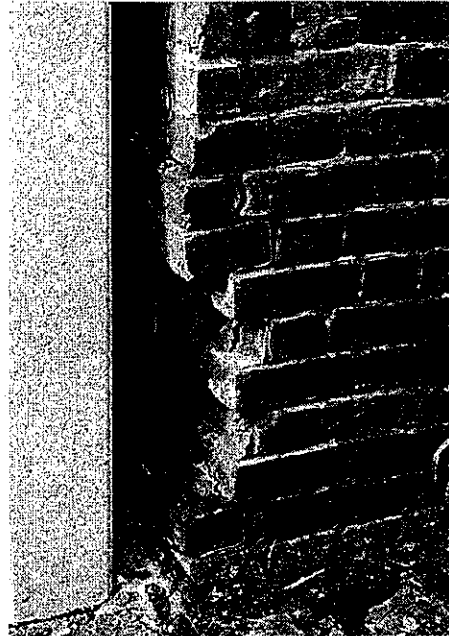
Photo 3.24: Exterior, Office & Toilet Wing, detail of damaged/partially demolished north-west corner of west elevation.

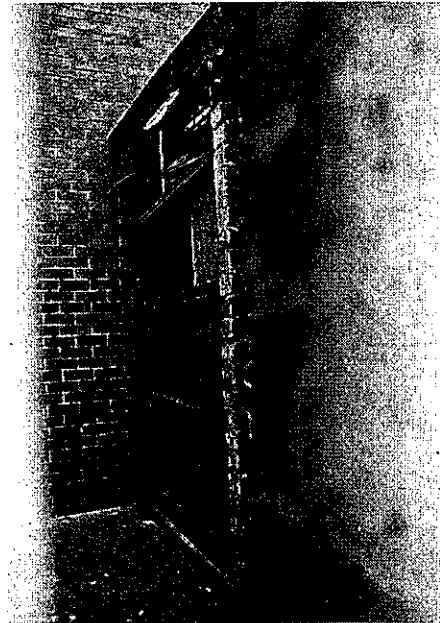
Photo 3.25: Exterior, Office & Toilet Wing, detail of open space showing partial demolition of toilet cubicle, timber framed galvanised corrugated iron partition (north end) and introduced raised concrete slab.

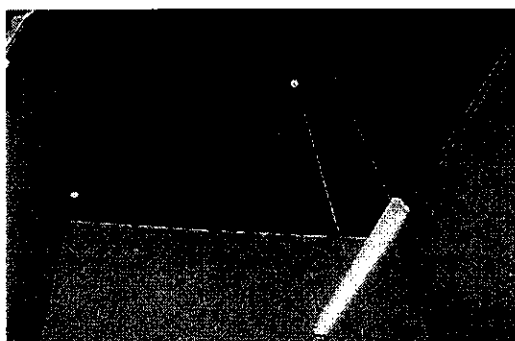
Photo 3.27: Interior, Shop (space FG03a). Detail of early stained timber lined ceiling.

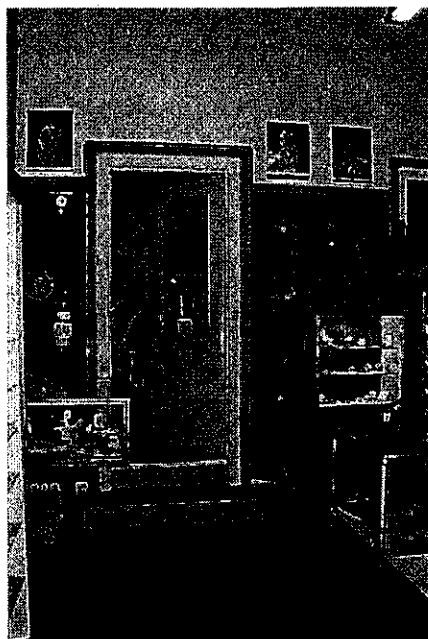
Photo 3.28: Interior, Shop (space FG03a). View of east internal wall with altered early panelled timber door and door architraves.

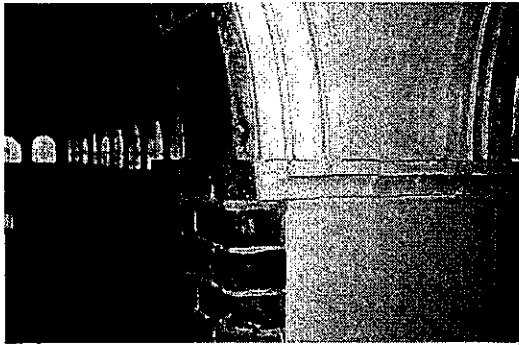
Photo 3.41: Interior, Landing & Stairs (space FF12). Detail of archway showing damaged/missing projecting brick and plaster cornices.

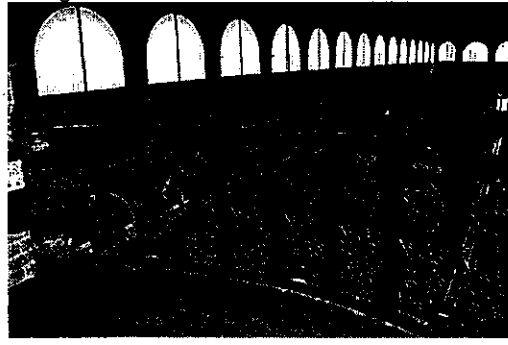
Photo 3.42: Interior, Landing & Stairs (space FF12). Detail of original curved landing with reconstructed sway bellied cast iron balustrade.

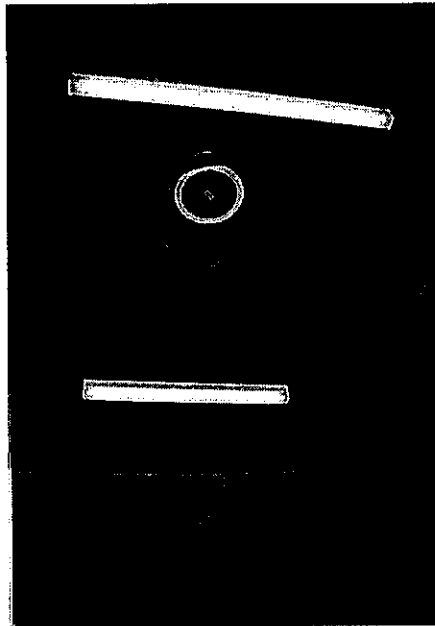
Photo 3.75: Interior, Ladies' Toilets (space B08a). Detail of introduced (but appropriate) stained beaded edged timber lined ceiling. Note the early ceiling ventilation opening with bolection mould frame and galvanised hood punctuated by the electrical fan.

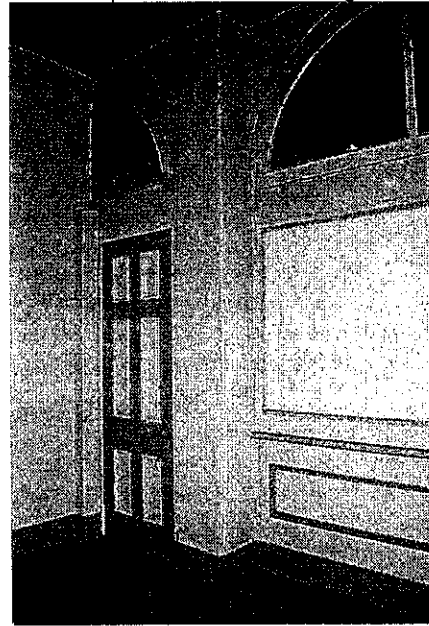
Photo 3.76: Interior, Ladies' Toilets (space B08a). View looking south-east showing introduced panelled timber and glazed arcade partition and appropriate six panelled timber door.

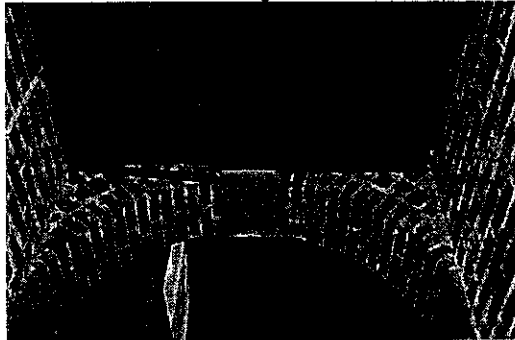
Photo 3.83: Interior, Exchange Hall (space H01). Detail of loose timber quad ceiling cornice on west end of rear eastern exit passage.

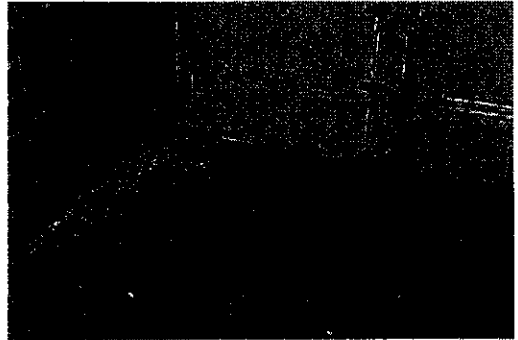
Photo 3.82: Interior, Exchange Hall (space H01). Detail of dampness under door opening and evidence of rising damp on the lower courses of the northern brickwork. The powdery nature of the mortar has left a residue on the floor.

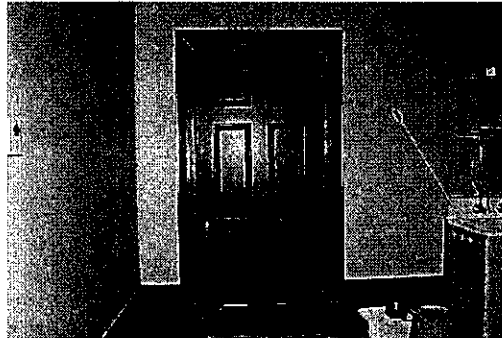
Photo 3.89: Interior, Call Room (space CR01). Detail of damaged door, showing fractured timber edge.

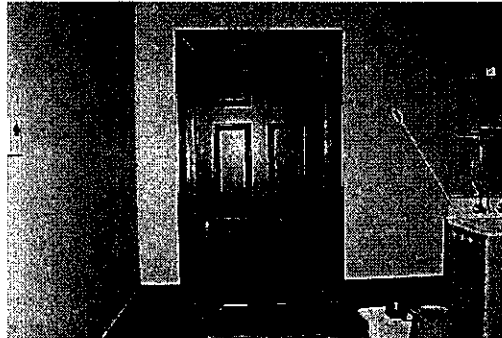
Photo 3.90: Interior, Call Room (space CR01). Detail of original six panelled timber door on west wall (south end) that leads to the passage (space T03).

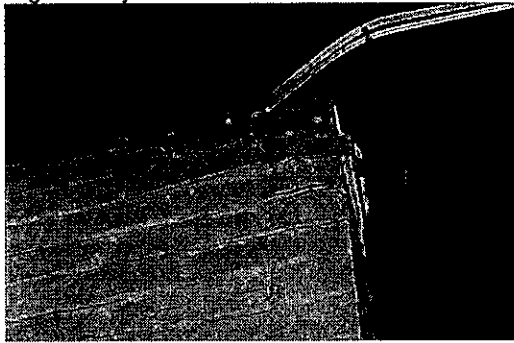
Photo 3.93: Interior, Passage (space T03). Detail of introduced electrical conduit that has inappropriately damaged the brick wall above the door into the office (space T02).

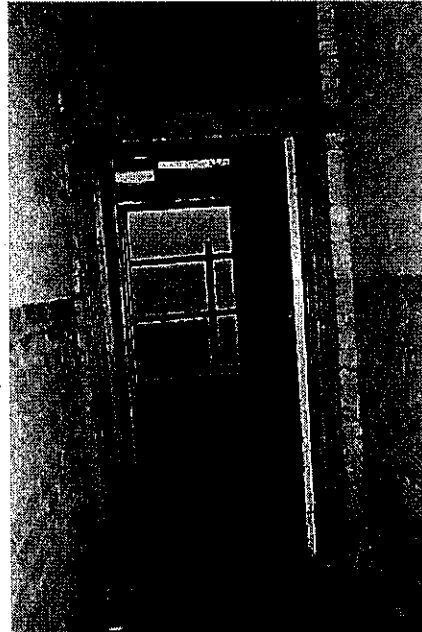
Photo 3.94: Interior, Passage (space T03). View looking north to Men's Toilet (space T01). Note the original timber framed doorway with transom window above, and the moulded timber architraves. Also note the concrete floor and evidence of dampness.

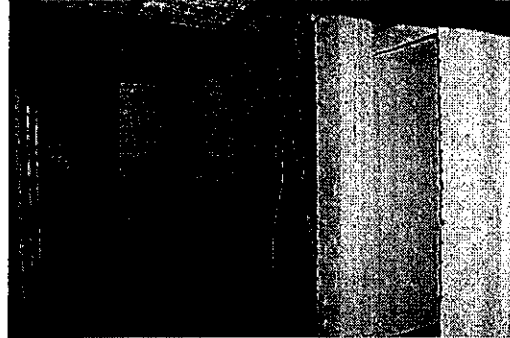
Photo 3.96: Interior, Men's Toilets (space T01). View looking south-west from northern partition. Note the substantial deterioration in the roof structure and brick walls, and the overgrown creeper. Also note the original doorway (in background) with the four panelled timber door.

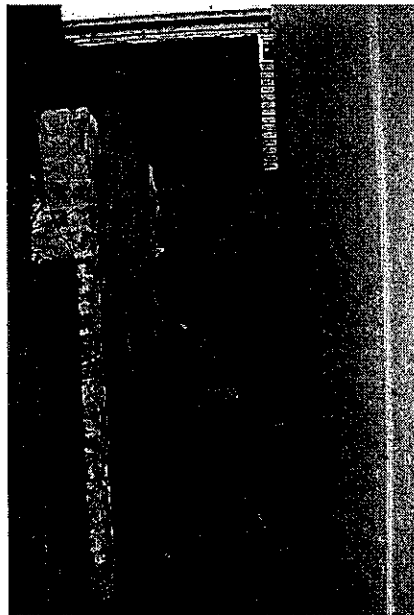
Photo 3.98: Interior, Men's Toilets (space T01). View showing area of demolished toilet cubicle (northern end of toilets). Note the damage to the west brick wall, introduced boundary wall of the new University of Ballarat building.

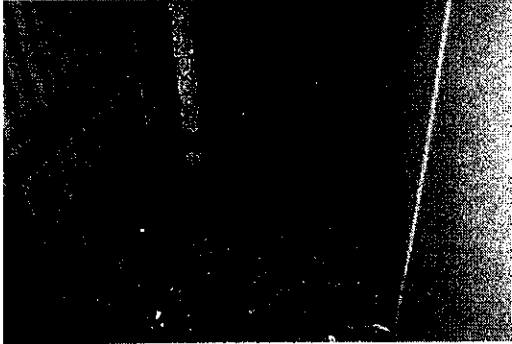
Photo 3.99: Interior, Men's Toilets (space T01). Detail of area of demolished toilet cubicle. Note the introduced raised concrete slab and the build up of debris within this open space.
