# Historical archaeological site card

BENALLA RAILWAY STATION AND YARD  
H8024-0016

Place name: BENALLA RAILWAY STATION AND YARD

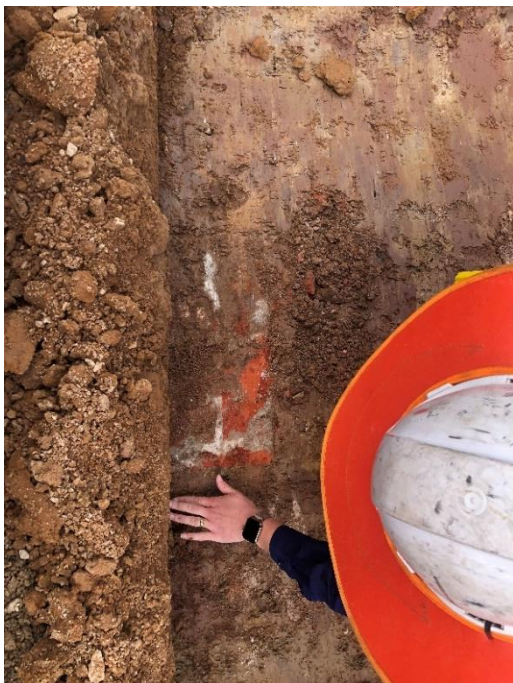
At 650 mm below the ground level, a solid object was identified directly adjacent to the south wall of the investigation area. This was cleaned using hand tools by the EMM archaeologists onsite. The object was identified as a structural element, later identified as a foundation pier. The pier, as exposed in the investigation area, was two bricks in width. Excavation continued to a depth of approximately 2 m and indicated the pier extended approximately 10 courses before stepping out at least three times by approximately a quarter of a brick (Plate 4.1 to Plate 4.3). Excavation was halted at 2.2 m due to safety and excavator constraints.

Plate 4.1 First excavator scrape over redbrick foundation

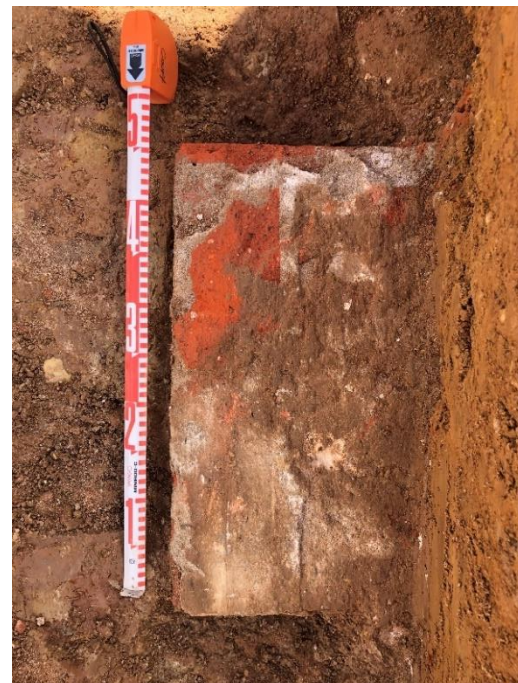
Plate 4.2 Top of redbrick foundation exposed

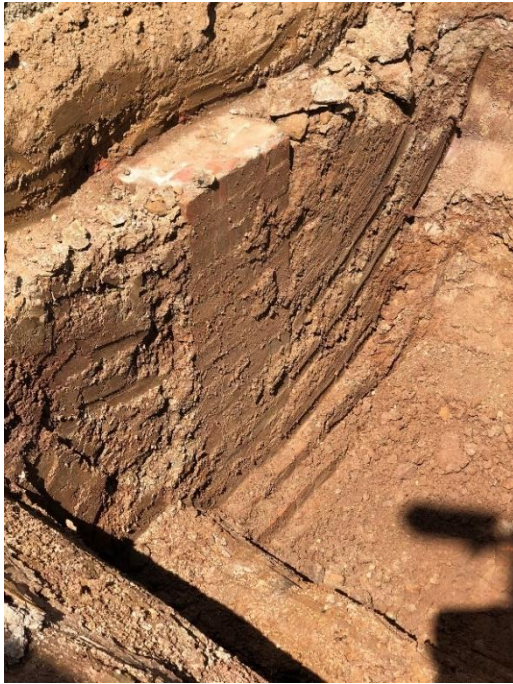
**Plate 4.3** Redbrick foundations with intact step down brick formation, 2 m below carpark surface

The brick pier identified during the mechanical excavation is probably related to the foundations of the demolished building, or the cellar. Due to the available plans not having a legible scale, it has not been possible to identify which part of the building has been encountered. More detailed records have been requested from Public Records Office Victoria. It is likely that more piers are retained in the subsurface deposit and could be identified during future works. There also may be a floor to the cellar, however during the mechanical excavation, deeper investigations were not feasible due to the limitations of the excavator and other safety related constraints. It is also possible that other objects were present in the cellar at the time of demolition. The overall fill material was reasonably clean (e.g. only a small number of bricks mixed in with soil). The results suggest that the fill is from a local source as similar deposits have been found in boreholes undertaken elsewhere on site for the project.

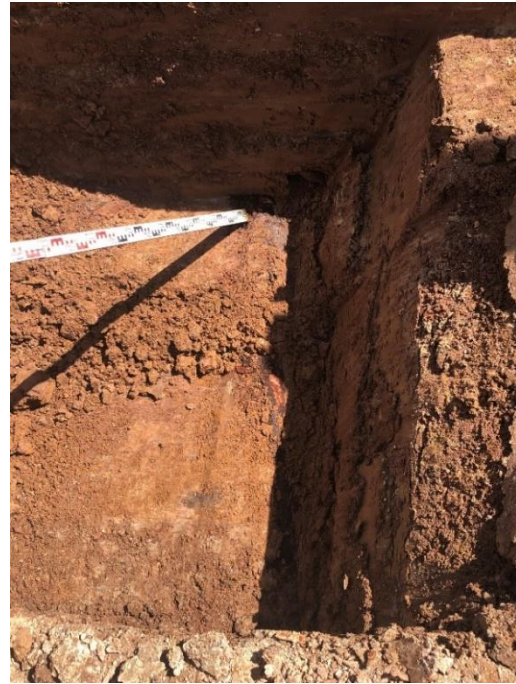
**Plate 4.4** Redgum beam lying N-S

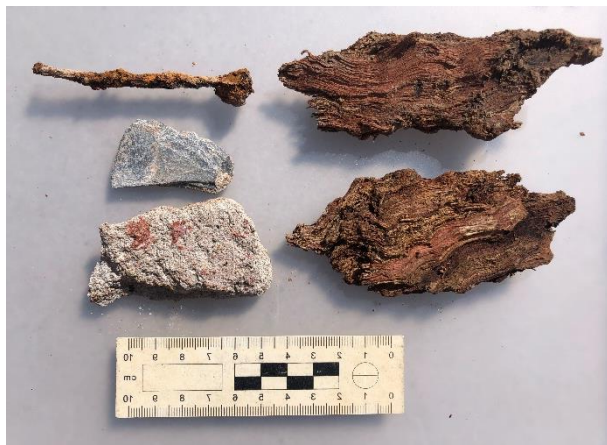
A small collection of building rubble artefacts were identified out of context (Plate 4.5 and Plate 4.7) including a handmade nail, loose pieces of the wooden beam, slate roof tile, white and red bricks and glazed bricks. The identified archaeology was covered in Geotech fabric for future identification and the loose artefacts placed in a bag in the northern non-destructive drilling hole (Plate 4.6 and Plate 4.8).

**Plate 4.5** Historical artefacts (from top left to bottom right): rusted nail, fragments from redgum beam, slate tile and white brick

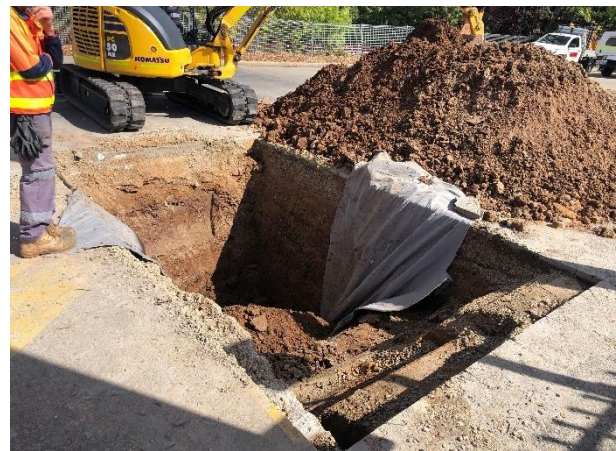
**Plate 4.6** Covering wooden beam and bricks with geofabric before reburial

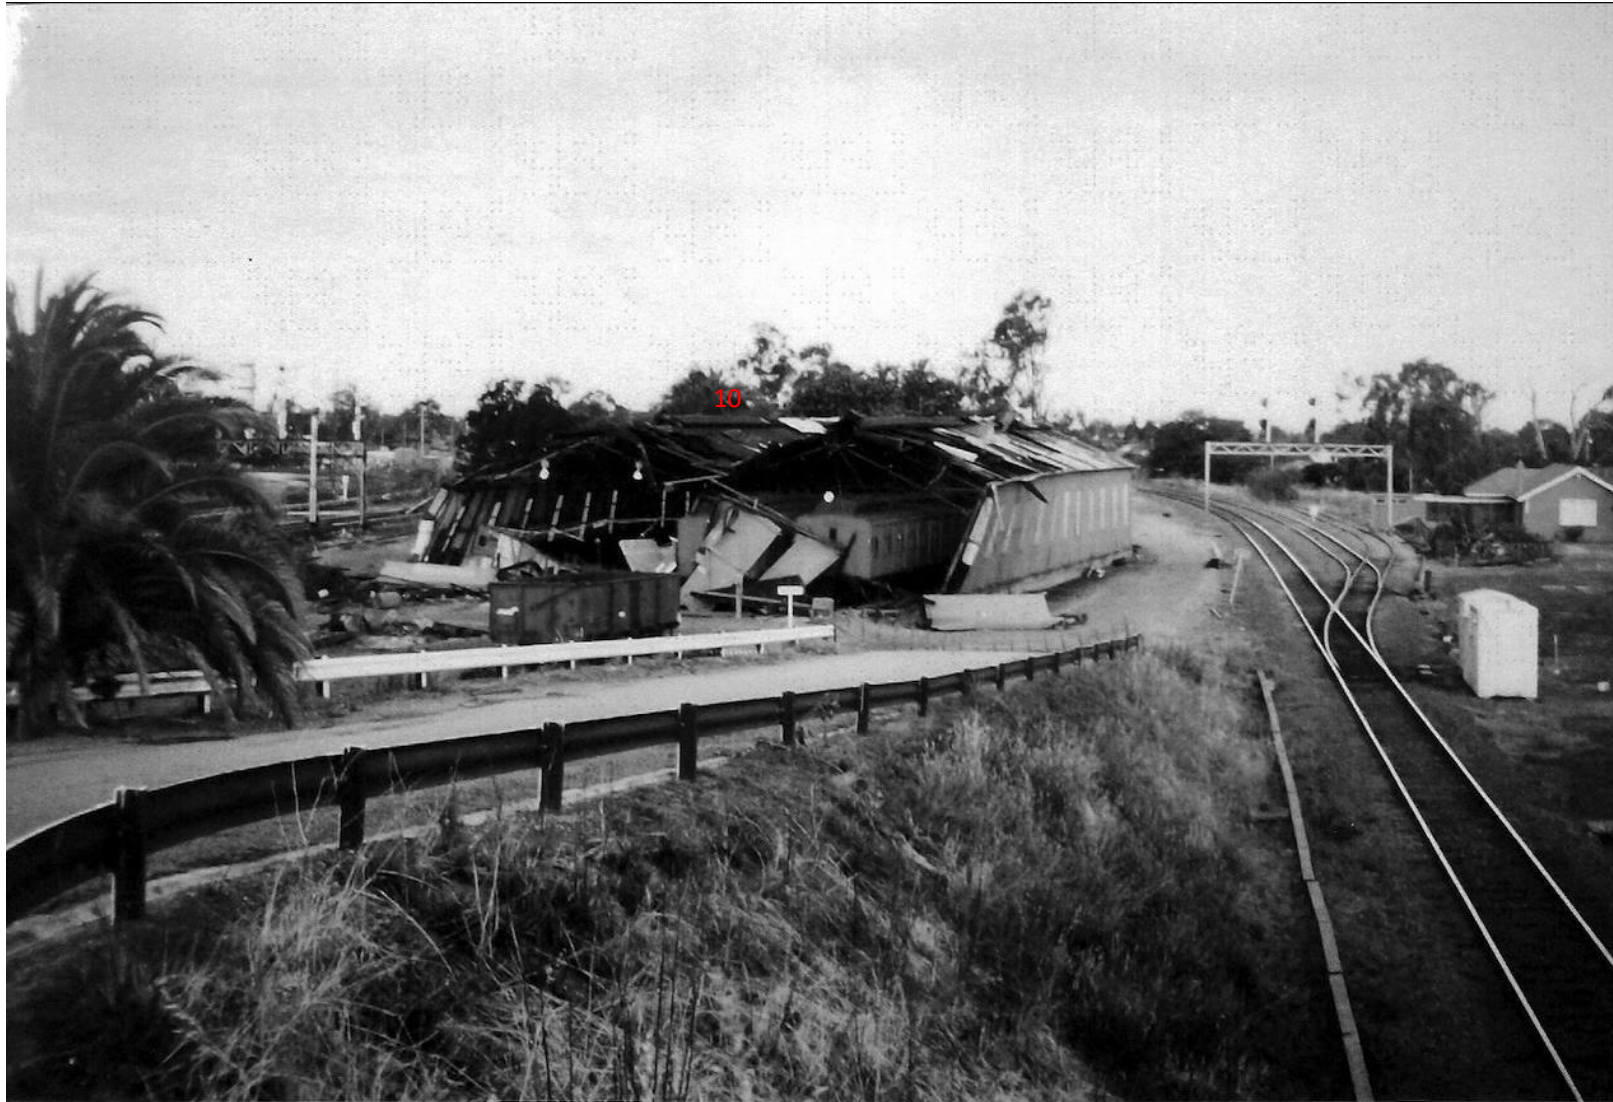
Plate Error! No text of specified style in document..16 Locomotive workshop in 1994 following collapse during storm

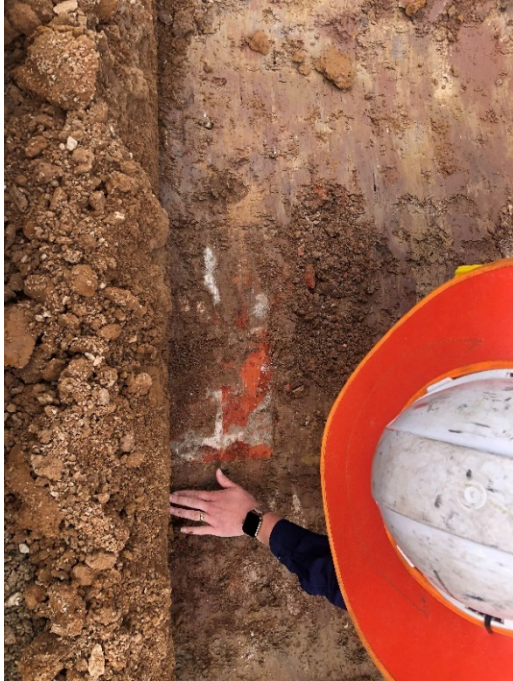
- At 650 mm below the ground level, a solid object was identified directly adjacent to the south wall of the investigation area. This was cleaned using hand tools by the EMM archaeologists onsite. The object was identified as a structural element, later identified as a foundation pier. The pier, as exposed in the investigation area, was two bricks in width. Excavation continued to a depth of approximately 2 m and indicated the pier extended approximately 10 courses before stepping out at least three times by approximately a quarter of a brick (Plate 4.3 to Plate 4.5). Excavation was halted at 2.2 m due to safety and excavator constraints.

**Plate 4.3** First excavator scrape over redbrick foundation

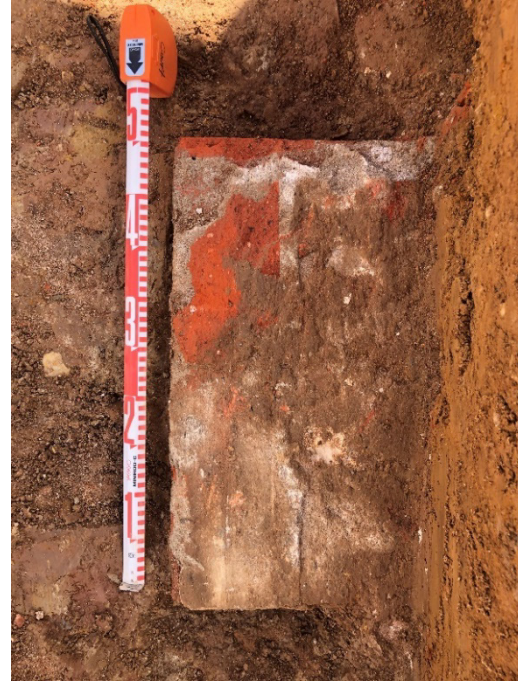
**Plate 4.4** Top of redbrick foundation exposed

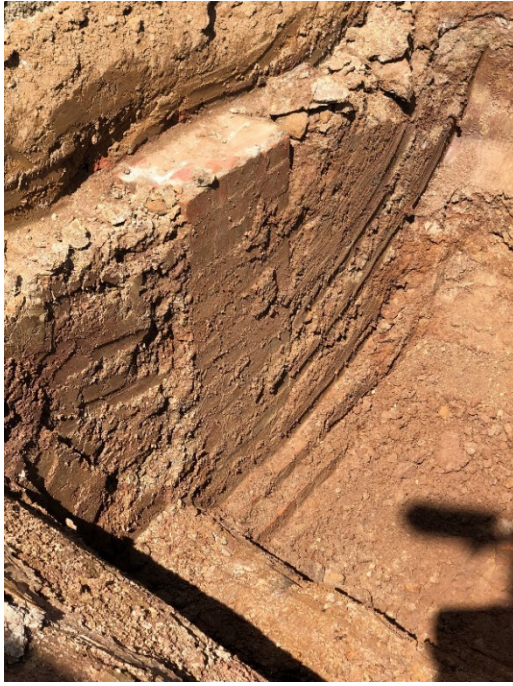
**Plate 4.5** Redbrick foundations with intact step down brick formation, 2 m below carpark surface

Based on the plans and photographs of the demolished building obtained from online sources, it was estimated that the monitored excavation took place at the southern end of the structure, toward the demolished water tower (Plate 2.7 to Plate 2.9). The brick pier identified during the mechanical excavation is likely related to the foundations of the demolished building, or the cellar. Due to the available plans not having a legible scale, it has not been possible to identify which part of the building has been encountered. It is likely that more piers are retained in the subsurface deposit and could be identified during future works. There also may be a floor to the cellar; however during the mechanical excavation, deeper investigations were not feasible due to the limitations of the excavator and other safety related constraints. It is also possible that other objects were present in the cellar at the time of demolition. The overall fill material was reasonably clean (e.g. only a small number of bricks mixed in with soil). The results suggest that the fill is from a local source, as similar deposits have been found in boreholes undertaken elsewhere on site for the project (Tetra Tech Coffey, pers. comm.).

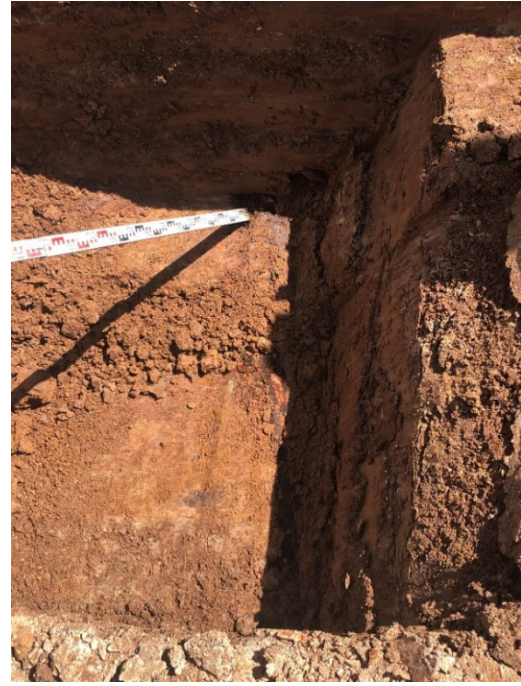
- At approximately 2 m, a wooden beam (thought to be red gum), or possibly a railway sleeper was uncovered, but not removed from the investigation area as it extended into both the west and east walls of the excavation (Plate 4.6).
- A small collection of building rubble artefacts were identified in unsecure contexts (Plate 4.7 and Plate 4.9) including a handmade nail, loose pieces of the wooden beam, slate roof tile, white and red bricks and glazed bricks. The identified archaeology was covered in geotech fabric for future identification and the loose artefacts placed in a bag in the northern non-destructive drilling hole (Plate 4.8 and Plate 4.10).

**Plate 4.6** Redgum beam lying N—S

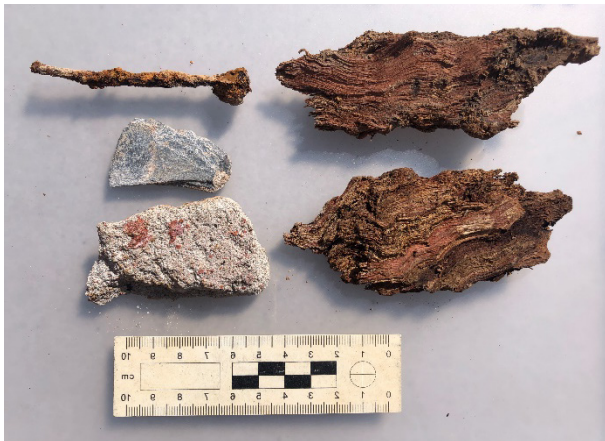
**Plate 4.7** Historical artefacts (from top left to bottom right): rusted nail, fragments from redgum beam, slate tile and white brick

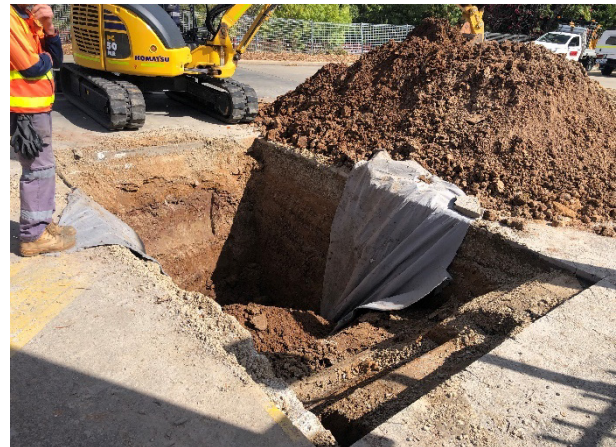
**Plate 4.8** Covering wooden beam and bricks with geofabric before reburial

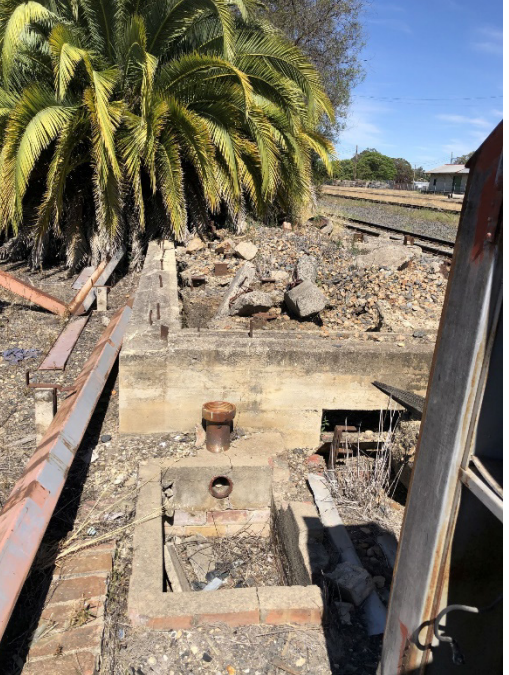
No.	Name	Description	Discussion/potential	Photo
9	Signal Box B	Rectangular concrete foundations extant to an approximate height of 500 mm. On the east side is a brick and concrete cistern for a toilet, with some ceramic sewerage pipes extant. The signal box has been filled with concrete and metal debris.	<p>Images indicate the signal box was the same as the extant Signal Box A, located at the Nunn Street level crossing.</p> <p>The concrete and metal debris appears to be the removed signal and light posts from around the station yard.</p> <p>The debris is unlikely to yield information not available from other sources. As a place of work, there is limited opportunity for the deposition and accumulation of artefacts. The structure of signal boxes is well established. It is considered the site holds limited to no archaeological potential.</p>

<p>View west. EMM 16.11.2023</p>
10	Locomotive workshop/ Fitters workshop / Repair shop	Bluestone foundation wall around the perimeter of the rectangular building. Set on top of the bluestone along some stretches is a timber beam. Poured concrete floor to interior. Two pits evident in the floor. Block and chain crane extant.	<p>Timber beam part of superstructure to tie the timber frame and attach the corrugated iron cladding that is visible in the historical photographs. It is considered the site holds limited to no archaeological potential.</p>

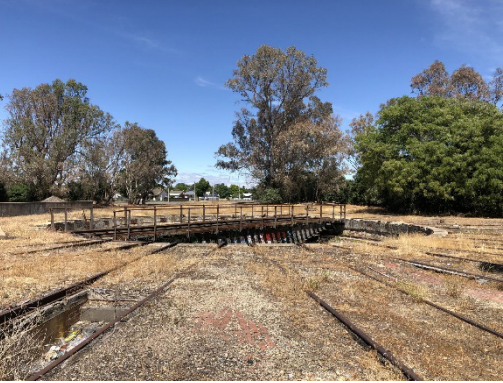
<p>View north. EMM 16.11.2023</p>
14	Round House	Superstructure of the round house has been removed. The turn-table remains in working order. Radiating tracks are extant. Brickwork paving between the radiating tracks is variably preserved. Located to the west are the foundations of a washhouse/ablutions not recorded on the plans	Brick paving suggests subsurface deposits are unlikely. Archaeological investigation is unlikely to add to an understanding of round houses and their use. It is considered the site holds limited to no archaeological potential.

<p>Round house, view west. EMM 16.11.2023</p>

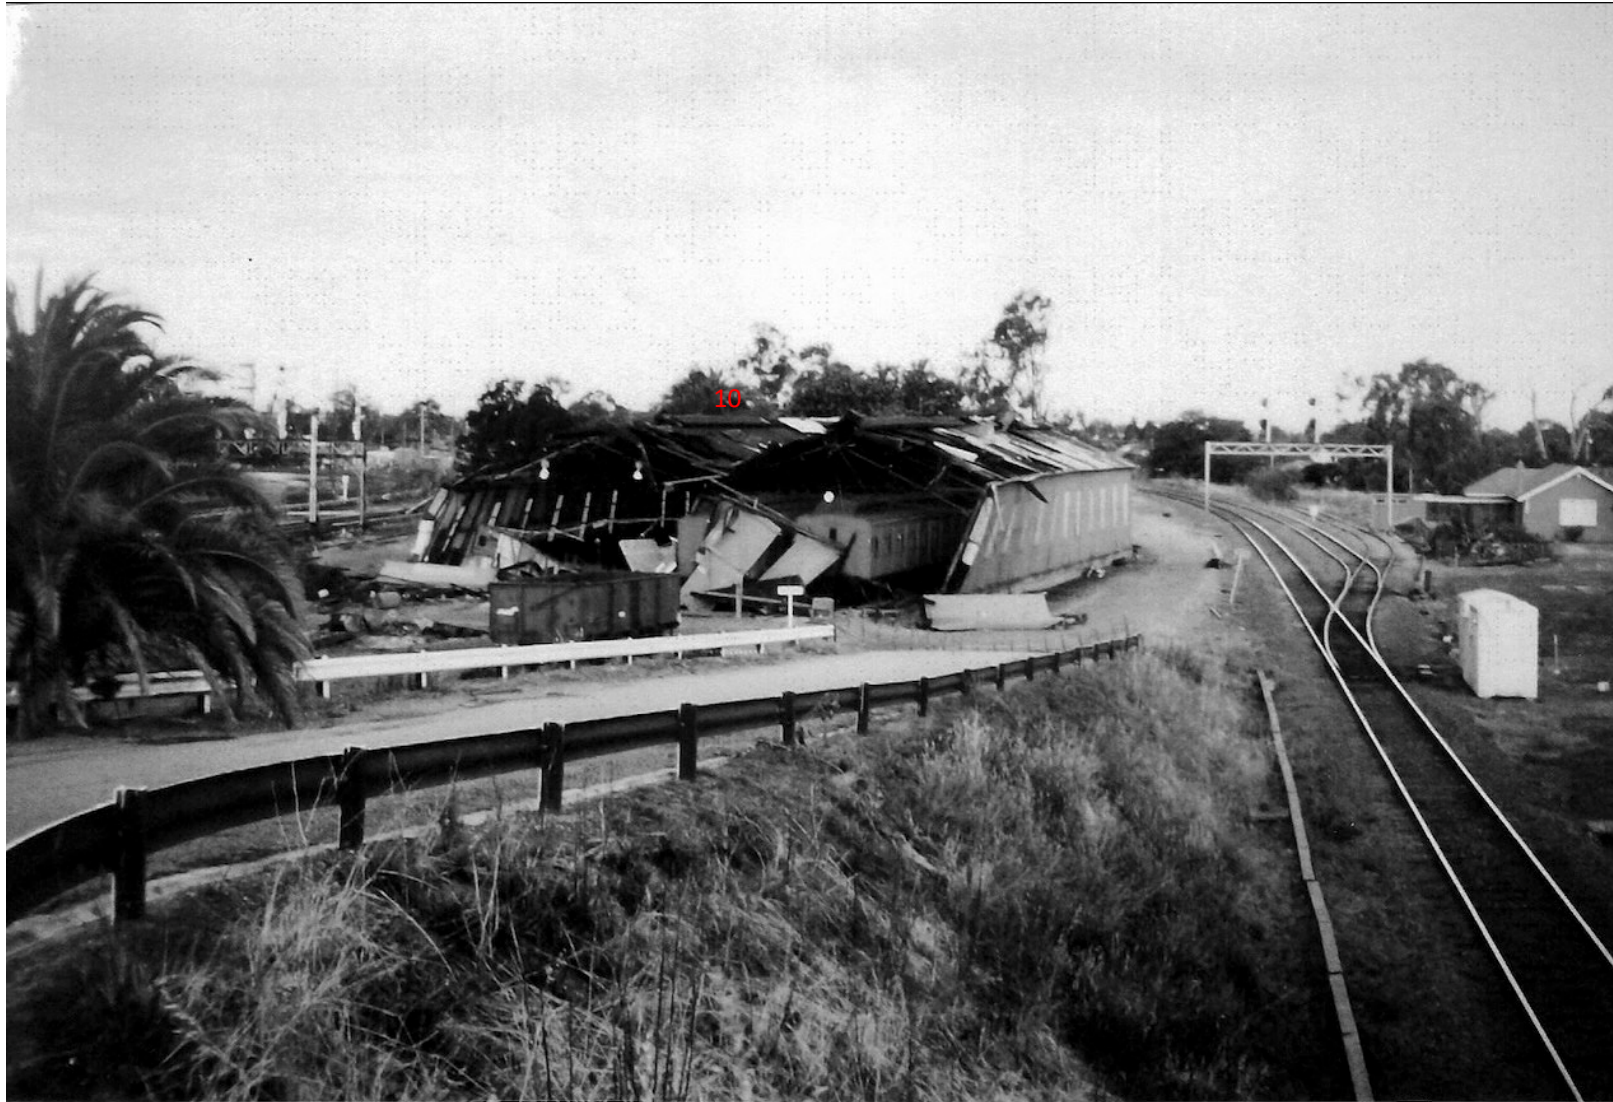
**Plate A.16** Locomotive workshop in 1994 following collapse during storm
