# **St. Paul's Anglican Church**

## **Humffray Street South, Ballarat**

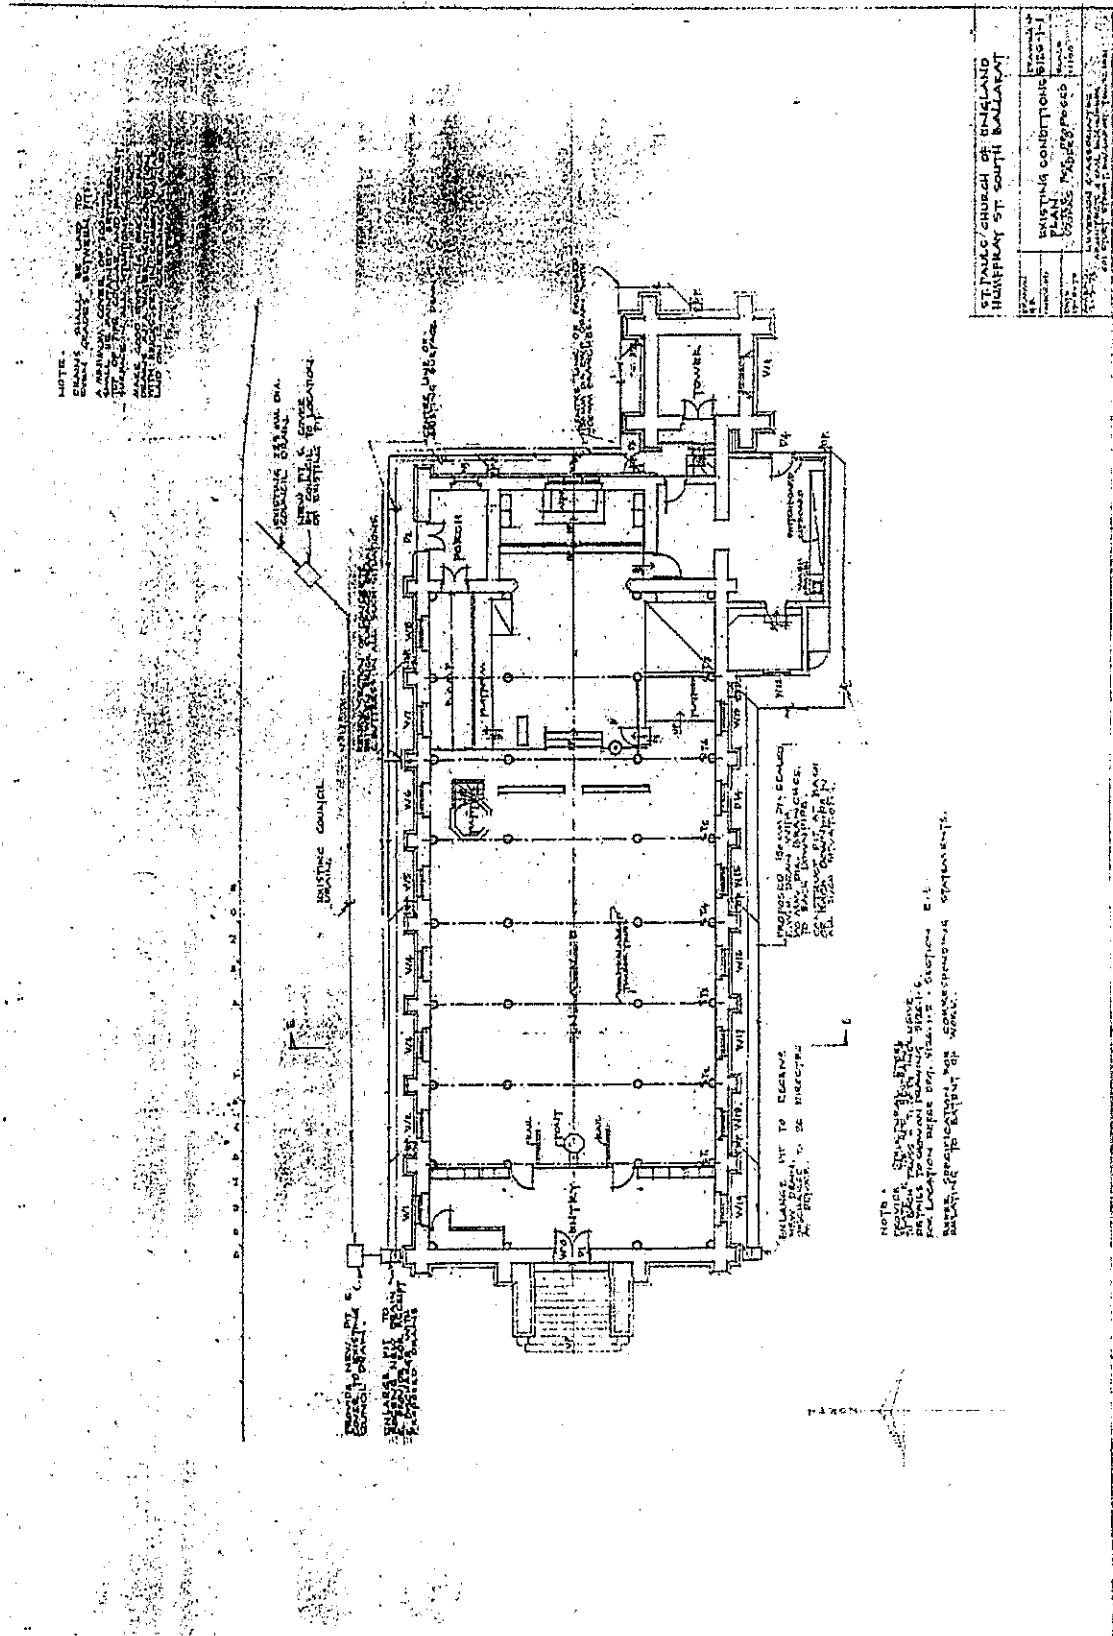
Figure 2.18: St. Paul's Church Existing Conditions Floor Plan by L.H. Vernon & Associates, 15 August 1978. Source: St. Paul's Anglican Church.

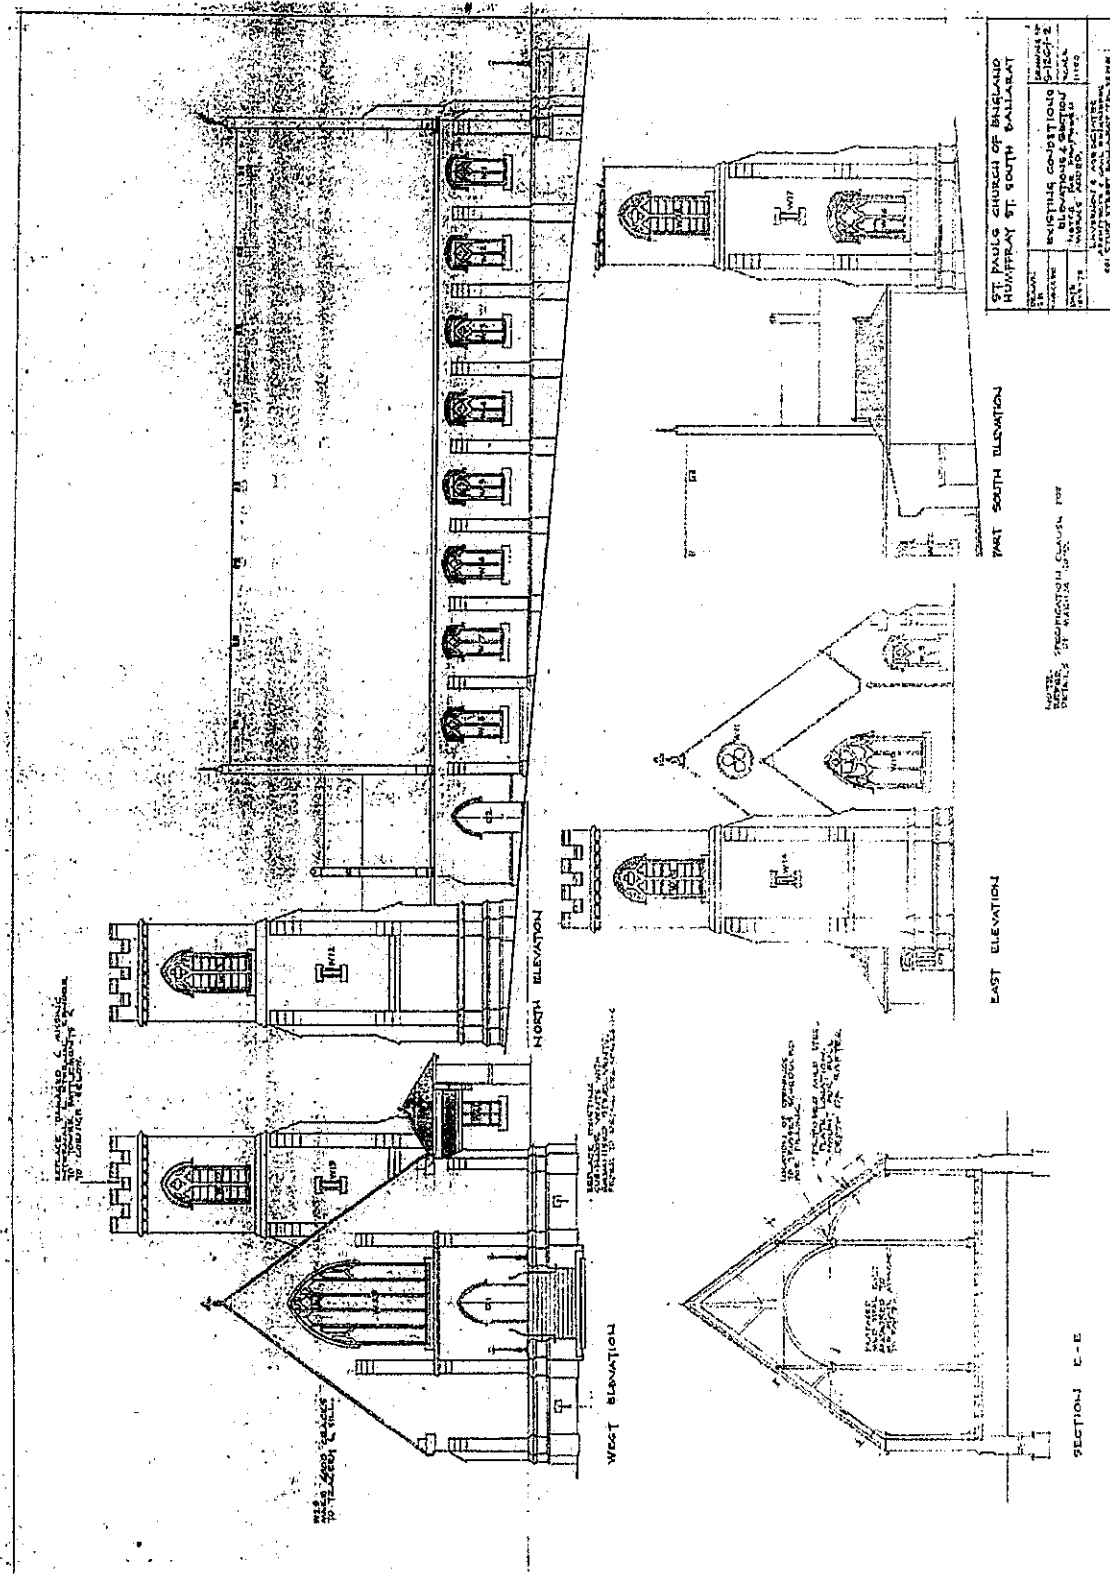
Figure 2.19: St. Paul's Church Existing Conditions Elevation & Section Drawings by L.H. Vernon & Associates, 16 August 1978. Source: St. Paul's Anglican Church.

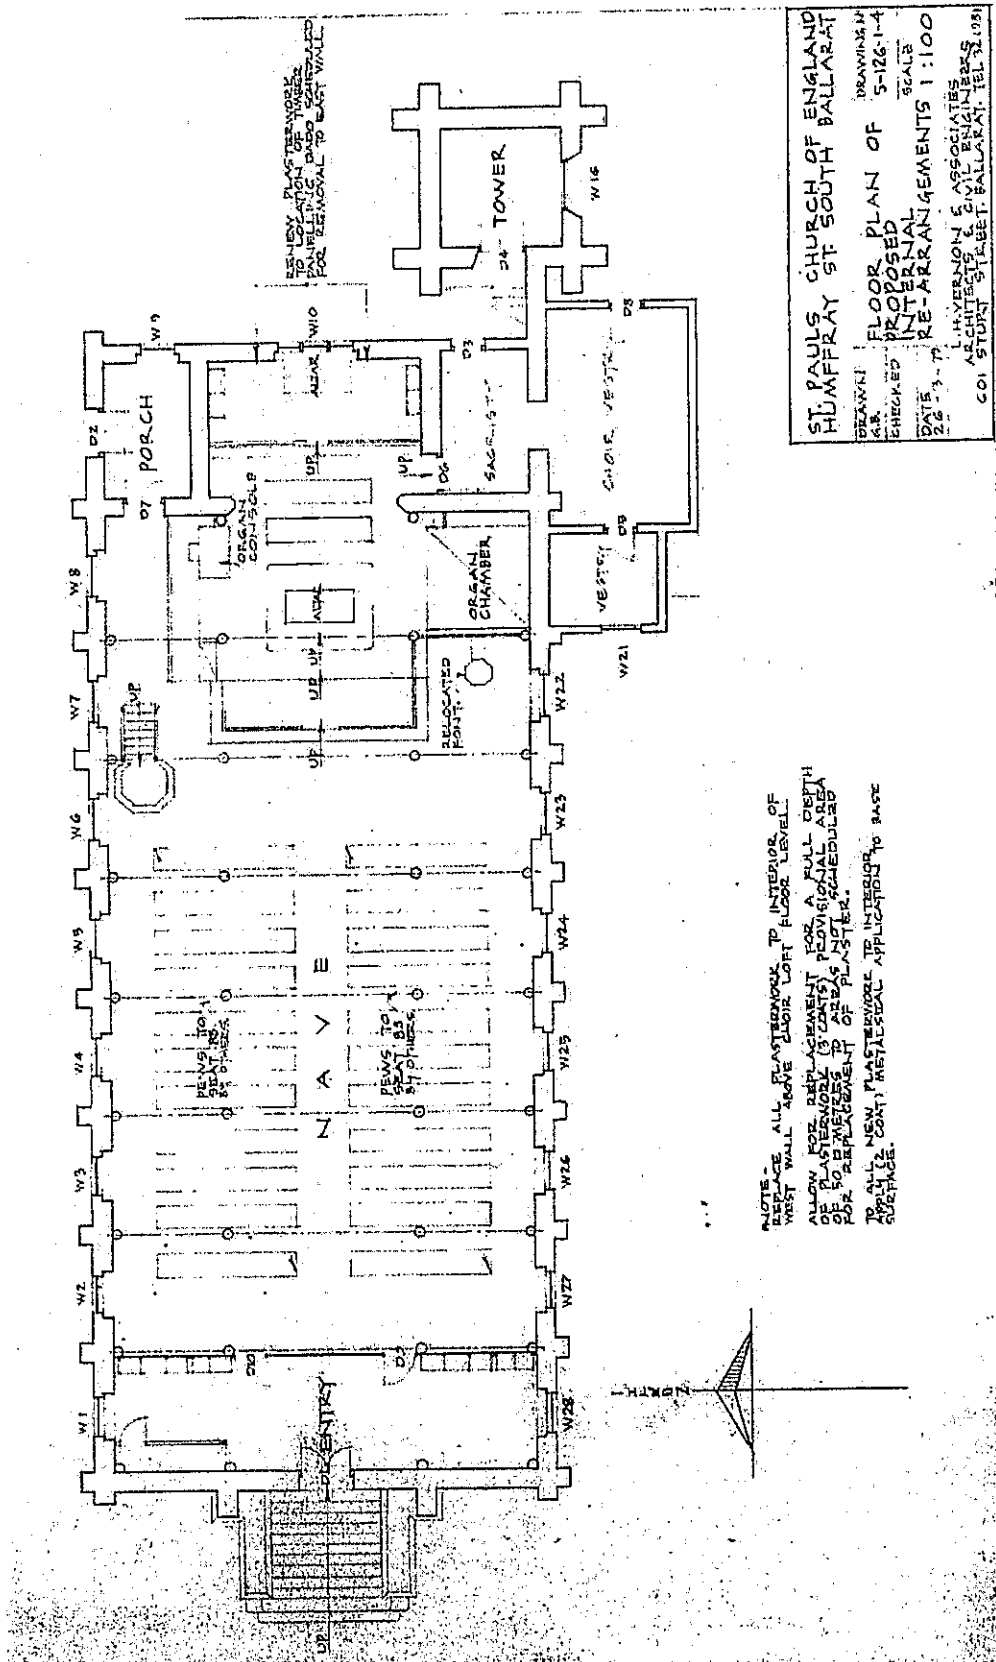
Figure 2.20: St. Paul's Church, floor plan of proposed internal arrangements by L.H. Vernon & Associates, 26 March 1979. Source: St. Paul's Anglican Church.

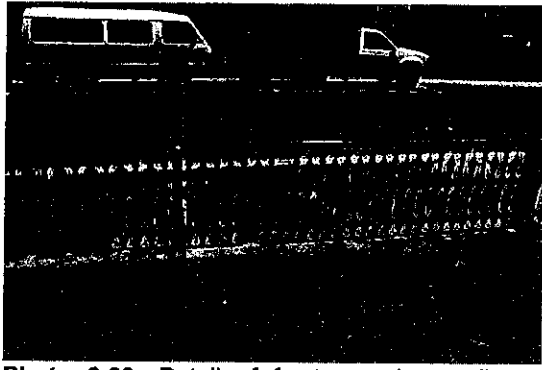
**Photo 3.09:** Detail of front cast iron palisade fence. Note the missing spears.

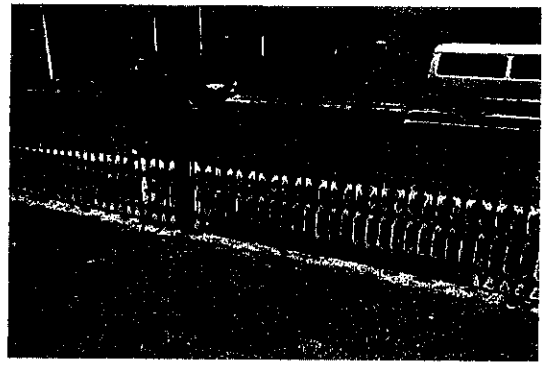
**Photo 3.10:** Detail of front cast iron palisade fence. Note the missing spears.

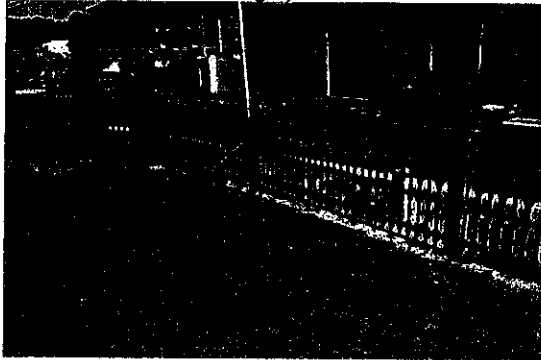
**Photo 3.11:** Front cast iron palisade fence.

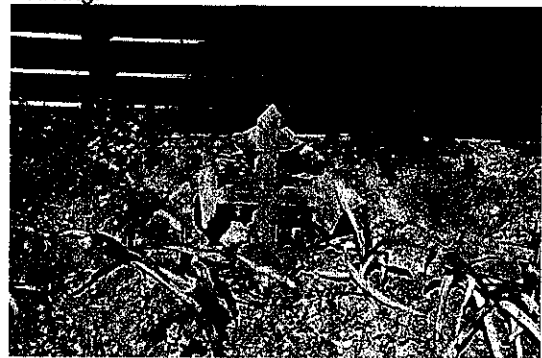
**Photo 3.14:** Detail of loose cross in the garden to the east of the cottage.

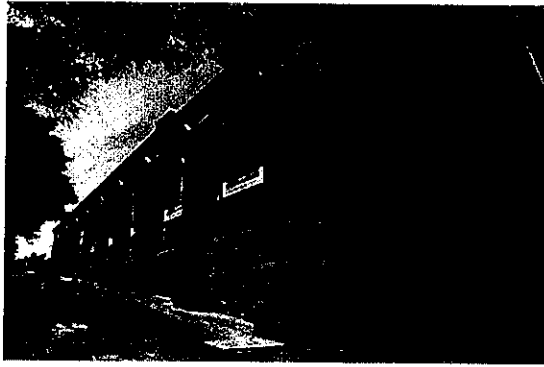
**Photo 3.15:** Exterior, north and west elevations (north-west corner).

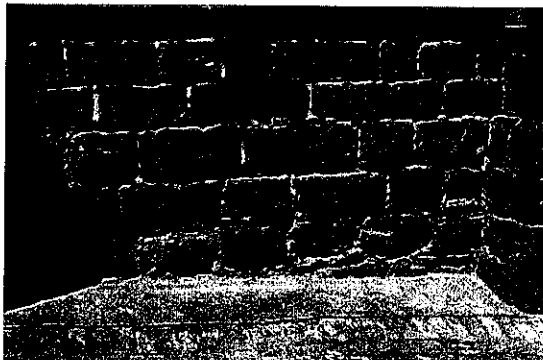
**Photo 3.17:** Exterior, north elevation. Detail of bluestone plinth showing evidence of rising damp in the powdery and spalling nature of the pointing.

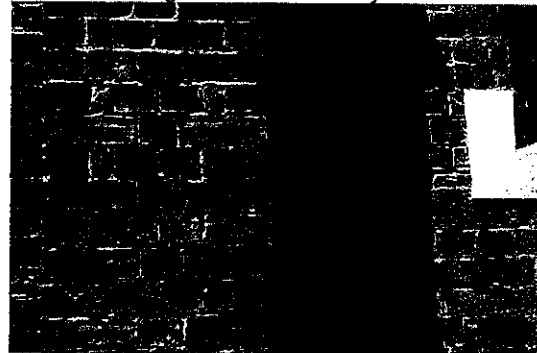
**Photo 3.18:** Exterior, north elevation. Buttress detail showing breakdown in pointing.

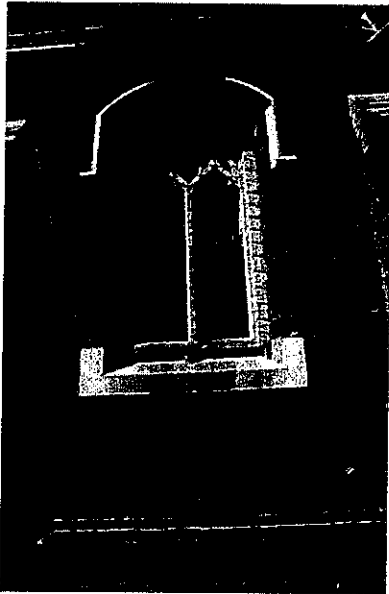
**Photo 3.19:** Exterior, north elevation. Detail of window 3. Note the introduced timber framing and metal grille over the window (causing rust stains on the window sills and brickwork below).

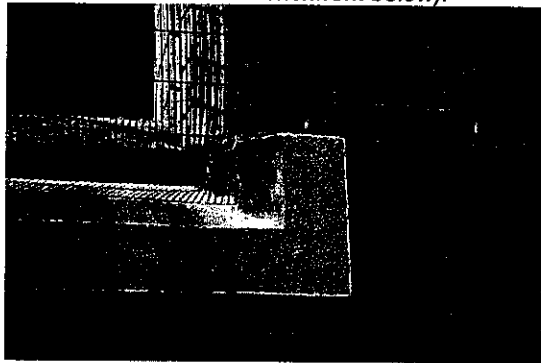
**Photo 3.21:** Exterior, north elevation. Detail of window 3. Note the rust stains on the window sill and the patch repair to the side of the sill.

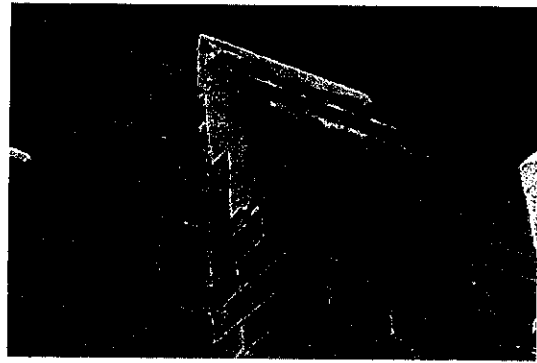
**Photo 3.20:** Exterior, north elevation. Cement rendered buttress capping detail.

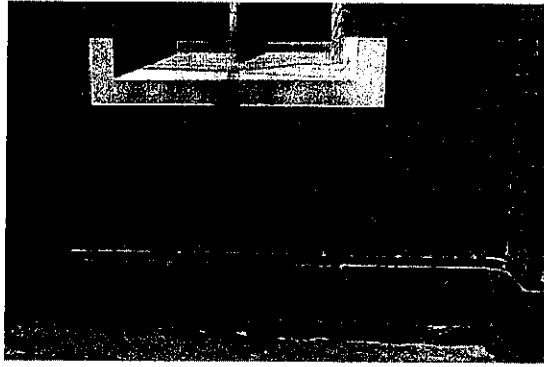
**Photo 3.23:** Exterior, north elevation. Detail of fretting brickwork and pointing possibly caused by rising damp.

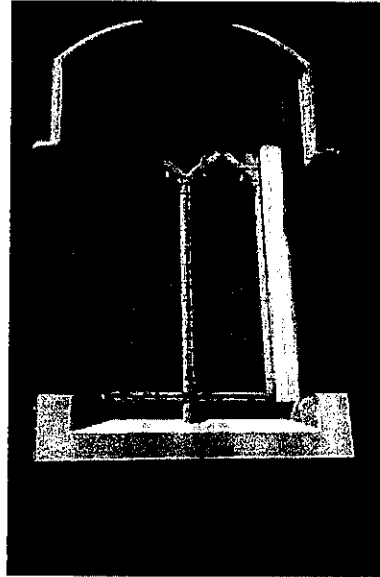
**Photo 3.24:** Exterior, north elevation. Detail of window 1. Note the introduced timber framing and metal grille over the window.

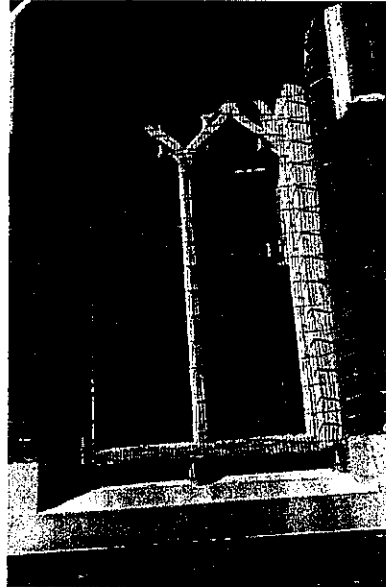
**Photo 3.26:** Exterior, north elevation. Detail of window 3. Note the introduced timber framing and metal security grille which has rusted and stained the window sill.

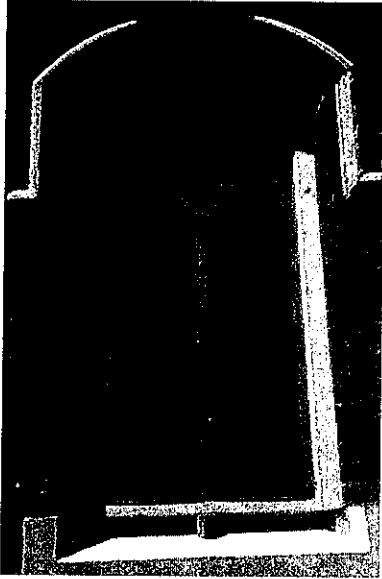
Photo 3.27: Exterior, north elevation. Detail of window 4. Note the introduced timber framing and the Perspex sheeting over the window.

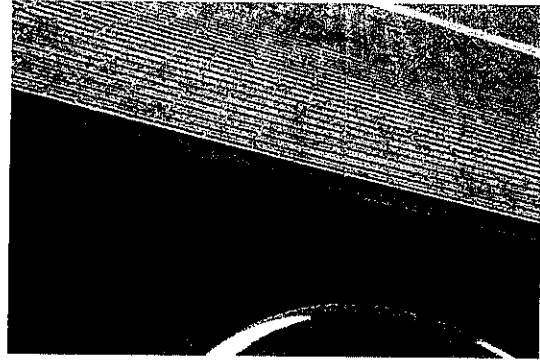
Photo 3.32: Exterior, north elevation. Note the pointing repairs to the voussoirs and other brickwork above the window opening. Also note the rust stains in the galvanised steel gutter.

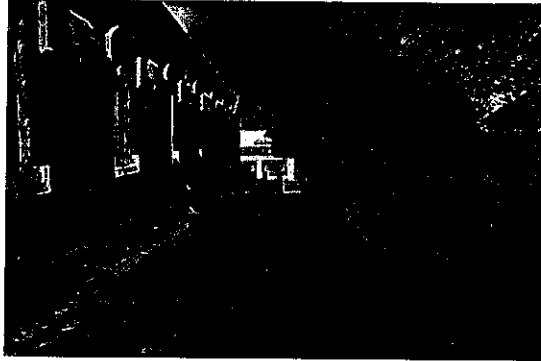
Photo 3.33: Exterior, north elevation looking west.

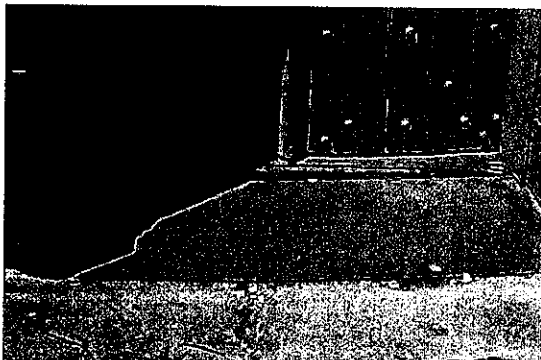
Photo 3.35: Exterior, north elevation. Detail of base of porch door. Note the rotted and loose timber threshold.

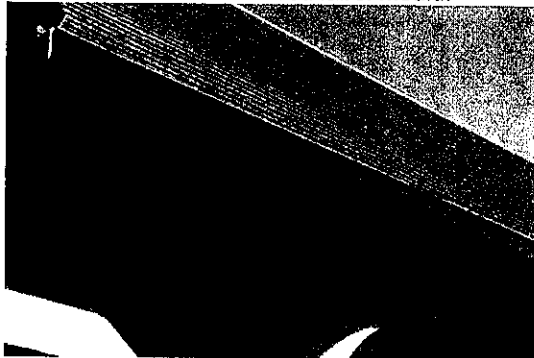
Photo 3.36: Exterior, north elevation. Detail of rusting galvanised steel gutters.

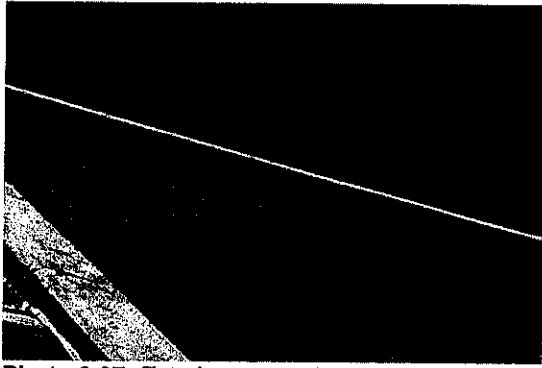
**Photo 3.37:** Exterior, north elevation. Roof detail. The slate tiles appear to be in good condition, but the ridge capping appears to be Colorbond, causing the rapid rusting of the galvanised steel gutters.

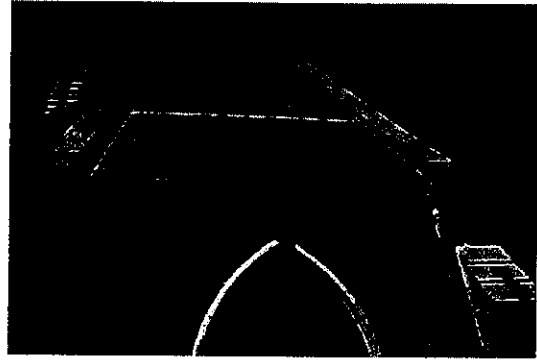
**Photo 3.38:** Exterior, north elevation. Detail of nave coping (west end) and porch coping. Note the introduced metal cappings over the copings that have the potential to cause moisture build up.

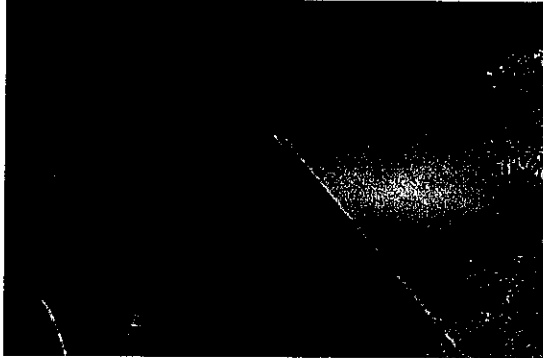
**Photo 3.39:** Exterior, north elevation. Roof detail.

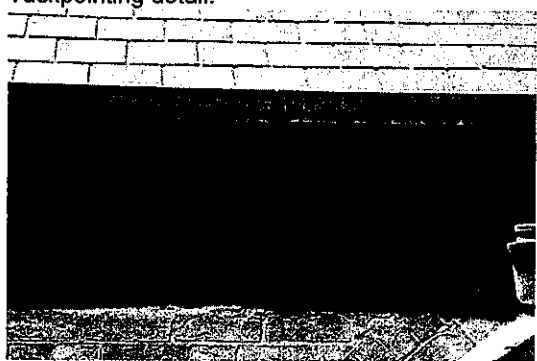
**Photo 3.42:** Exterior, north elevation. Detail of rusting galvanised steel gutter.

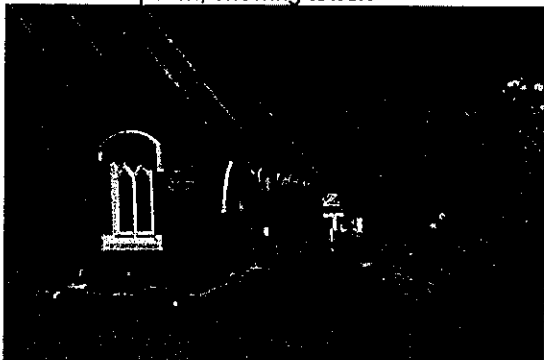
**Photo 3.43:** Exterior, east elevation (north end) showing porch gable end.

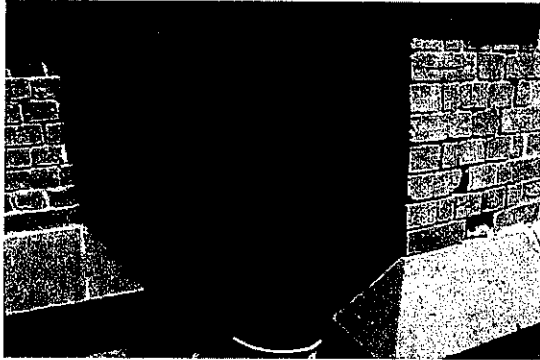
**Photo 3.55:** Exterior, east elevation. Detail of deteriorated pointing and brickwork above plinth on tower.

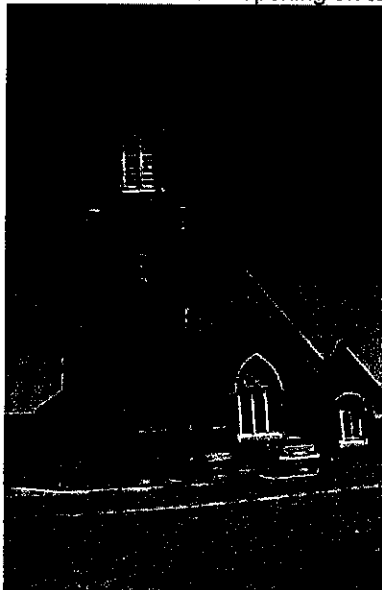
**Photo 3.56:** Exterior, east elevation.

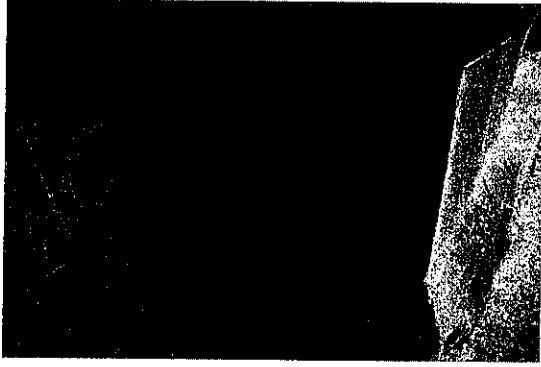
Photo 3.61: Exterior, south elevation. Detail of foundation stone on tower plinth.

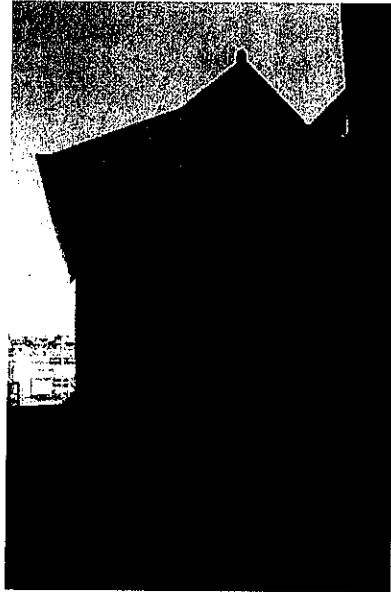
Photo 3.62: Exterior, east elevation. Detail of vestry addition.

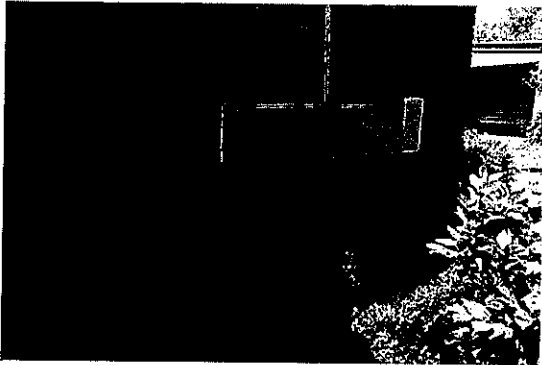
Photo 3.71: Exterior, west elevation. Office wall showing evidence of deterioration in the brickwork.

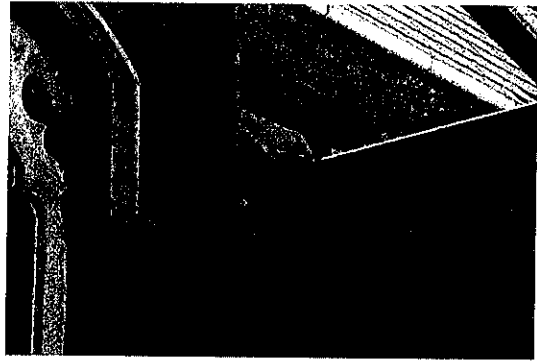
Photo 3.72: Exterior, west elevation. Detail of the junction of the office roof that awkwardly punctuates the original buttress capping of the nave.

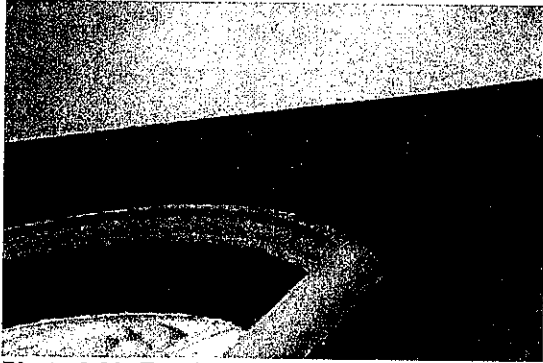
**Photo 3.83:** Exterior, south elevation. Gutter detail showing signs of rusting.

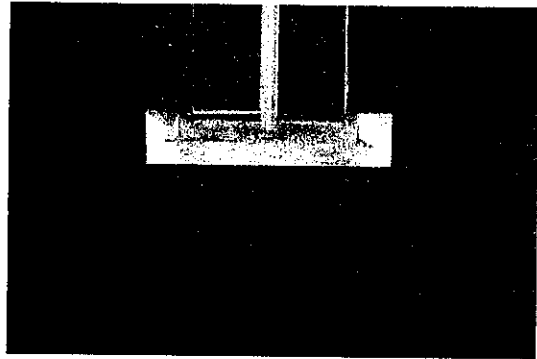
**Photo 3.84:** Exterior, south elevation. Detail showing evidence of deterioration in pointing immediately under sill. Also note the staining on the window sill.

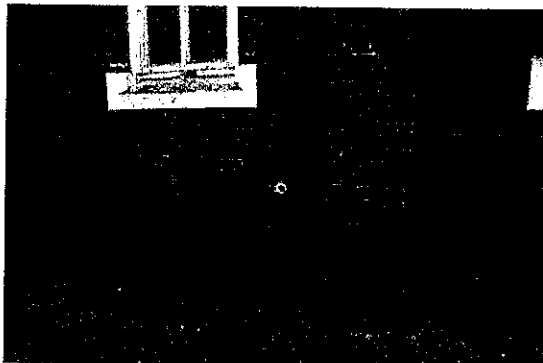
**Photo 3.85:** Exterior, south elevation. Detail of brickwork and bluestone plinth.

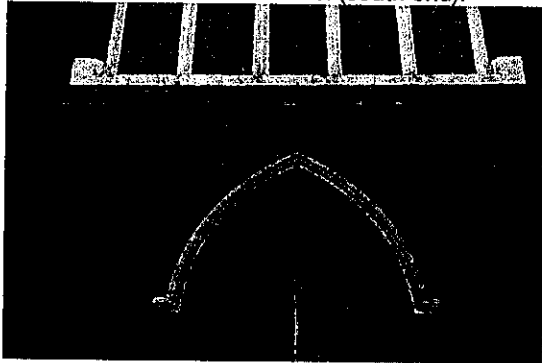
**Photo 3.91:** Exterior, west elevation. Door head and label mould detail. Also note the vertical wall crack between the door opening and the window above, which has spread through the cement rendered stringcourse.

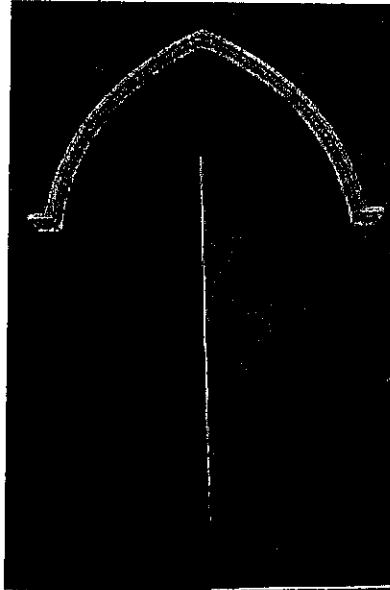
**Photo 3.92:** Exterior, west elevation. Door detail.

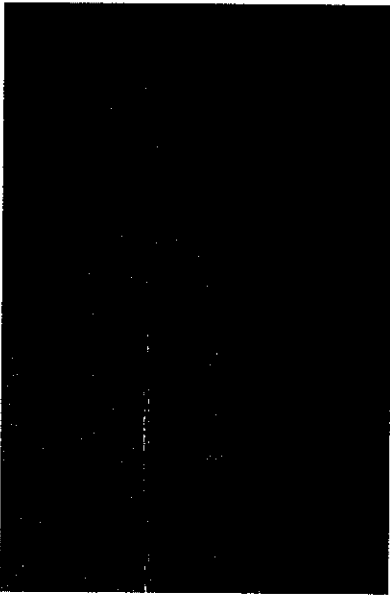
**Photo 3.151:** Interior, Space 3. Chancel arch and ceiling detail. Note the damaged stencilling as a result of falling damp (damage occurred in 2004).

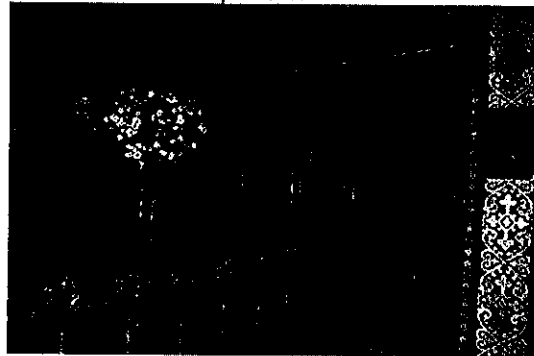
**Photo 3.152:** Interior, Space 3. View looking south-east from chancel arch.

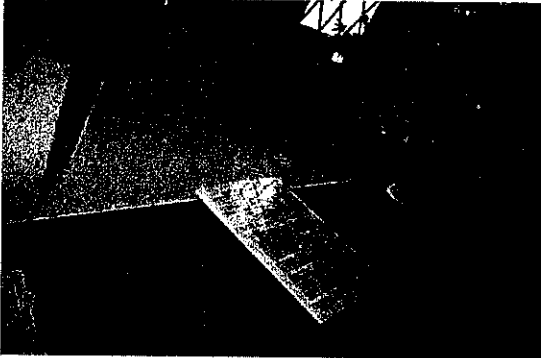
Photo 3.155: Interior, Space 2. Detail of sill of window 8. Note the cracking along the sill.

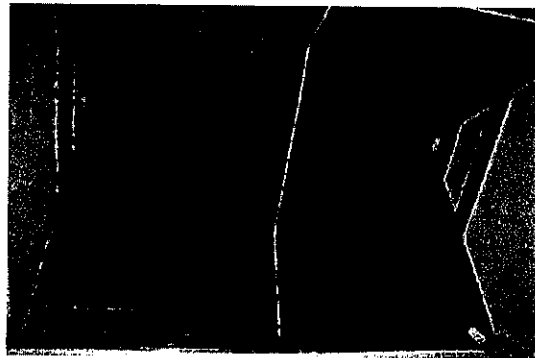
Photo 3.156: Interior, Space 4. Detail of porch ceiling.

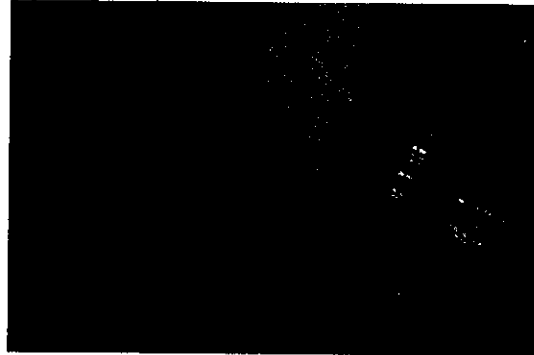
**Photo 3.166:** Interior, Space 5. Detail of spalled hard plaster as a result of rising damp.

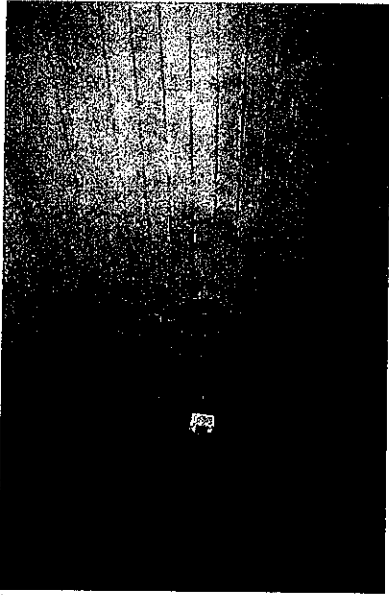
**Photo 3.167:** Interior, Space 6. Vestry ceiling detail.
