NEWTOWN URBAN CONSERVATION STUDY. - 'C' CITATIONS. Ref: 152
Richard Peterson Architect & Conservation Consultant. 1997.

NAME: —			
ADDRESS: 113 Prospect Road			
USE: House			
SIGNIFICANT DATE:		CONSTRUCTION DATE: 1912	SOURCE: 1
DESIGNER: —		BUILDER: —	
CRITERIA: Ar1; H1.		HISTORIC THEME: 2.3	
DESCRIPTION: STYLE: Edwardian STORIES: 1 DETACHED.			
MATERIALS: WALLS Brick		ROOF Slate	STRUCTURE Lb.
CONDITION: Good		INTACTNESS: Very good	THREATS: —
SIGNIFICANT INTACT ELEMENTS: MATERIALS. Slate. FORM. FACADE. VERANDAH. ROOF FORM. ROOF DECORATION. VERANDAH DECORATION. CHIMNEYS. Pots. WINDOWS.			
SIGNIFICANCE:			
TYPE:		HISTORICAL. ARCHITECTURAL.	
LEVEL:		LOCAL.	
DESIGNATION EXISTING:		PLANNING SCHEME.	
RECOMMENDED CONTROL:		PLANNING SCHEME.	
OBSCURED.	SURVEY: RP	DATE: 8.2.1997	NEGS: 7.21 & 1274.30

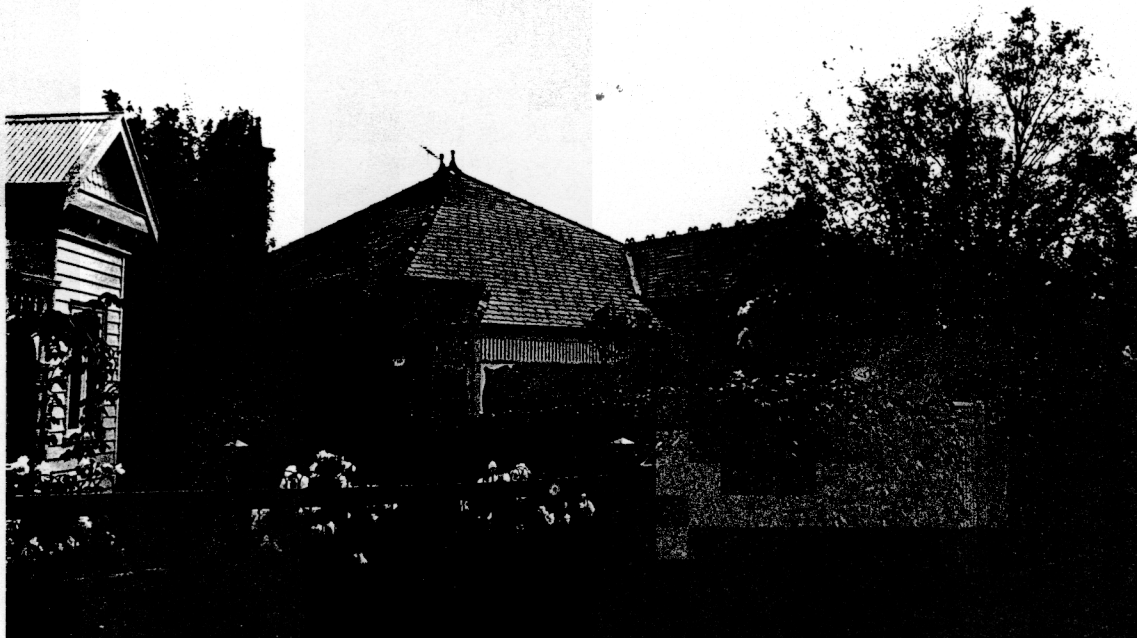
VISUAL DESCRIPTION: A double-fronted red brick Edwardian house with a slate hipped roof. This has unglazed terracotta chimney pots, cresting and finials. The right bay projects as a gable, its upper section jettys, roughcast and timbered. At the side are skillion window-hoods on fretwork brackets.

INTACTNESS: Very good. One finial is damaged. There is a sympathetic timber addition at rear, but the high fence is not appropriate.

CONDITIONS & THREATS: Good. The roof slate may need some maintenance.

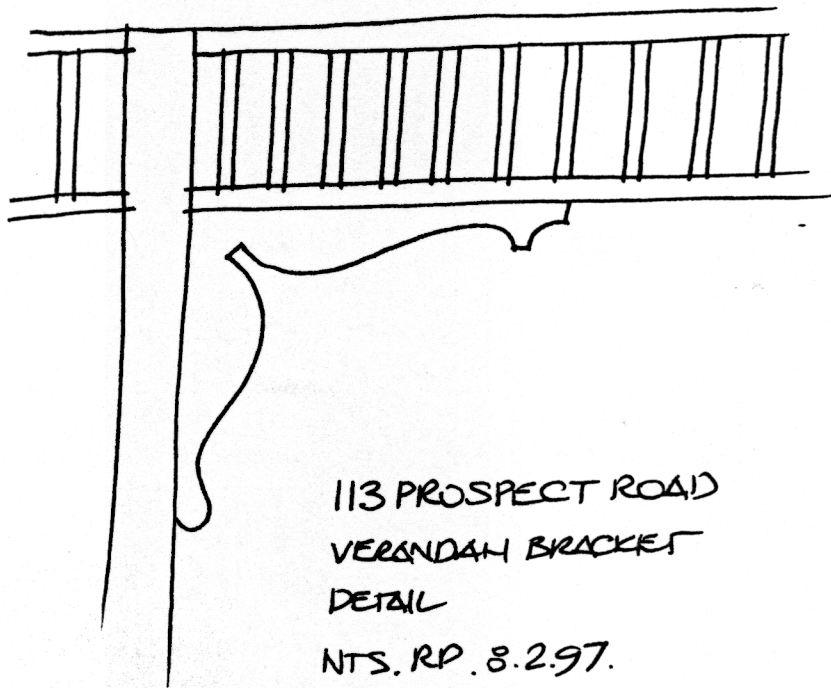
113 PROSPECT ROAD
VERANDAH BRACKET
DETAIL
NTS. RP. 8.2.97.

The hipped verandah is under the roof in the angle. It has a palisade valance over a rail, which is catenary curved over the entrance, with ogee arched fretwork brackets. The entrance is in the angle, with one side and fanlight and a four-panelled door.
