BACCHUS MARSH HERITAGE STUDY.**Ref: 272**

NAME: Christ Church Anglican Church Myrniong.**PREVIOUS NAME:** Christ Church, Church of England, Myrniong.**ADDRESS:** Hardy Street, Myrniong.**TITLE DETAILS:****USE:** Church**CONSTRUCTION DATE:** 1864 **SOURCE:** Sign & 1**CRITERIA:** H2; So1,3/H2; Ar1,3; So1,3**HISTORIC THEME:** Community life/ Townships.**DESCRIPTION:** **STYLE:** E E Gothic **STORIES:** 1 **DETACHED.****MATERIALS:** **WALLS** Stone **ROOF** Iron **STRUCTURE** Lb, trusses.**CONDITION:** Good **INTACTNESS:** Good **THREATS:****SIGNIFICANT INTACT ELEMENTS:**

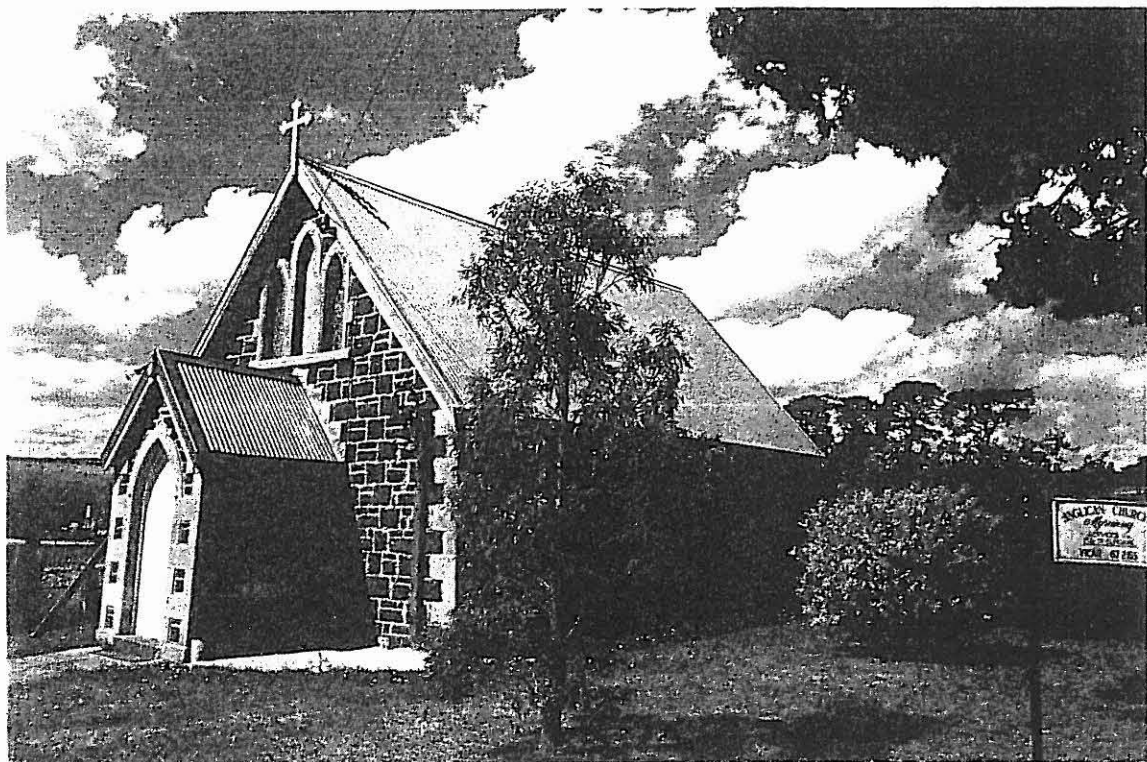
INTACTNESS: Excellent. No alterations are apparent.

CONDITIONS & THREATS: Good. It has been poorly repointed in inappropriate Portland cement at different times, presumably after structural problems. There have been various structural measures taken. There are four metal tie-rods between timber plates in each nave side wall, and four other tie-rods at eaves level. In the south-west corner is an old S-shaped plated. There are four further tie-rods in the porch west wall. It has been re-roofed.
