NAME: Former Union Bank of Australia
ADDRESS: 165, 167 Smith St.
CONSTRUCTION DATE: 1889-1890
ALTERATNS/ADDITNS: Original parapet
 signwriting removed;
 transom lunette replaced
ARCHITECT: Inskip and Robertson
BUILDER: Unknown
FIRST OWNER: Union Bank of Australia
FIRST OCC./USE: Ditto/Bank
PRESENT OWNER: Robert Alston & Co. Pty.
 Ltd., 59-61 Smith St.
 Fitzroy
PRESENT OCC./USE: 165 - Dr. Garrett;
 167 - Solicitors office
 169 - T.A.B. offices
CONSTRUCTION
MATERIALS: Rendered brickwork
INTACTNESS/
CONDITION: Externally intact
AREA/STREETSCAPE: Part of recommended streetscape A18.

BUILDING ANALYSIS AND EVIDENCE:

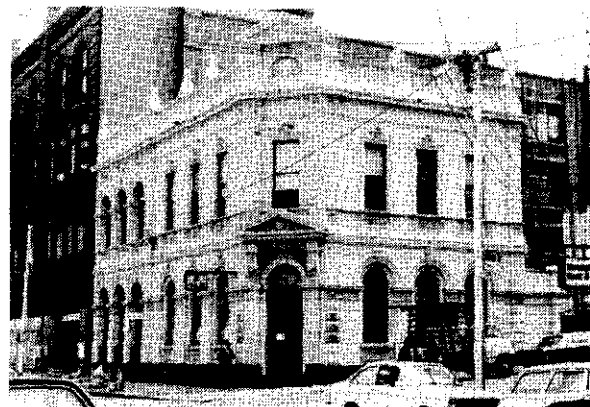
The building is in an excellent state of intactness. An early photo of c1905 survives², showing that the only changes have been the removal of the raised bank sign, below cornice level ("The Union Bank of Australia"), the replacement of the corner transom lunette and the removal of the old Union Bank window signwriting

It provides an excellent example of an intact boom style bank building and attached residence. The architectural motifs are unusual and eclectic; reduced elevated pediments over the windows, Greek key patterning at ground floor impost level, draped ionic entrance consoles, and sill panels with relief mouldings. The corner entrance pediment has the bank initials UBA as a crest.

It is recommended that this bank be added to the Historic Buildings Register, the Register of the National Estate and be specified under Clause 8 of the Town and Country Planning Act (3rd Schedule).

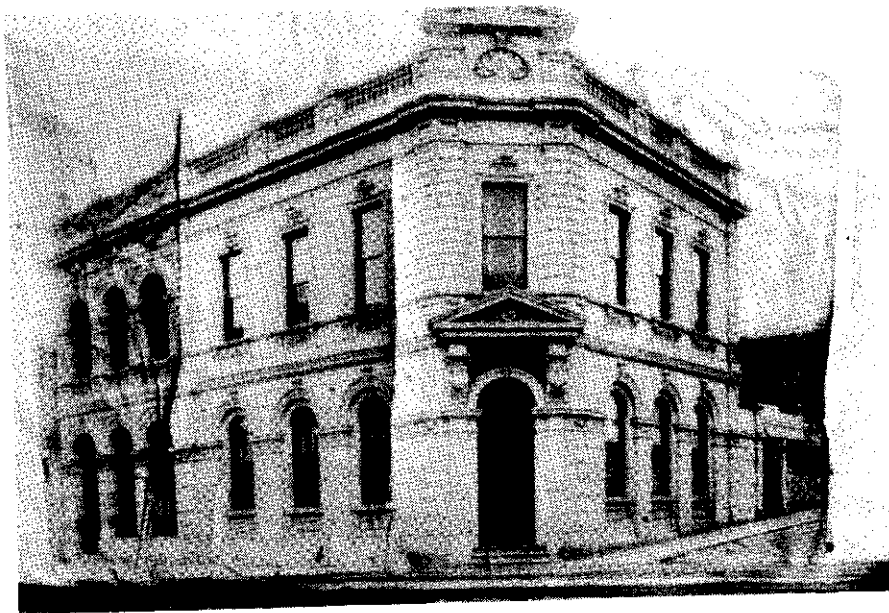
(32) Photograph of Union Bank c.1905.
