Manningham Heritage Garden & Significant Tree Study

Significant Tree Information Sheet

Tree Identification No.: 43
Botanical Name: *Pinus radiata*
Common Name: Monterey Pine
Location: 11 Bellevue Ave, Doncaster East

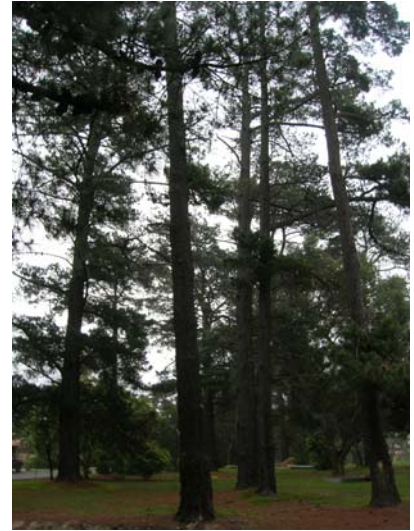
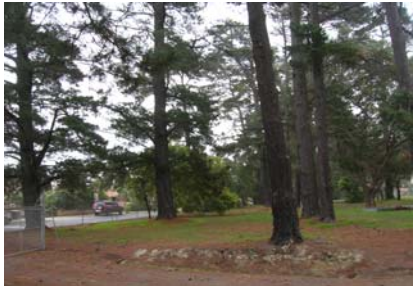
Other/Notes: Trees are sparse in the upper canopy with deadwood present.

Health Rating: 3

Threats/Risks to Tree: Works to the road and the rest of the streetscape, including trenching, could damage the trees closest to the road.

Other/Notes: Some trees have extended limbs and others have been v-crotched. Generally speaking the trees have been managed to avoid structural defects.

Structure Rating: 4-1

Works Required & Priority:	Trees should be assessed by a qualified arborist and deadwood removed, v-crotching managed and any rot cleaned up. Any wires or other debris attached to the trees should also be removed.
Management Prescriptions:	The tree should be assessed every two years by a qualified arborist, carrying out works as required. Tree replacement must be carefully managed so that not all the trees are removed at once, while at the same time the area must be managed so that pine seedlings do not completely take over. It is recommended that certain seedlings be left to grow and that excepting for safety reasons, no more than 10% of the trees be removed in the same year. As large groups of trees start to reach the end of their life expectancy a gradual removal policy must be implemented.
Existing Overlay Controls:	No Overlays
Statement of Significance:	The Monterey Pines at 11 Bellevue Ave, Doncaster East are of local significance for their contribution to the aesthetic value of the streetscape in screening the reservoir and for their size, being among the largest Monterey Pines viewed as part of this study.
