Manningham Heritage Garden & Significant Tree Study

Significant Tree Information Sheet

Tree Identification No.: 24

Common Name: Pin Oak

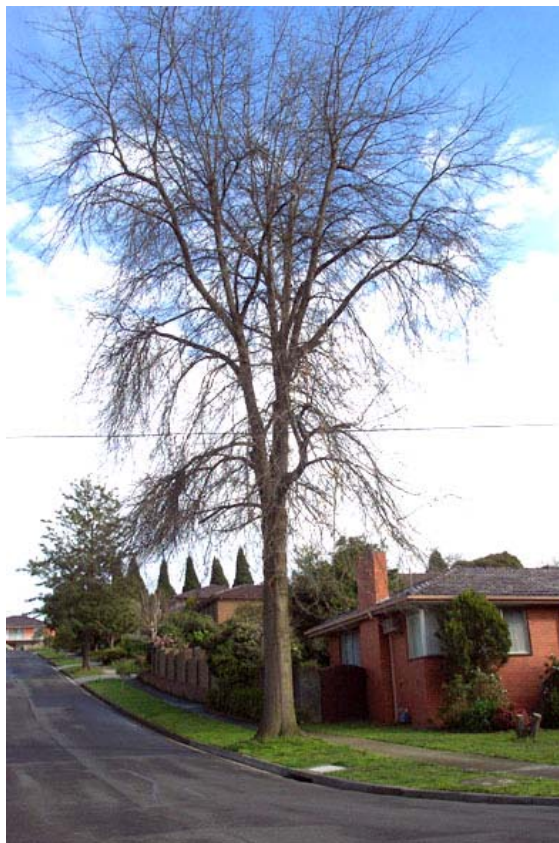
Other/Notes: Tree appeared to be in good health at the time of inspection.

Other/Notes: Tree is v-crotched and will eventually require cabling. A small wound exists at the base of the trunk on the tree's south-west side, and the tree is starting to lift the footpath on the northern side; although it has not cracked the concrete. The form of the tree is slightly irregular due to the v-crotched trunk, however it should be noted that there are no powerlines directly interfering with the growth of the canopy, allowing

good size and form to develop. Powerlines are present some distance to the trees east and have not impacted on initial form development, although they will prevent full expansion of the trees canopy in this direction.

Works Required & Priority: Canopy thin for aesthetic purposes and deadwood within the next six to twelve months.

Management Prescriptions: Assessments should be continued by a qualified arborist every twelve months, with work being carried out as required. The v-croched trunk should also be subject to regular inspections to determine when cabling is required. Eastern side of tree may need to be pruned by a qualified arborist to clear area around powerlines.
