### Manningham Heritage Garden & Significant Tree Study

### Significant Tree Information Sheet

Tree Identification No.:		85					
Botanical Name:		Quercus canariensis					
Common Name:		Algerian Oak					
Location:		Wonga Park Primary School, 41 Dudley Road, Wonga Park					
Private	and X	Public land					
Melway F	Ref:	24 H9					
Setting/Position:		Four Algerian Oaks within the grounds of Wonga Park Primary School. Two are located along the front boundary with the third in the centre of a courtyard and the final tree beside the toilet block.					
No. of trees:		4					
Height:		12-14m (average)					
Canopy	Spread (m) E-W	20m (courtyard), 8m (front boundary - both)					
	N-S:	& 14m (toilet block) 20m (courtyard), 10-12m (front boundary – both) & 13m (toilet block)					
DBH:		1009mm (courtyard), 989mm (front - north) 844mm (front – south) & 810mm (toilet block)					
Approx. Age of Tree:		110 years					
TPZ: 12.1m (courtyar 11.9m (front-no 10.1m (front-so 9.7m (toilet bloc		orth) 3.3m (front-north) outh) 3.0m (front-south)

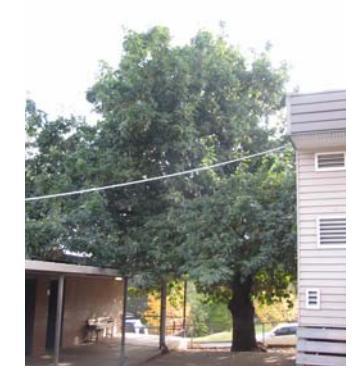
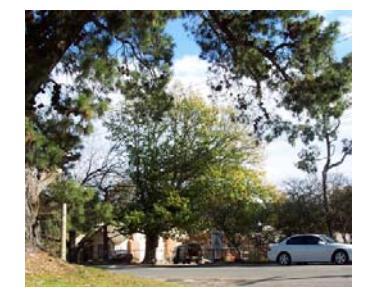
Pests/Diseases	Dead wood	Х	Dieback	Х	
Stunted growth	Stress	Х	Rot	Х	
Leaf necrosis	ecrosis Low foliage density		Possum damage		
			oints. The oak in the courtyard has had s garden bed had been built up around true ress and dieback from incorrect pruning.		
Other/Notes:	removed from base - whe	re the original gar	den bed had been built	up around tru

Both trees along the front boundary have been quite significantly pruned to accommodate power lines on the east side of the canopies. Bricks and building rubble have been stockpiled under the canopy of the southern boundary tree.

Co-dominant branches			V-crotched			
Irregular branch structure			Low-hanging branches (unsafe)			
Diseased limbs			Other	Х		
Other/Notes:	The northern of the two trees on the front boundary has multiple leaders from 2m, some at irregular angles. The tree near the toilet block has some limbs extended over this and is lifting the paving. Tree has been lopped to clear the road and building, and tree is exhibiting signs of stress due to a small soil surface area. Some root girdling and collar formation on lopped branches is also present.					
Structure Rating:	2-3					
Works Required & Priority:	Remove minor deadwood from within the canopies of the trees in the street and courtyard as soon as practically possible. The tree near the toilet block has a large lopped branch that requires removal due to its collar formation, it would also benefit from the removal of some of the concrete from around its base if practicable. Other lopped leaders and rot and dieback should also be cleaned as soon as practically possible.

Management Prescriptions:	Correct pruning of the trees is essential in order to preserve the health of the trees and their structural integrity (and therefore safety). This is best carried out by a qualified arborist who should assess the trees every 2-3 years identifying and carrying out works as required. This should also include an aerial assessment.					
Existing Overlay Controls:	Heritage Overlay (HC Area (UGBA)	)52), <sup>°</sup>	Vegetation Protection Overlay (VPO1), Urban G	owth Boundary		
Statement of Significance:	The four Algerian Oaks within the grounds of Wonga Park Primary School, Dudley Road, Wonga Park are considered to be of regional significance for their aesthetic value and relationship to the heritage listed Wonga Park Primary School (opened 1895).					
Overall Tree Rating:	3					
Recorded by:	Susan Tallon					
Date:	14-03-03					
ID Confirmed:	Susan Tallon
