Manningham Heritage Garden & Significant Tree Study

Significant Tree Information Sheet

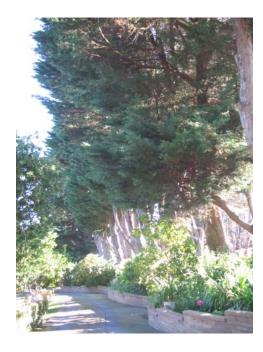
Other/Notes:	The lower canopy of the trees on 333 High St was removed at the time of the Ash Wednesday Bushfires to try and reduce fire risk. Trees at 351 High Street have some internal canopy dieback, those at 360 have some inner canopy deadwood. A large drain was dug along the western side of the road around 1997 and would have damaged the root system of these trees leading to stress and possible structural instability. A retaining wall has also been built around the base of the trees at 344 High St, which may have the same result. Some trees on the western side of the road have suffered from disease infestation.
Threats/Risks to Tree:	The driveway is cut close to the trees along the southern boundary of 333 High Street,

with some filling having occurred around the base of the western most trees. A retaining wall has also been cut near some of the trees. Road work and associated trenching for services etc. is a threat to all trees. Power lines run along the western side of the street with lopping to clear them being a threat to trees on this side of the road.

Other/Notes:	 333 High St – Trees are branching from the base with many being multi-leadered with extended branches. Trees also lose the occasional branch during windy weather. Many of the trunks/leaders are on an angle and appear to be branches that would not naturally be the main leader. The construction of a drain along the road may also have stressed and destabilised the trees. 339 High St – Trees have been lopped to clear power lines and have poor structure, branching from the base away from the road. The construction of a drain along the road may also have stressed and destabilised the trees. These trees were assessed from the road. 344 High St – Trees generally have poor structure and are branching from low and have been lopped. The construction of a retaining wall near the base of the trees may have stressed and destabilised them. These trees were assessed from the road. 351 High St – Trees have been lopped to clear power lines. The construction of a drain along the road may also have stressed and destabilised the trees. The construction of a drain along the road. 361 High St – Trees have been lopped to clear power lines. The far tree to the south of the property is v-crotched and starting to split and break apart. One leader has been removed. 360 High St – The trees formed a hedge in the 1960's but were pruned to grow upwards after a similar hedge over the road was destroyed by "hedge burners". The trees are now poorly structured with many large epicormics.

Works Required & Priority:	All trees should be subjected to a structural assessment and maintenance work by a qualified arborist within the next three months. This would be most effective if all trees were assessed by the same arborist, who would check the stability of limbs and the over all tree as well as for the presence of rot in the leaders.
Management Prescriptions:	All trees should be annually by a qualified arborist, identifying and carrying out works as required. The costs of maintaining such large rows can be significant and should if possible be either (a) subsidised or fully funded by the council or (b) carried out by council arboricultural staff in order to lift the burden of cost from the land holders. A replacement strategy should also be implemented for when trees required removal, as this species is not especially long lived and the trees in this area are of poor structure. These trees will require careful monitoring to determine when removal is required. Additional management prescriptions for individual properties are as follows: 333 High St – The trees with concrete completely around their base (near western end of southern boundary row) should be especially monitored. 360 High St – Limbs are to be kept clear of the house through pruning as required. Clearance pruning may also take place to the south of the row where branches over hang the driveway. However this must be carried out by a qualified arborist and should be limited to the large overhanging branch.
