## Manningham Heritage Garden & Significant Tree Study

### Significant Tree Information Sheet

**Tree Identification No.:** 76

**Location:** 3-21 Unwin St,  
Templestowe

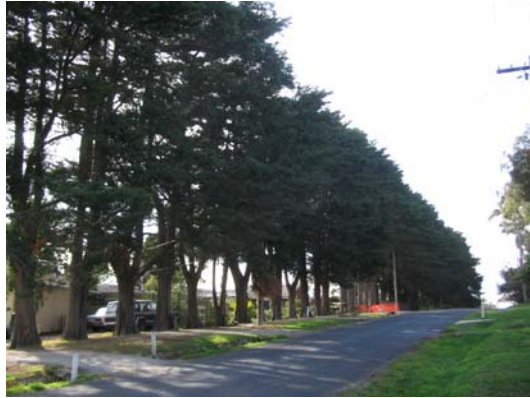
**Other/Notes:** Some inner canopy deadwood present and some sparseness.

**Health Rating:** 3

**Other/Notes:** Many trees have co-dominant/v-crotched branches from low and are of poor structure. Many trees are branching from a height of around 4m, suggesting they may have once been pruned as a hedge. Trees have good form.

**Structure Rating:** 4

**Works Required & Priority:** Trees require assessment by a qualified arborist within the next three months due to their poor structure.

**Management Prescriptions:** The trees should be assessed annually by a qualified arborist, carrying out works as required. The costs of maintaining such large rows can be significant and should if possible be either (a) subsidised or fully funded by the council or (b) carried out by council arboricultural staff in order to lift the burden of cost from the land holders. A tree replacement strategy should be implemented involving the replacement of any trees removed with the same species.
