H10

REGISTER OF SIGNIFICANT TREES - REGISTRATION FORM

- 1.1 Family Fagaceae
- 1.2 Botanical Name Quercus robur
- 1.3 Common Name English Oak
- 1.4 Name of particular specimen if it has one, eg. "The Corroboree Tree"  
"Donaldsons Oak"
- 1.5 Is the specimen indigenous or introduced? (circle one)
- 1.6 Identified by/or reference \_\_\_\_\_

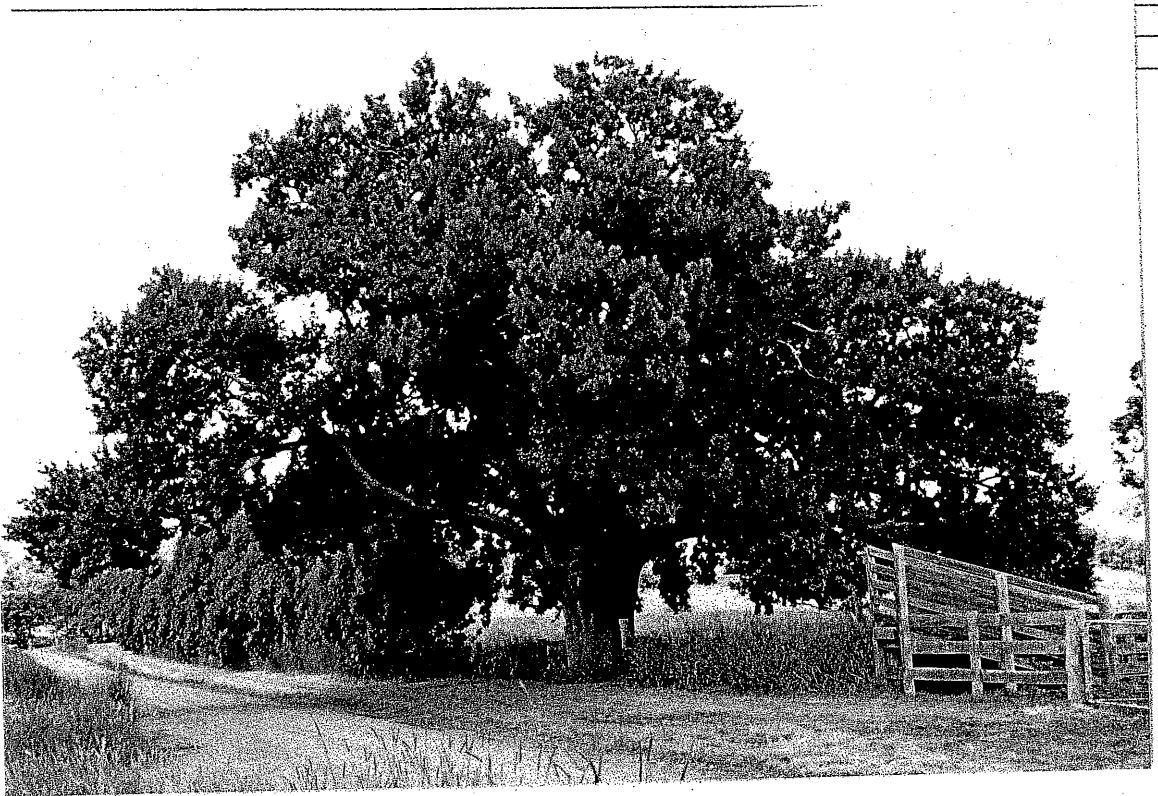
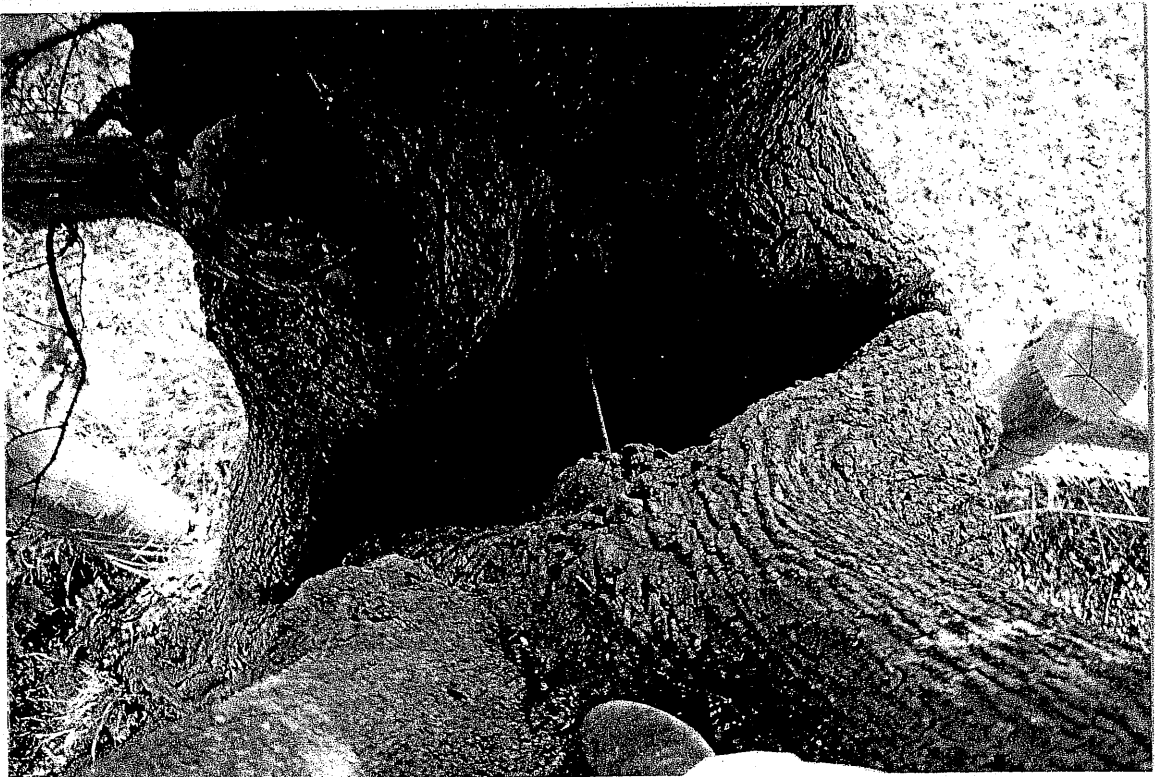
Large trunk cavity - a number of rod prongs have been installed  
into the cavity to ensure tree structure remains intact.  
Continual ongoing maintenance.
