Preliminary Report
Ballarat Mining Exchange

6 Lydiard Street North, Ballarat

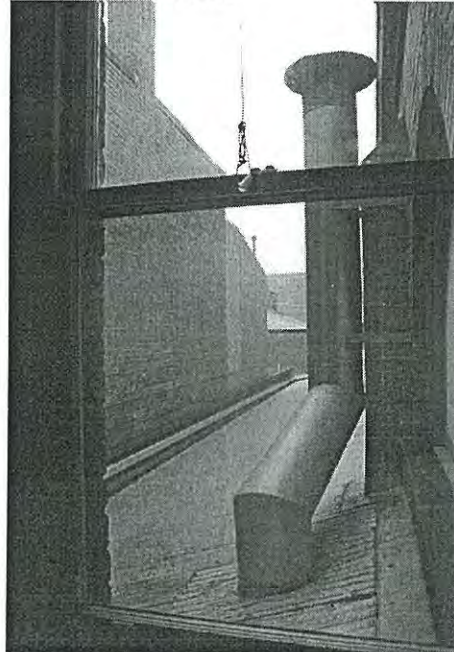
Photo 3.16: Exterior, Exchange Hall, north elevation (clerestory level), west end showing introduced zincalume ventilation stack which is causing rusting at the junctions of the base cladding and the roof cladding.

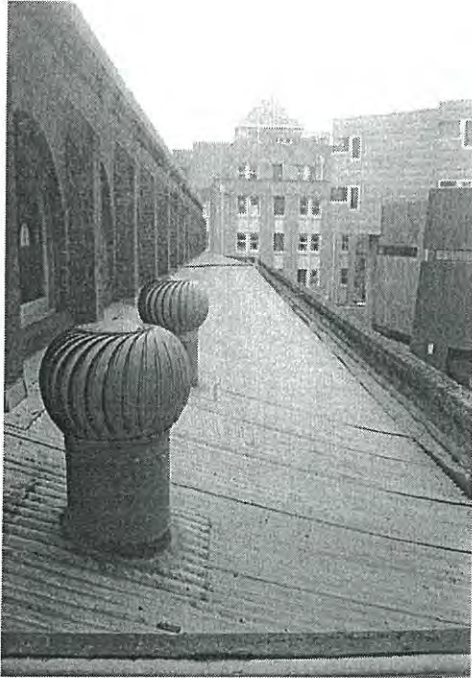
Photo 3.17: Exterior, Exchange Hall, south elevation (clerestorey level), west end, showing galvanised ventilation stacks.

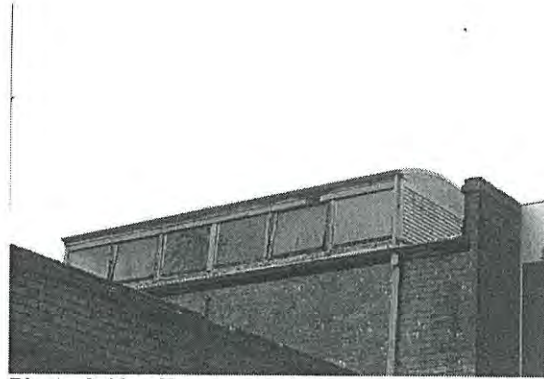
Photo 3.18a: Exterior, Call Room, south elevation showing deteriorated framing and cladding of lantern light.

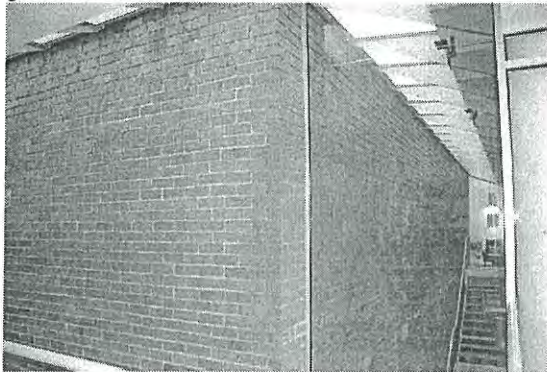
Photo 3.18b: Exterior, Call Room, view of north and east elevations now largely enclosed by the new University of Ballarat building.

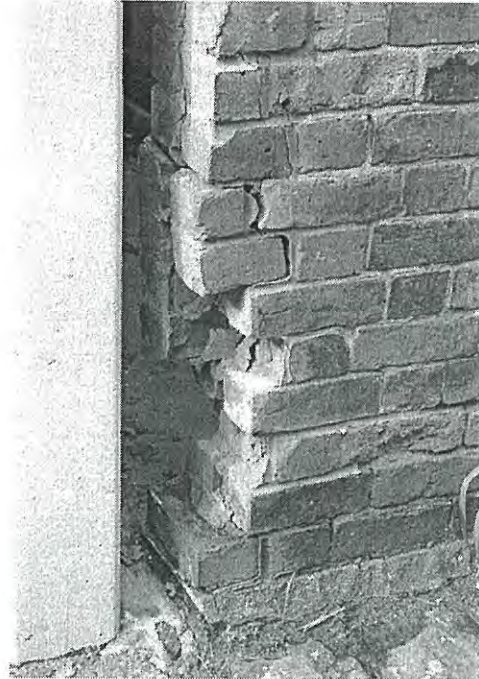
Photo 3.24: Exterior, Office & Toilet Wing, detail of damaged/partially demolished north-west corner of west elevation.

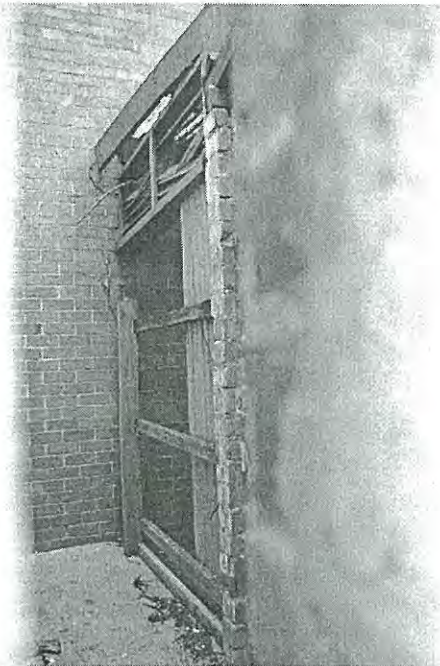
Photo 3.25: Exterior, Office & Toilet Wing, detail of open space showing partial demolition of toilet cubicle, timber framed galvanised corrugated iron partition (north end) and introduced raised concrete slab.

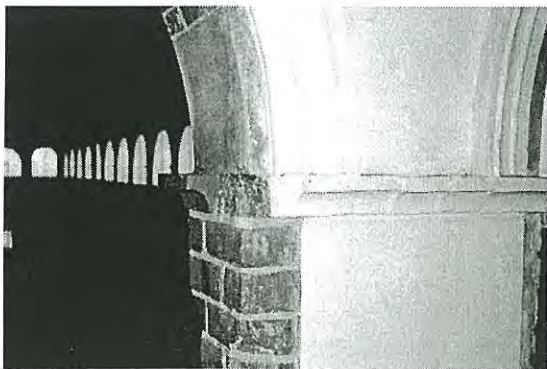
Photo 3.41: Interior, Landing & Stairs (space FF12). Detail of archway showing damaged/missing projecting brick and plaster cornices.

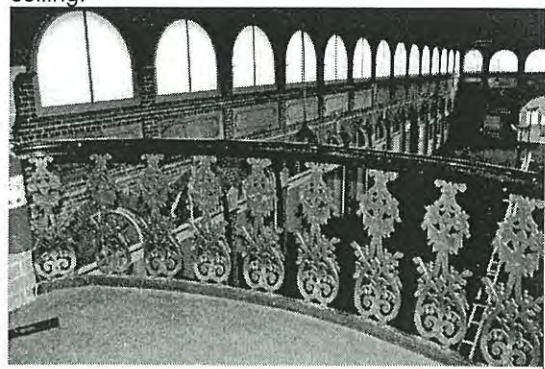
Photo 3.42: Interior, Landing & Stairs (space FF12). Detail of original curved landing with reconstructed sway bellied cast iron balustrade.

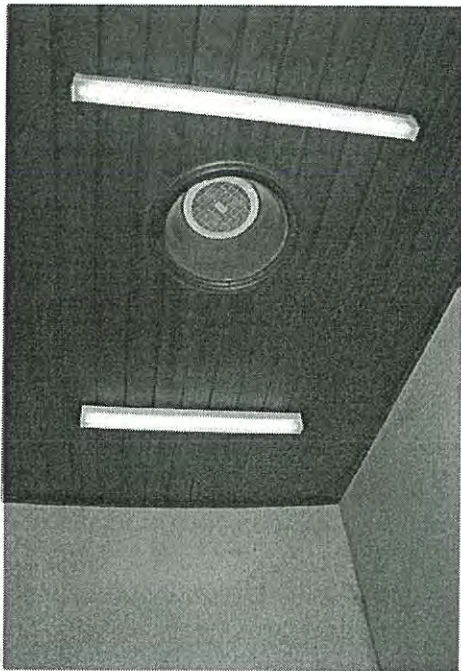
Photo 3.75: Interior, Ladies' Toilets (space B08a). Detail of introduced (but appropriate) stained beaded edged timber lined ceiling. Note the early ceiling ventilation opening with bolection mould frame and galvanised hood punctuated by the electrical fan.

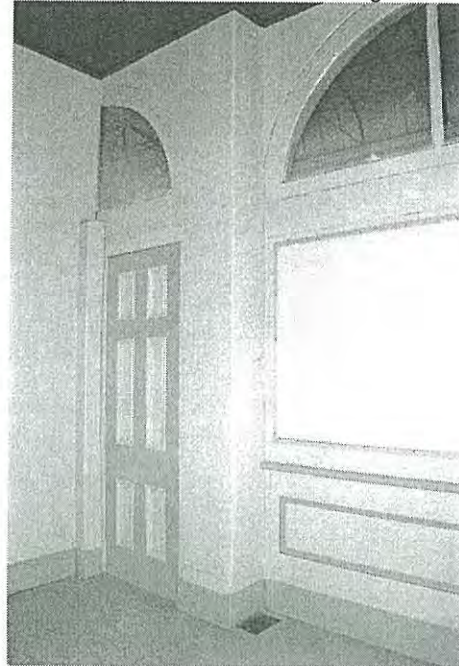
Photo 3.76: Interior, Ladies' Toilets (space B08a). View looking south-east showing introduced panellled timber and glazed arcade partition and appropriate six panellled timber door.

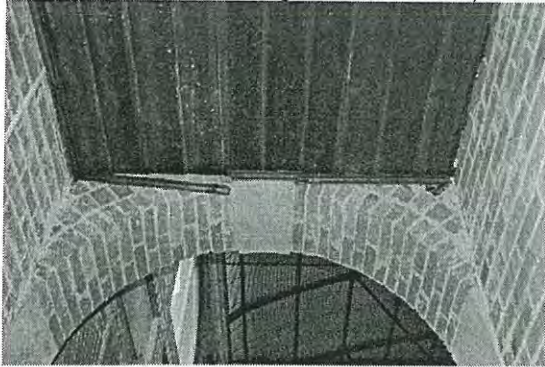
Photo 3.83: Interior, Exchange Hall (space H01). Detail of loose timber quad ceiling cornice on west end of rear eastern exit passage.

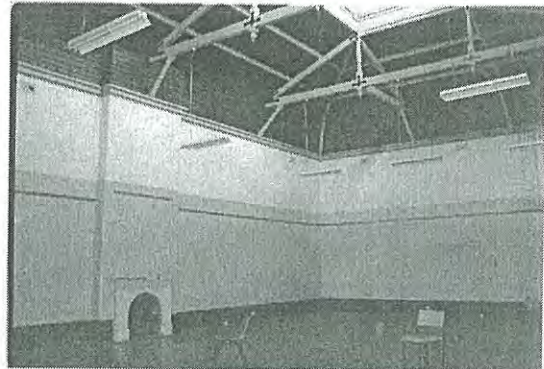
Photo 3.84: Interior, Call Room (space CR01). View looking north-east showing large timber lined ceiling with Queen Post trusses and lantern light, and the central fireplace on the north wall.

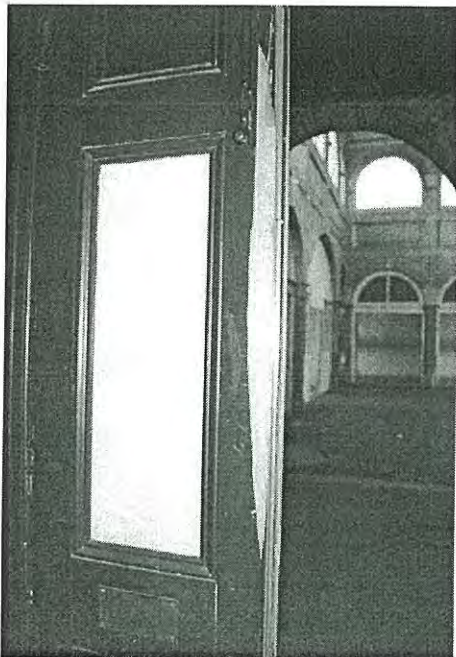
Photo 3.89: Interior, Call Room (space CR01).
Detail of damaged door, showing fractured timber
edge.

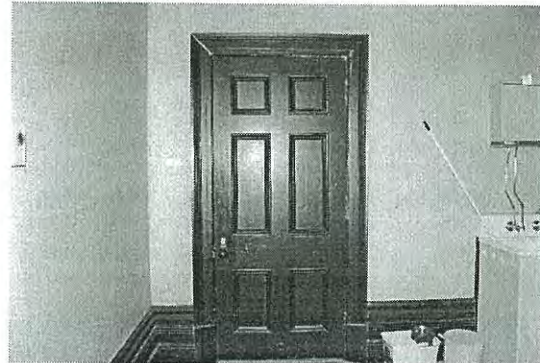
Photo 3.90: Interior, Call Room (space CR01).
Detail of original six panelled timber door on west
wall (south end) that leads to the passage (space
T03).

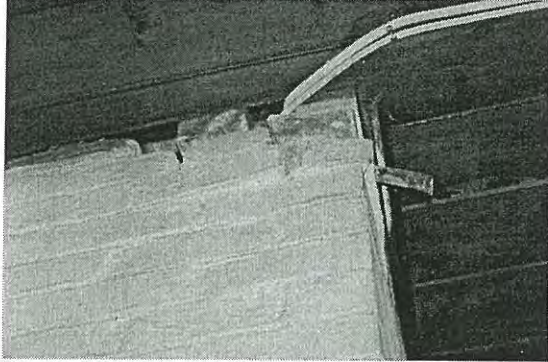
Photo 3.93: Interior, Passage (space T03). Detail of introduced electrical conduit that has inappropriately damaged the brick wall above the door into the office (space T02).

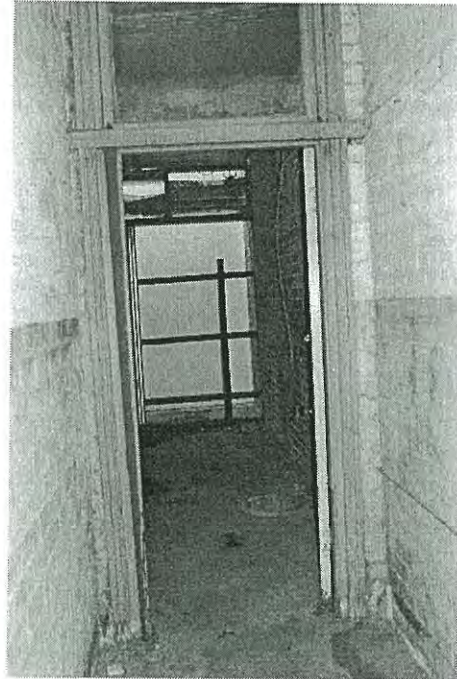
Photo 3.94: Interior, Passage (space T03). View looking north to Men's Toilet (space T01). Note the original timber framed doorway with transom window above, and the moulded timber architraves. Also note the concrete floor and evidence of dampness.

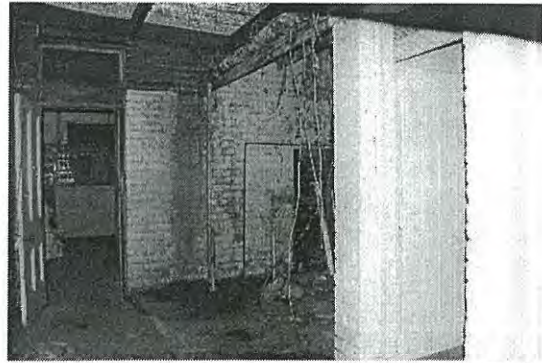
Photo 3.96: Interior, Men's Toilets (space T01). View looking south-west from northern partition. Note the substantial deterioration in the roof structure and brick walls, and the overgrown creeper. Also note the original doorway with the four panelled timber door.

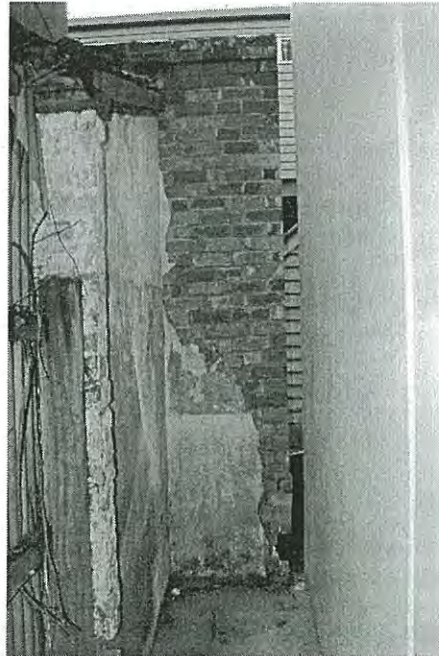
Photo 3.98: Interior, Men's Toilets (space T01). View showing area of demolished toilet cubicle (northern end of toilets). Note the damage to the west brick wall, introduced boundary wall of the new University of Ballarat building.

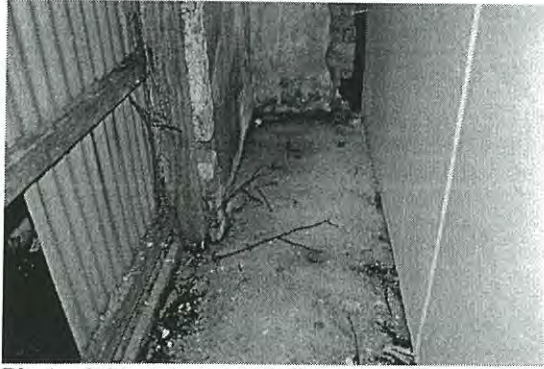
Photo 3.99: Interior, Men's Toilets (space T01). Detail of area of demolished toilet cubicle. Note the introduced raised concrete slab and the build up of debris within this open space.
