NEWTOWN URBAN CONSERVATION STUDY. - 'C' CITATIONS. Ref: 243

Richard Peterson Architect & Conservation Consultant. 1997.

ADDRESS: 9 Talbot Street

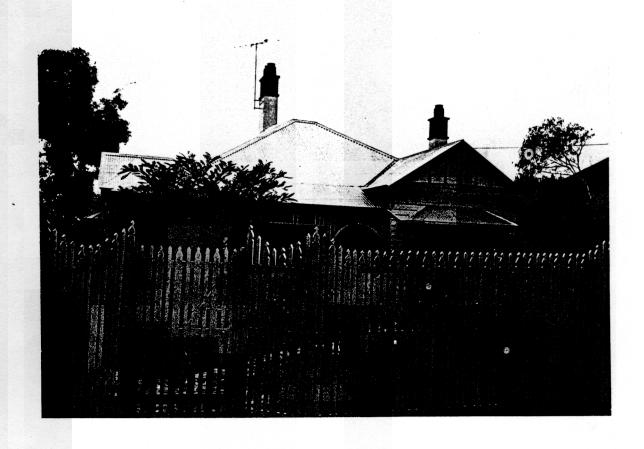
CONDITION: Excellent INTACTNESS: Very good

VISUAL DESCRIPTION: A triple-fronted timber Edwardian house with a high-hipped roof. Gables are set forward at right and left side rear. Upper gables are timbered roughcast with bellies in an ogee curve, supported on ogee fretwork brackets. Barge ends are shaped. They have hipped ripple-iron window-hoods on large fretwork convex brackets with tulip motifs.

Windows are double. The verandah extends around the angle under the hip, slightly breakpitch, with two deep arches and a palisade over a rail valance. This has decorative fretwork panels of tulip pairs. Brackets are decorative fretwork. Chimneys are rendered with a brown brick frieze and unglazed terracotta pots.

INTACTNESS: Very good, but the fence is recent.

CONDITIONS & THREATS: Excellent. The floor level is very low which may inhibit sub-floor ventilation: the garden level may need to be reduced.
