CITY OF GEELONG WEST

URBAN CONSERVATION STUDY: BUILDING IDENTIFICATION FORM.

1986

46 Hope Street

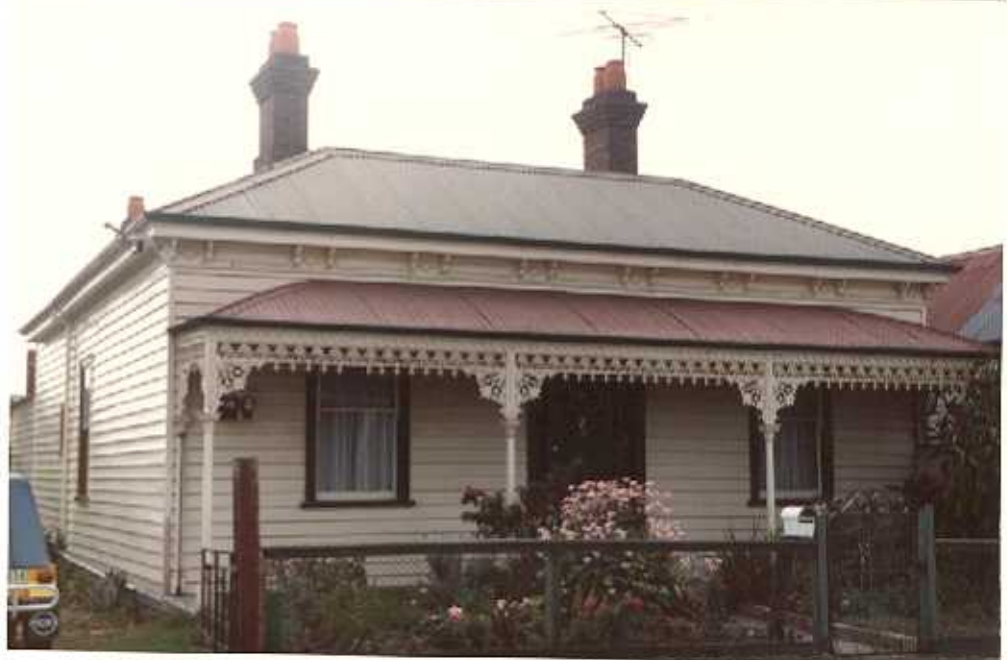
Description: A single-storey weatherboard Victorian house with a corrugated iron hipped roof and verandah. It is symmetrical in design with a central doorway, windows either side and brick chimneys similarly placed.

Decorative elements include turned wood eaves brackets interspersed with diamond and rectangle shapes in relief. The verandah is supported by slender iron columns with corinthian capitals and is surrounded by fine lace ironwork.

Integrity: The integrity of this building is good. The concrete verandah floor and the fence are the main detracting elements.

No.	Sympathetic	S.G.	Inappropriate	S.G.	Extremely Inappropriate
<i>46</i>			<i>fence and gates</i>	—	
<i>46</i>			<i>concrete ver. floor</i>	<i>S</i>
