## RESIDENCE

516 Barkly Street

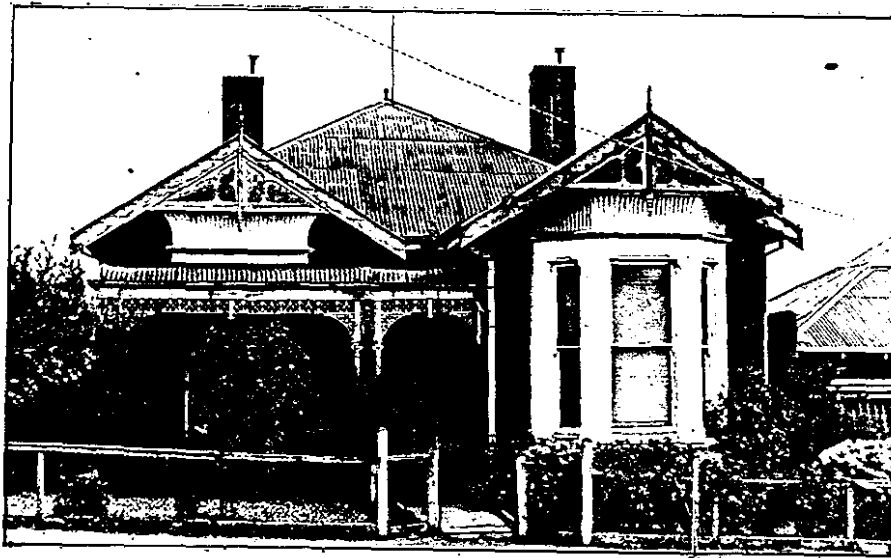
This late Victorian style brick villa is situated on the opposite corner of Cameron Street from "Clowance" and is an important element of the area. The main features of interest are the bay windows with a fluted cornice fanning out to join the roof gable. The gable ends of the roof have decorative stucco and timber barge boards with a decorative finial. The detailing of this house is transitional between Victorian and Edwardian architectural styles and it was probably constructed around 1910.

Retention of this contributory residence is to be encouraged. However no specific recommendations are made for demolition control.
