BUILDING TITLE SYNAGOGUE  
LOCAL GOVERNMENT AREA CITY OF BALLAARAT

NATIONAL ESTATE PROJECT No.  
DOCUMENTATION OF LISTED HISTORIC BUILDINGS IN VICTORIA

## SYNAGOGUE, BARKLY STREET

### BUILDING ANALYSIS AND DESCRIPTION

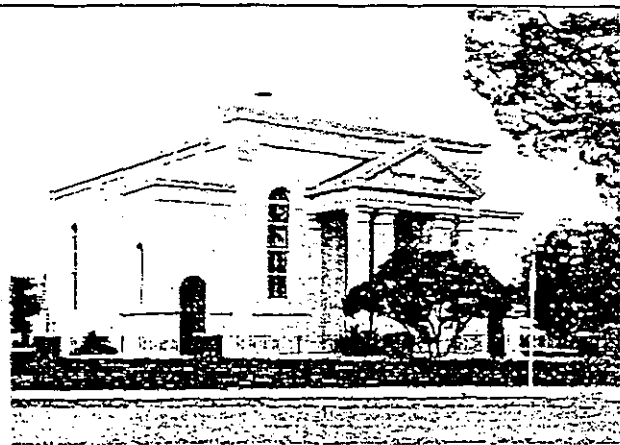
TITLE REFERENCE Vol Fol  
DIRECTORY  
NEGATIVE FILE FILM 2 / FRAME 33

This building follows the pattern of old European Orthodox Synagogues which are distinctly different from the modern and more liberal Temples. The building is constructed of brick and originally had only the pilasters, columns, pediment, window reveals and cornice rendered. Sadly all the face brickwork has now been rendered.

The building takes the form of a single rectangle with a portico supported on pairs of squared Tuscan columns and pilasters. Hebrew lettering in the tympanum has a mysterious cipher-like quality and contributes to the building's intrigue. The portico and main building are roofed in slate. Corner pilasters at the front support a deep cornice. Elegant round headed sash windows, flanked by pilasters, complete the remainder of the building exterior.

Two small wings have been added on either side of the facade. These additions repeat the cornice pattern and continue a moulding incorporated beneath the front windows. Round headed openings to doors and windows detract from the original simplicity of the building, as evidenced in the early photo.

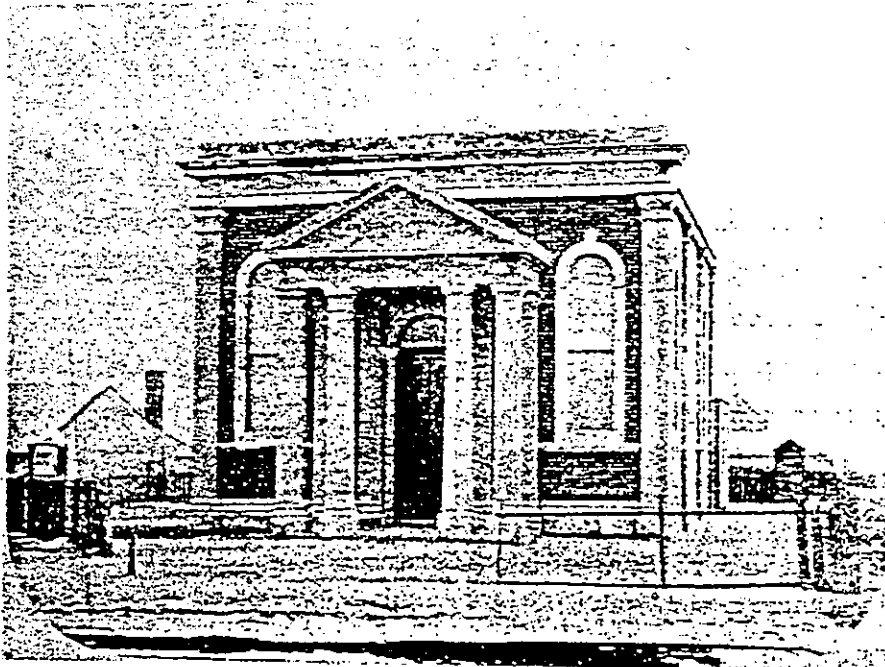
The foundation stone of the Synagogue was laid on 25 January 1861 and the brick building, designed by T.B.Cameron was opened on 18 March 1861. 1861 for a cost of £900.<sup>1</sup> At a later date the two wings were added and the original face brickwork rendered (see photograph.H20514, 1861 attached). This may have been undertaken in 1886 when T.B.Cameron called for tenders for a new Synagogue<sup>2</sup> or when renovations were carried out in 1903. The Synagogue was restored in 1961.
