BUILDING NO. 8.  
'CLIFTON VILLA'  
502 EYRE STREET

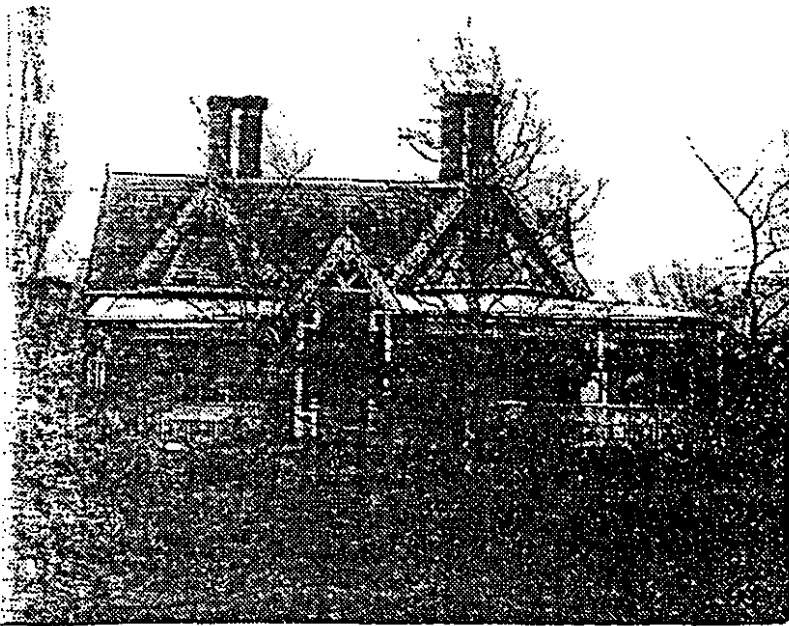
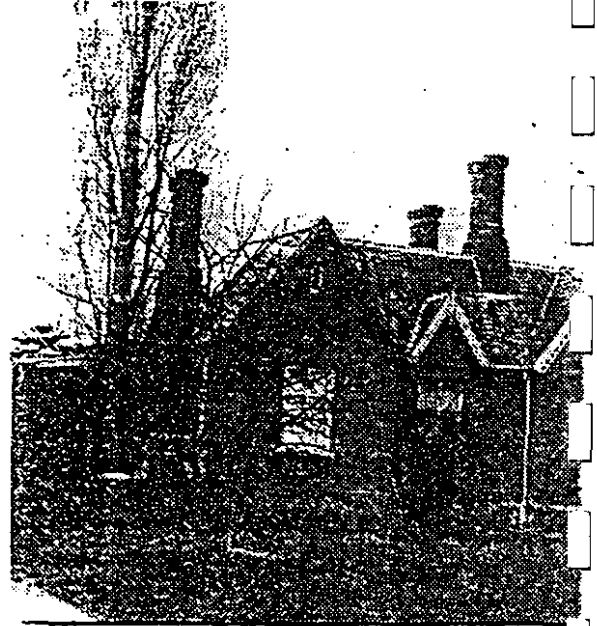
The picturesque Gothic style was adopted in the design of this red brick house, and the composition and character are indicative of pattern book design. Steep slate roofs end in gables which feature decorative barges and finials, and distinctive paired chimneys are cylindrical with spiral patterns. A typical verandah encompasses two sides of the building, decorated with cast iron valence, brackets, columns and balustrading, and containing a decorated gable over the entrance. Polygonal bay windows of the front facade add to the Gothic character of the house, and the asymmetrical form, together with the spacious corner setting, impart a picturesque quality.

'Clifton Villa' is largely intact but is in a generally poor condition. Both the building and the surrounding grounds require urgent maintenance and repair work and it is recommended that a conservation analysis is undertaken before future work is carried out.

It is recommended that 'Clifton Villa' be added to the Historic Buildings Register and protected under Clause 8 of the Town and Country Planning Act. (Third Schedule).
