BACCHUS MARSH HERITAGE STUDY.**Ref:** 27

Richard Peterson Architect & Conservation Consultant. Daniel Catrice Historian 1994.

NAME: Buckler's Farm (Chouting?)**PREVIOUS NAME:****ADDRESS:** Bucklers Road. Parwan South(?) (Shire of Werribee, on Shire Boundary).**TITLE DETAILS:****USE:** Farmhouse.**SIGNIFICANT DATE:** ?**CONSTRUCTION DATE:** ?**SOURCE:**

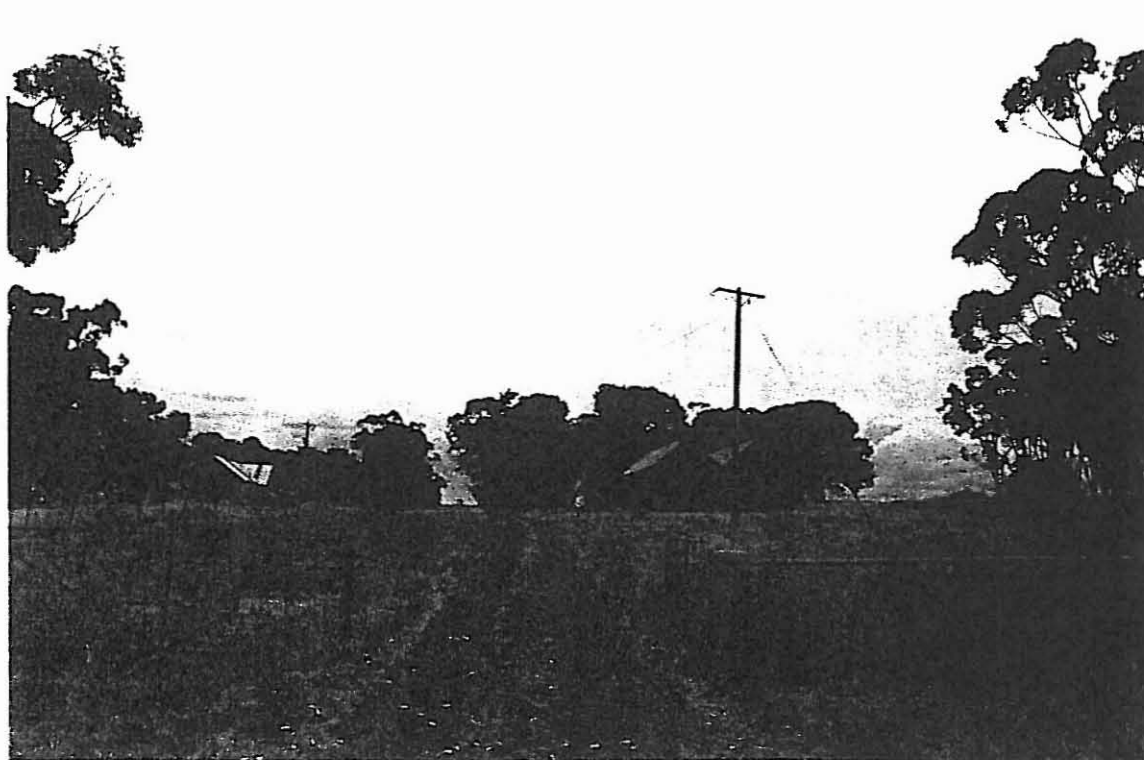
VISUAL DESCRIPTION: House. A red brick Edwardian house with a T-shaped plan. The gable-ends have finials and cross-bars. There is a skillion verandah around on three sides. Chimneys are bi-chromatic brick. Two large outbuildings and a wooden pavilion appear to be a similar date, with corrugated iron cladding, timber latticework and finials. Bucklers Road is lined with a drystone wall for 200 metres and a further 200 metres of post and wire fence with a drystone base, one side only. The outbuildings are in Bacchus Marsh Shire, but the drystone walls and house are in Werribee Shire.

Wall. The substantial dry stone wall stands 1.2 metres high and demonstrates the considerable skill of the waller. Through stones are evenly placed about one third up the wall and coping is regular. The main stones are unevenly coursed, but carefully placed with extensive plugging. The wall evidently originally extended all the way to the Rowsley Exford Road, forming one side of the entrance drive to the present Buckler's farm property.
