# BUILDING IDENTIFICATION FORM 73

## RICHMOND CONSERVATION STUDY

BUILDING ADDRESS 234 COPPIN ST.

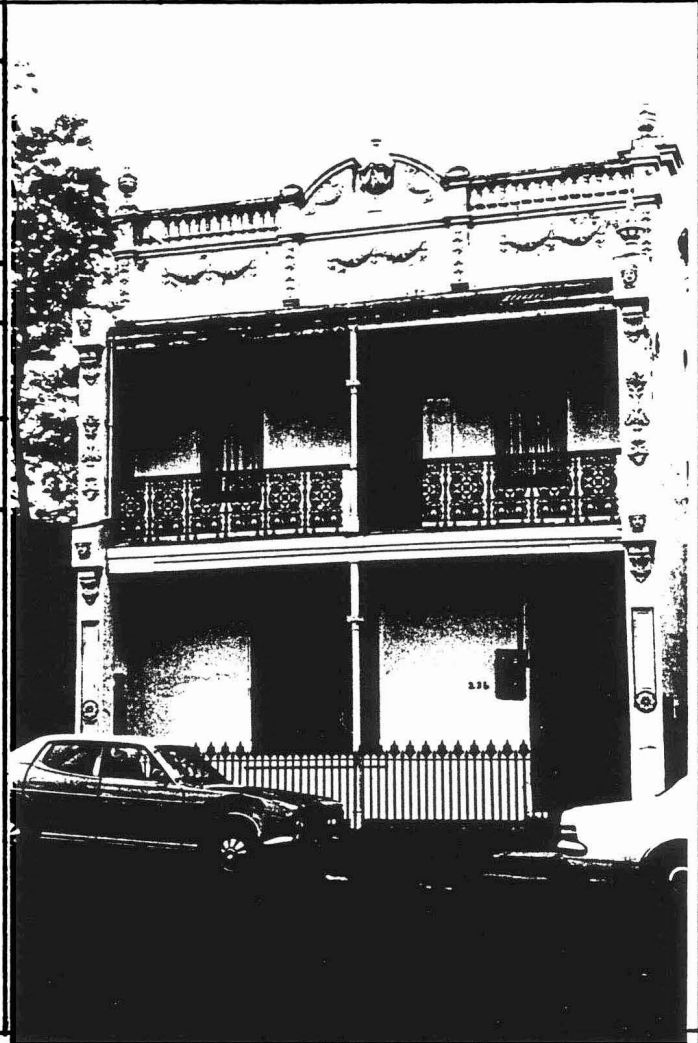
LINING OVER  
DOOR HIGHLIGHT

PAINT COLOUR.

This Victorian terrace features an intricately detailed facade, featuring ornamental festoons, urns, friezes, consoles, and broken pediment.

0
