BUILDING IDENTIFICATION FORM

RICHMOND CONSERVATION STUDY

BUILDING ADDRESS *5 DICKMAN ST*

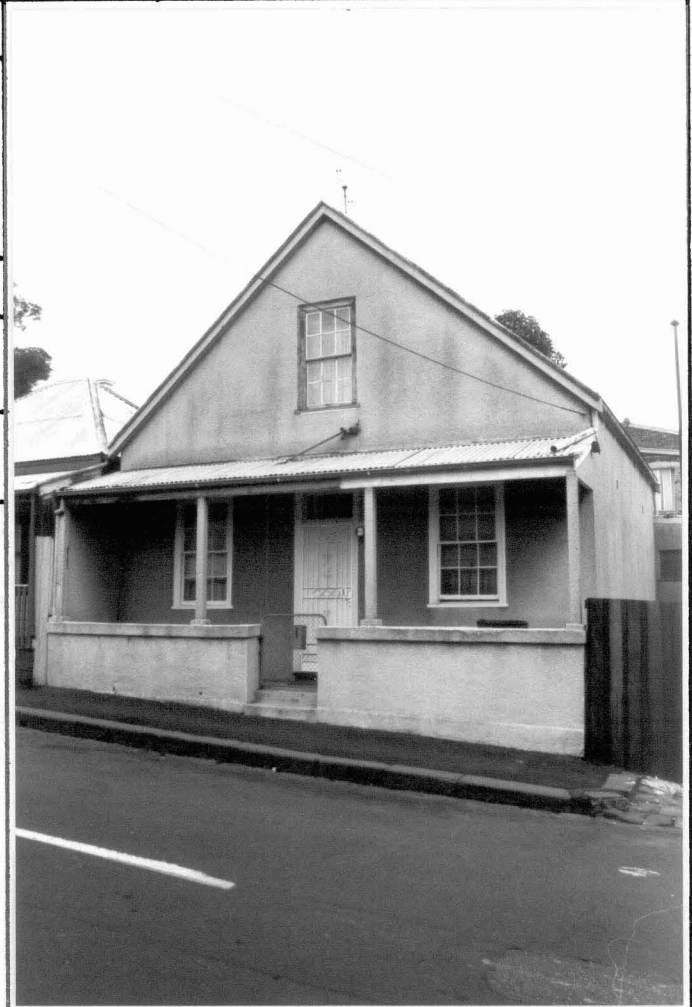
Walls *LATER RENDER*

Roof *IRON*

This early Victorian cottage was constructed sometime prior to 1875, with a characteristic gable attic form. The dwelling retains twelve panel windows.

No.	Sympathetic	S.G.	Inappropriate	S.G.	Extremely Inappropriate	S.G.
					<i>RENDER TEXTURE</i>	<i>RAM</i>
					<i>FENCE</i>	<i>S</i>
