BACCHUS MARSH HERITAGE STUDY.**Ref:** 282

Richard Peterson Architect & Conservation Consultant. Daniel Catrice Historian 1994.

NAME: Millside.**ADDRESS:** Mount Blackwood Road (NE cnr Muirs Lane).**TITLE DETAILS:****USE:** Farmhouse.**CONSTRUCTION DATE:** 1910s**SOURCE:** Visual.**CRITERIA:** H1; Ar1.**HISTORIC THEME:** Agricultural**DESCRIPTION:** **STYLE:** Edwardian **STORIES:** 1 **DETACHED.****MATERIALS:** **WALLS** Timber **ROOF** Iron **STRUCTURE** Stud**CONDITION:** Good**INTACTNESS:** Very good**THREATS:****SIGNIFICANT INTACT ELEMENTS:**

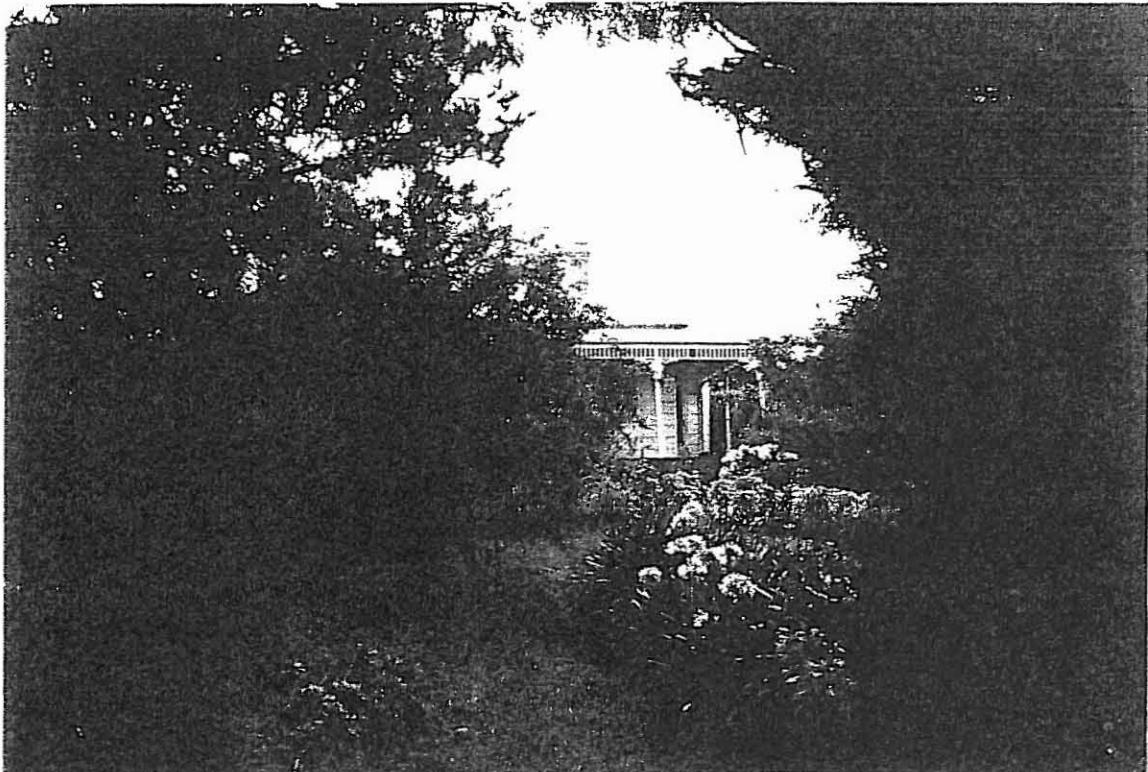
VISUAL DESCRIPTION: A double-fronted timber Edwardian farmhouse. The left hand bay is set forward as a gable, with a bull-nosed timber verandah in the angle, returning on the right hand side. This has fretwork decorative brackets under a rail valance and Doric posts. The house has exposed rafters and ashlar timber boards to the front.

There are a number of contextual elements. There is a late nineteenth century timber outbuilding at right. This is separated from the house by a hedge. The front boundary has a row of pines, there is an arbor at the pedestrian woven wire gate (there is a similar gate in the hedge) in a corrugated iron fence, and there is also a hand-forged metal gate. On the front boundary of the paddock at left, in front of the pines, is a split post and wire fence on a rubble drystone base, with three drops between posts. This extends from Muirs Lane on both sides of Mt Blackwood Road, northwards. The best section is north-east of the property of J.E. Gan. There is an extensive view westwards over rolling paddocks with pine windbreaks of the Mymiong Creek valley.

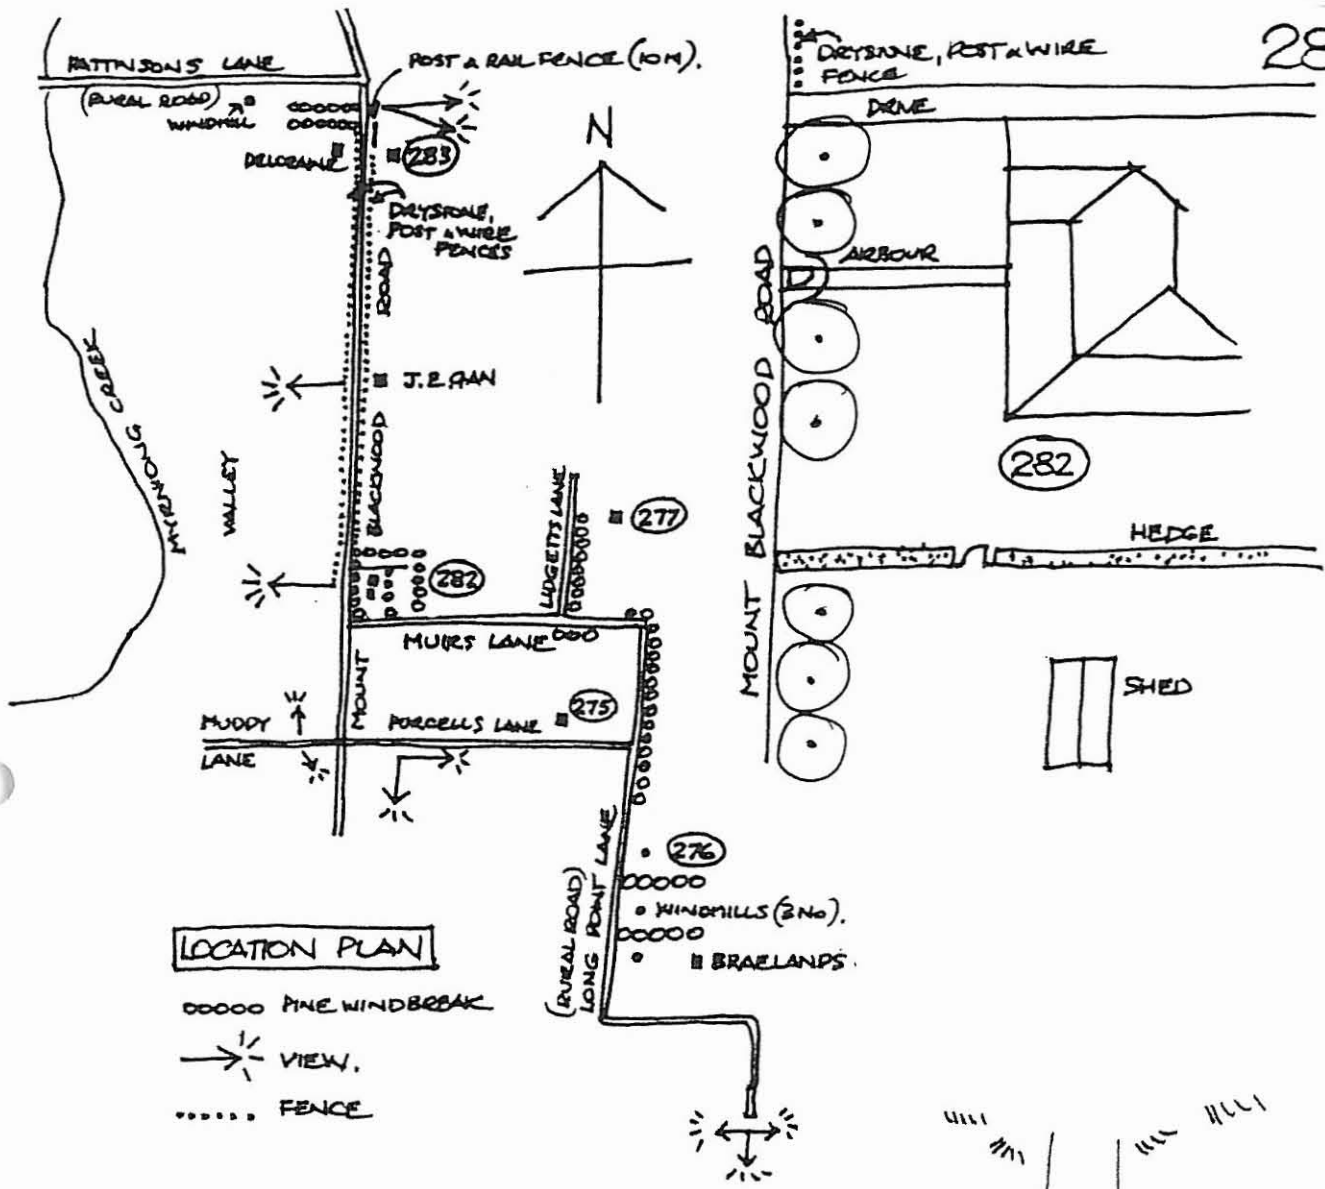
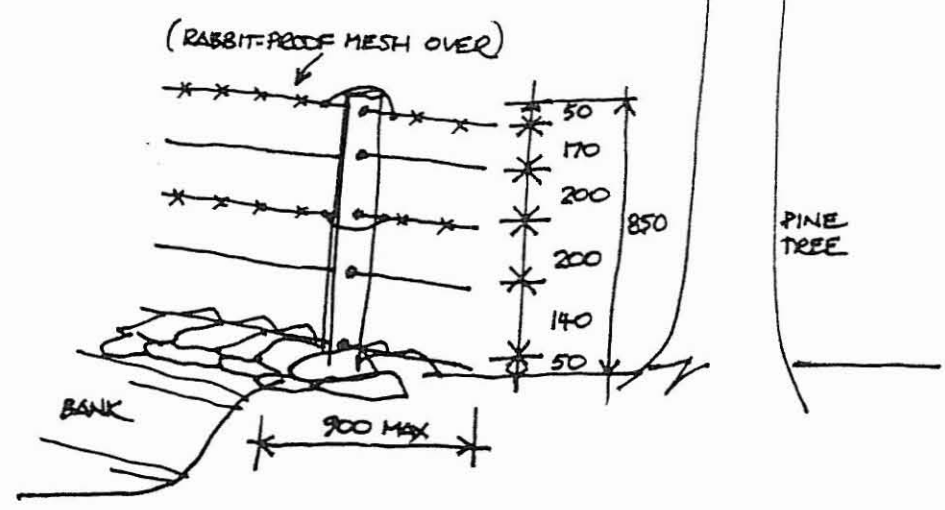
Landscape. The windbreaks subdividing the various paddocks and yards of this property are a combination of *Pinus radiata* (Monterey Pine) and *Cupressus macrocarpa* (Monterey Pine). The majority of the trees are in good condition with some dead branches on the pines which will require pruning. They form a good screen to the property and would provide shelter in a reasonably exposed area. The cypresses are not as large as similar specimens within the district, but this may be due to localised soil and climatic conditions within the property.

INTACTNESS: Very good.

CONDITIONS & THREATS: Good.
