# BUILDING IDENTIFICATION FORM

RICHMOND CONSERVATION STUDY

BUILDING ADDRESS *21, 23 ERIN ST.*

BUILDING TITLE *TARRAGONA*

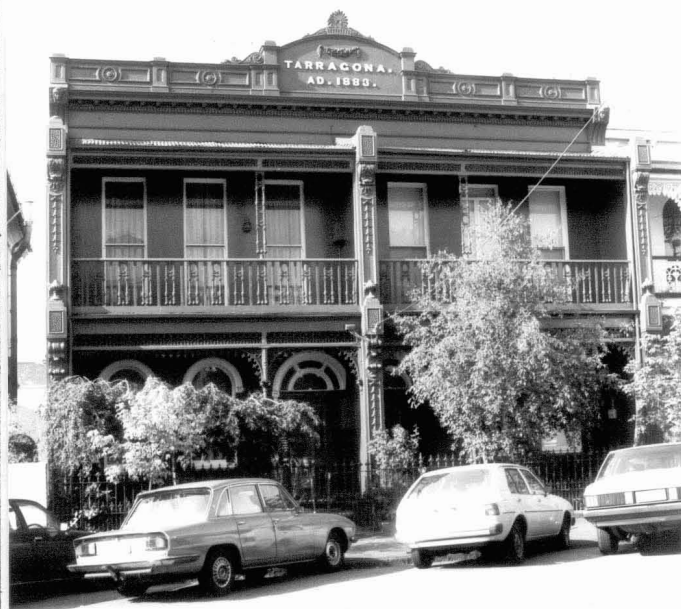
ornamental  
wall detailing ☒

original  
doors/windows ☒

intact verandah  
structure ☒

original  
parapet ☒

intact verandah  
decoration ☒

early  
fence ☒

*VERANDAH  
& PATH TILES* ☒

good ☒

No.	Sympathetic	S.G.	Inappropriate	S.G.	Extremely Inappropriate	S.G.
			<i>MISSING PARAPET IRONS</i>	<i>O</i>		
			<i>PAINTED RENDER</i>	<i>RAM</i>		
			<i>BALUSTRADE IRONS &amp; RAIL</i>	<i>S</i>		
			<i>1ST FLR. VER. POST</i>	<i>S</i>

*A GOOD EXAMPLE OF THE LATE VICTORIAN  
TERRACE HOUSES THAT FORM THE IMPORTANT ERIN ST.  
STREETSCAPE.*

O = reinstate original designs

S = reinstate sympathetic alternative

RAM = Remove by approved method
