BUILDING IDENTIFICATION FORM

RICHMOND CONSERVATION STUDY

BUILDING ADDRESS *198 Lennox Street*

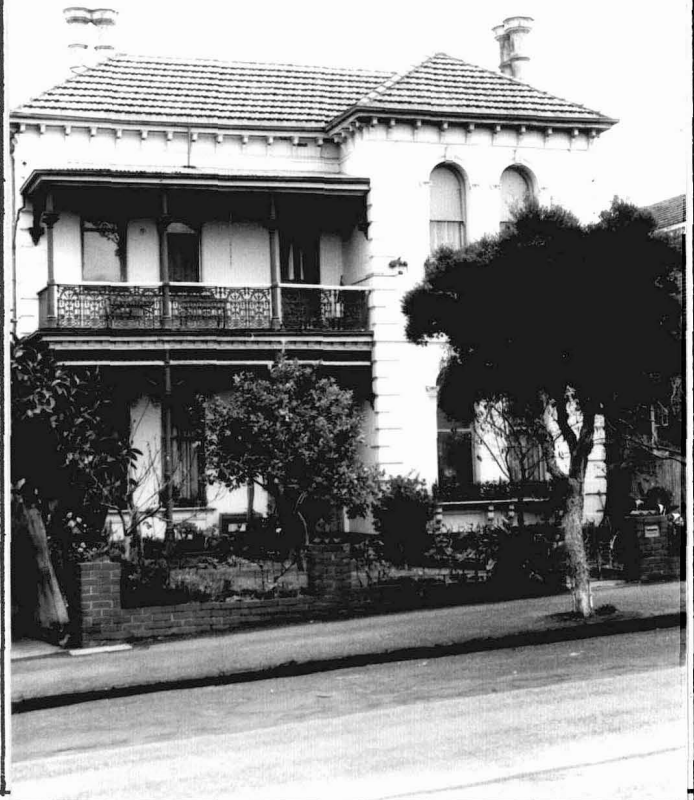
Walls *Render*

Roof *Terracotta tiles*

Well conceived and executed Victorian villa featuring arch headed openings, and french doors. Articulated by applied render quoins, and features unusual hexagonal chimney capping.

No.	Sympathetic	S.G.	Inappropriate	S.G.	Extremely Inappropriate	S.G.
			<i>Terracotta tile roof</i>	<i>S</i>
