# BUILDING IDENTIFICATION FORM

RICHMOND CONSERVATION STUDY

BUILDING ADDRESS **7-13 PARKER ST**

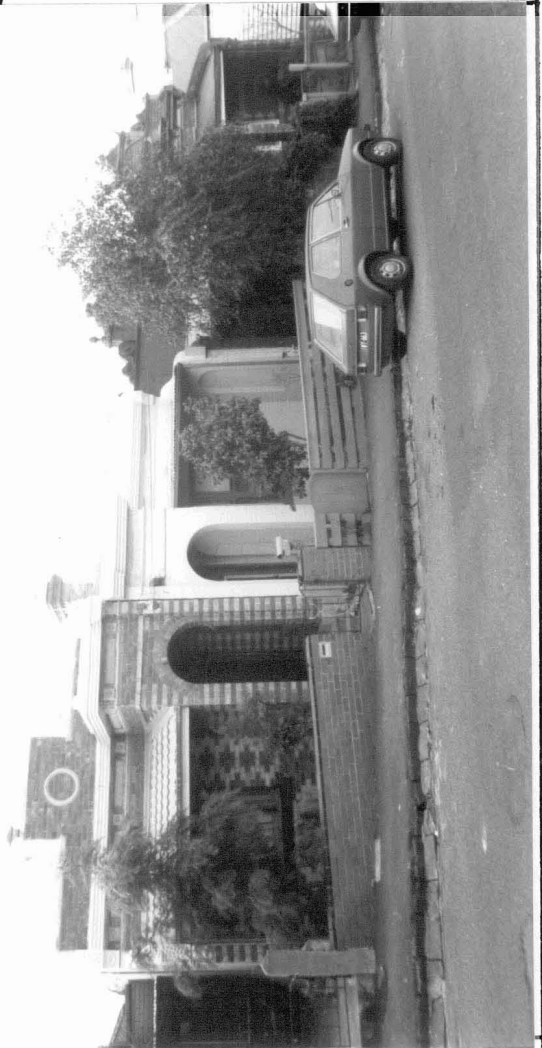
NEG. FILE **34-21**

original unpainted wall finish **7, 13**

intact verandah decoration **11**

original doors/windows **7, 9, 11**

original chimneys **7, 9, 13**

No.	Sympathetic	S.G.	Inappropriate	S.G.	Extremely Inappropriate	S.G.
<b>9, 11</b>					<b>PAINTED BRICKWORK</b>	<b>RAM</b>
<b>9</b>					<b>MODIFIED PARAPET</b>	<b>0</b>
<b>9</b>					<b>VERANDAH</b>	<b>0</b>
<b>7</b>					<b>METAL TILE VER. ROOF</b>	<b>0</b>
<b>7, 9, 11</b>			<b>FENCES</b>	<b>S</b>		
<b>11</b>					<b>PORCH REMOVED</b>	<b>0</b>

This row of brick polychromatic Victorian dwellings, is notable for the unusual plan form with a side entrance vestibule. The group maintains some integrity with original wall finishes, and provides an important streetscape element.

O = reinstate original designs

S = reinstate sympathetic alternative

R = remove

RAM = Remove by approved method
