BUILDING IDENTIFICATION FORM

RICHMOND CONSERVATION STUDY

BUILDING ADDRESS *9 Ketherwood Street.*

BUILDING TITLE "*Valencia*"

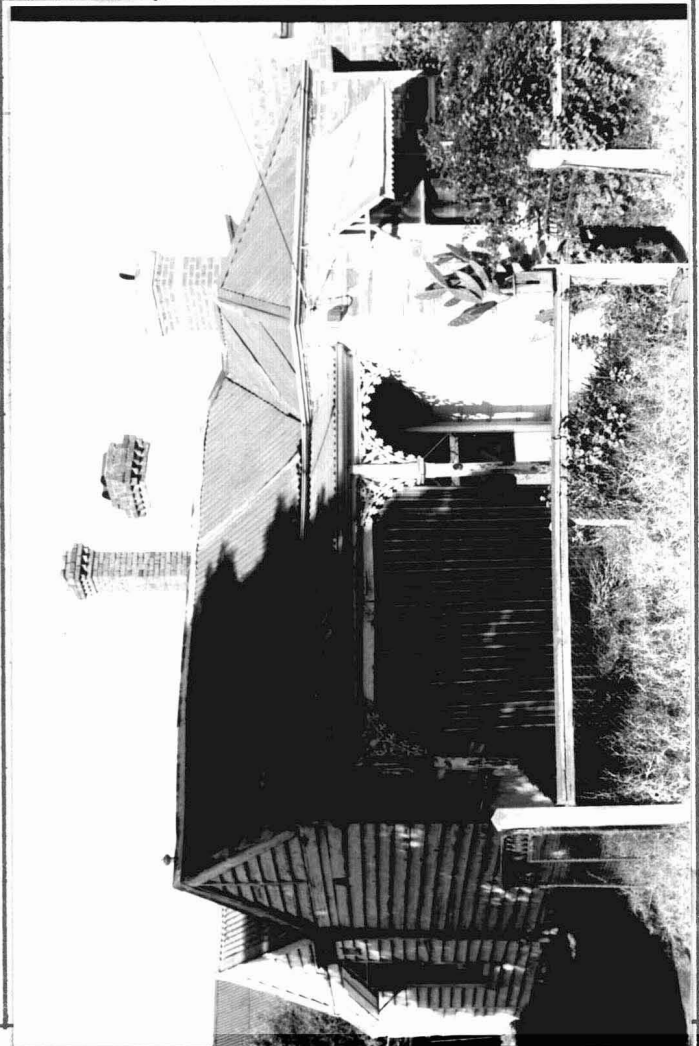
Walls *Timber* Roof *Corr. Iron*

early paint colour scheme	<input type="checkbox"/>	eaves, roof or gable decoration	<input checked="" type="checkbox"/>
original unpainted wall finish	<input type="checkbox"/>	intact verandah decoration	<input checked="" type="checkbox"/>
ornamental wall detailing	<input checked="" type="checkbox"/>	early fence	<input checked="" type="checkbox"/>
original doors/windows	<input checked="" type="checkbox"/>	early garden	<input type="checkbox"/>
intact verandah structure	<input checked="" type="checkbox"/>	other prominent contrib. elevations	<input type="checkbox"/>
original parapet	<input type="checkbox"/>	<i>Window Hood</i>	<input checked="" type="checkbox"/>
original roof form & finish	<input checked="" type="checkbox"/>		<input type="checkbox"/>
original chimneys	<input checked="" type="checkbox"/>		<input type="checkbox"/>

COMMENTS *Original cottage probably dates back to early Victorian period. Note rare use of vertical lining boards and timber quoining on original facade.*

BUILDING AT REAR ALLEGEDLY FORMER PENTECOSTAL CHURCH.
