Building:	House	Significance:	B
Address:	234 Coppin Street, Richmond	Melway Map Ref:	2H C6
Building Type:	Residence	Construction Date:	1889
Architect:	Unknown	Builder:	Unknown

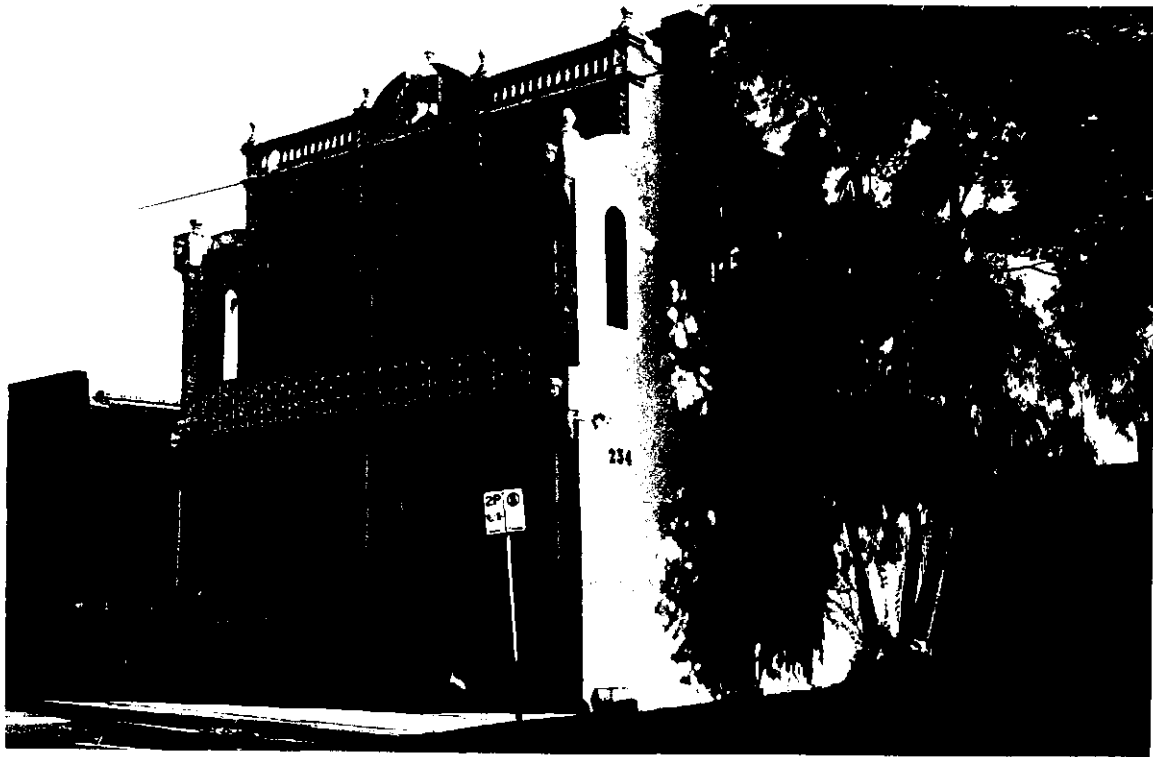
234 Coppin Street, Richmond, is a double-storey 19th century Italianate style house, of rendered masonry construction. It has a two-storey verandah supported on cast iron columns with an ornate cast iron lacework frieze and balustrading panels at first floor level. The frieze at ground floor level has been removed. Two wing walls with curved parapets enclose the verandah at each end, embellished with cement rendered classical masks, consoles and applied relief decoration. There are two arched openings in the wing walls at first floor level, and one at ground floor level. The window at ground floor is a tripartite arrangement of double-hung sashes, and there are three unequally spaced double-hung sashes at first floor level, all now fitted with iron bars. The facade is surmounted by an ornate parapet featuring classical balustrading above a swagged frieze, crowned by a segmented arched broken pediment with a large swagged urn in the centre.

The original cast iron palisade front fence survives.

234 Coppin Street, Richmond, is of local architectural significance. The house is representative of the late 19th century double-storey form, and is a good example of the Italianate style. The house is substantially intact, retaining most of the original cement render and cast iron decoration, and is notable for its unusual broken pedimented parapet.
