Building: Derby House Significance: B

Address: 1 Derby Street, Collingwood Melway Map Ref: 2C D12

Building Type: Residence Construction Date: 1876

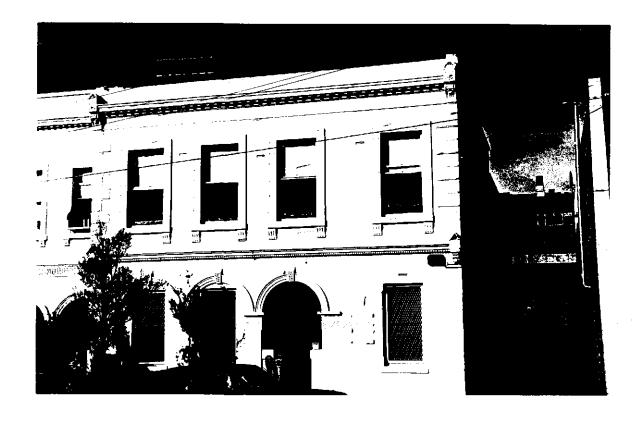
Intactness:		Condition:	
G[] F[x] P[]		G[x] F[] P[]	
Existing Heritage Listings:		Recommended Heritage Listing	S:
Victorian Heritage Register	[]	Victorian Heritage Register	[]
Register of the National Estate	[]	Register of the National Estate	[x]
National Trust	[]	Heritage Overlay Controls	[x]

Derby House, 1 Derby Street, Collingwood, is a two storey double-fronted asymmetrical rendered brick house, attached to the terrace at Nos. 3-7. The ground floor has a three-bay arcaded loggia, with moulded heads and keystones, at the eastern end, and a single window on the street alignment to its right. The first floor comprises four single windows with rendered moulded dressings and bracketed sills. There is a dentillated moulded string course at first floor level, and the first floor has quoining. The parapet has a moulded cornice. The windows are timber-framed double-hung sashes.
