Building:	Former Arthur Williams Shoe Factory	Significance:	B
Address:	202 Langridge Street, Abbotsford	Melway Map Ref:	2D H12
Building Type:	Factory	Construction Date:	1909
Architect:	Unknown	Builder:	Unknown

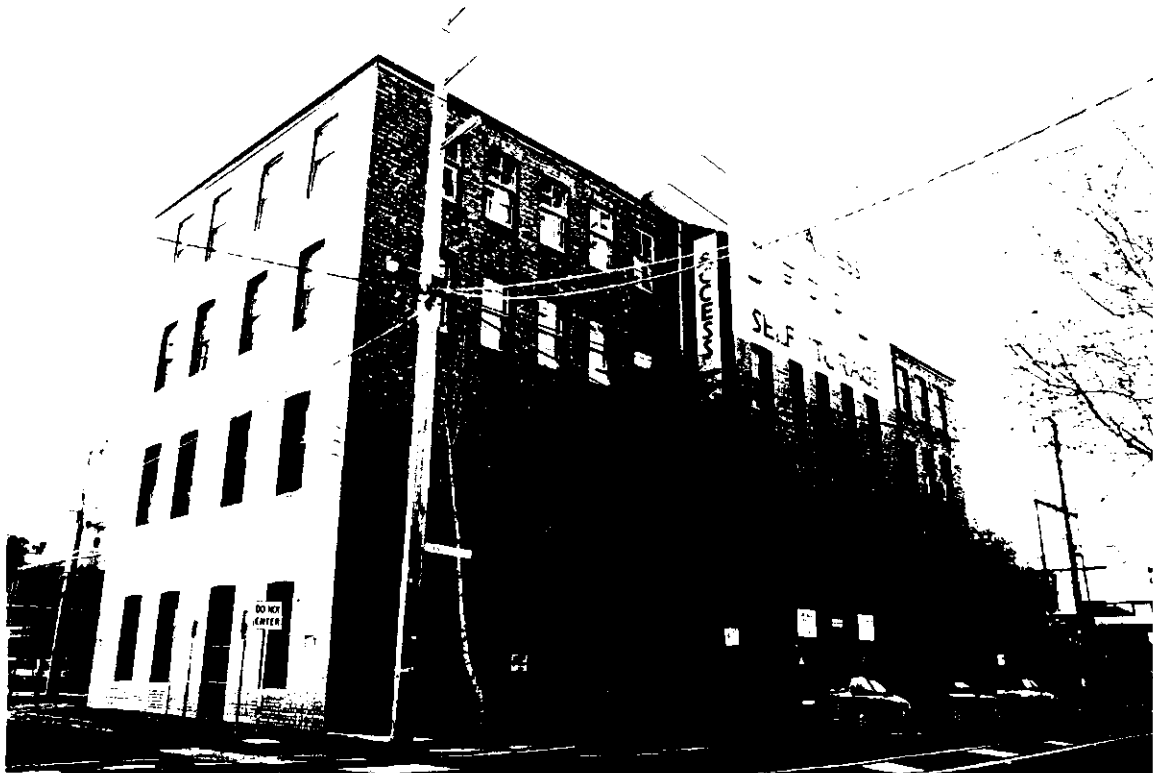
The former Williams Shoe Factory, 202 Langridge Street, Abbotsford, is a large four storey brick industrial building between Henry and Russell Streets. The south elevation, to Langridge Street, is symmetrical, and has a taller, projecting central section of five bays, with a relatively small central entrance door flanked by small, recessed rendered name panels. The three street elevations of the building are punctuated by evenly spaced window openings. Windows are four paned timber-framed double-hung sashes.

To the rear of the east end of the building is an addition, facing Russell Street. Also of four storeys, it has a trabeated facade with face brick piers, recessed, rendered spandrel panels and a rendered cornice.
