<b>Building:</b>	Terrace	<b>Significance:</b>	B
<b>Address:</b>	143-145 Langridge Street, Collingwood	<b>Melway Map Ref:</b>	2C G12
<b>Building Type:</b>	Residences	<b>Construction Date:</b>	1884
<b>Architect:</b>	Unknown	<b>Builder:</b>	Unknown

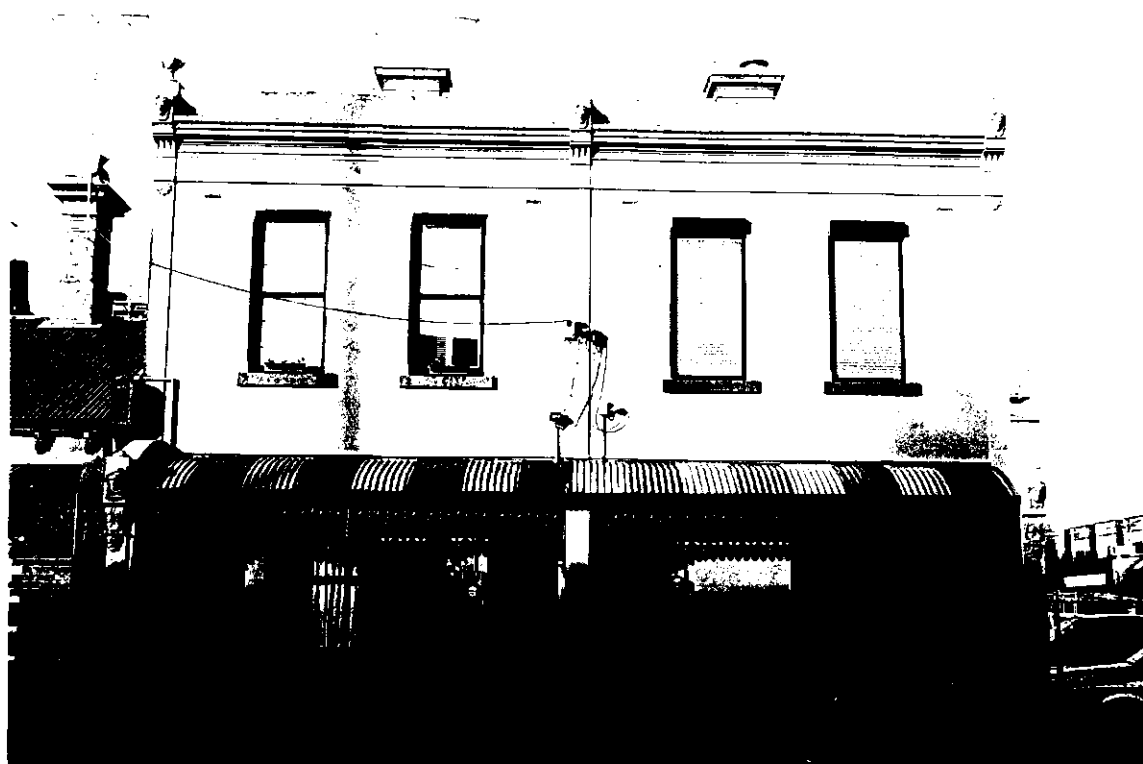
The terrace at 143-145 Langridge Street, Collingwood, comprises two two-storey attached brick houses. Italianate in style, they have rendered brick walls. At ground floor level, each dwelling has a door and single window, and at first floor level, two windows. There is a curved-profiled corrugated-iron clad verandah between brick wing walls with rendered copings, masks and consoles. There is no balcony. The verandahs have cast iron lacework friezes and cast iron columns. The roof is concealed behind a rendered parapet with a cornice, but no pediment, and is penetrated by two rendered chimneys with moulded caps. Windows are timber-framed double-hung sashes.

External roller shutters have been added to the windows of No. 145.

Both houses retain original iron picket front fences
