<b>Building:</b>	Terrace	<b>Significance:</b>	B
<b>Address:</b>	58-62 Oxford Street, Collingwood	<b>Melway Map Ref:</b>	2C D11
<b>Building Type:</b>	Residence	<b>Construction Date:</b>	1858-64
<b>Architect:</b>	Unknown	<b>Builder:</b>	William Turnbull?

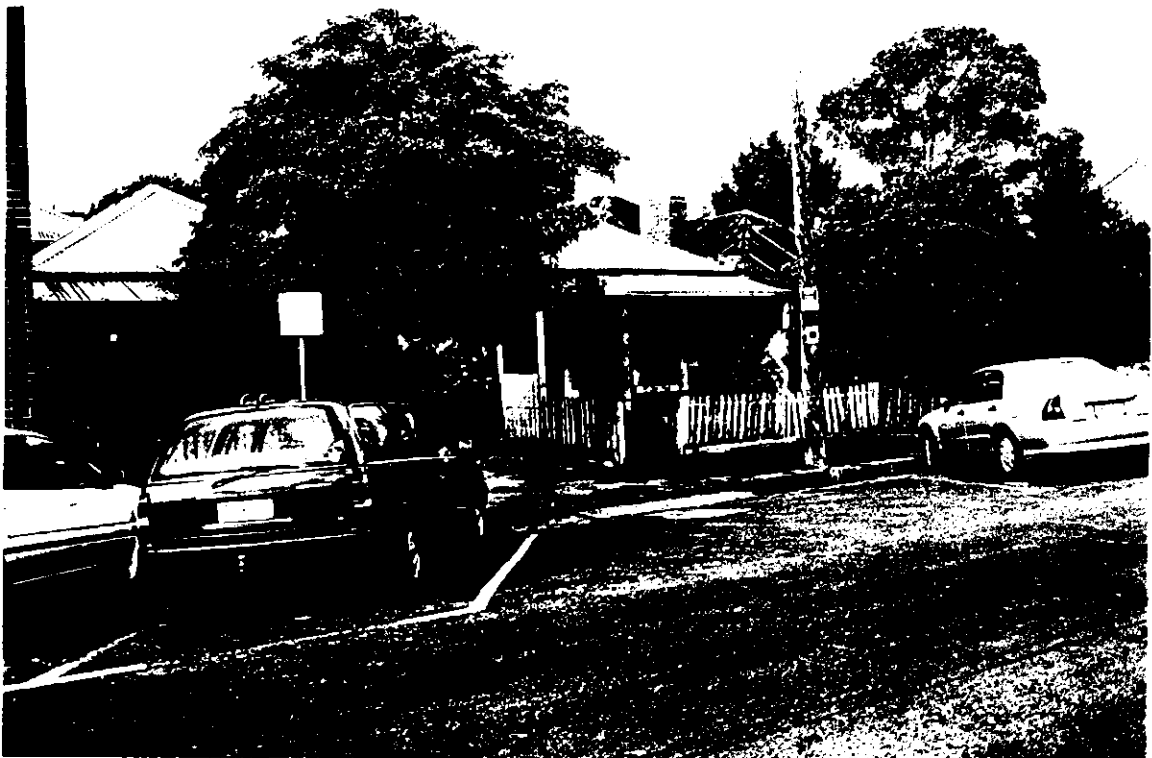
**Intactness:**  
G[ ] F[x] P[ ]

**Condition:**  
G[ ] F[x] P[ ]

The houses at Nos. 58-62 are three one- and two-storey bluestone cottages with hipped corrugated iron roofs. Nos 58 and 60 are attached, whilst No. 62 is detached, separated from the others by a right-of-way. Each cottage has a verandah with a corrugated iron roof supported on timber posts. Windows are multi-paned, double-hung sashes. Door and window openings have pick-faced bluestone quoining, which have been painted on Nos. 60 and 62. To the rear of each of the houses are two-storey brick sections, also with hipped corrugated iron roofs.

Victorian Heritage Register [ ]  
Register of the National Estate [x]  
Heritage Overlay Controls [x]
