| Site: | Street Trees | Significance: | В |
| Address: | Queens Parade, between Alexandra Parade & Delbridge Street, Clifton Hill | Map Ref: | 44 B2 |
| Access: | Unrestricted | Survey Date: | 7/5/98 |

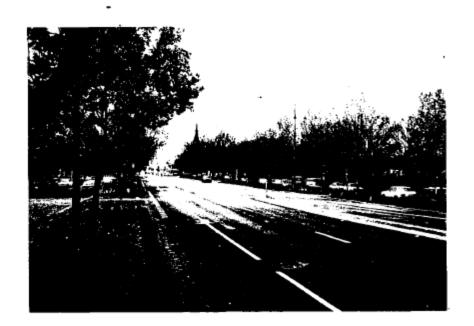
| Condition: E[]G[]F[x]P[] Recommended Heritage Listings: | |

Queens Parade is divided into two sections: a central major traffic flow, and narrow service lanes on each side of the road. The dividing medians are bordered with uncut basalt rocks which form a prominent and decorative feature. The outer curb is constructed of cut basalt blocks, and the drainage channel is lined with basalt pitchers.

The site features a double avenue of Plane Trees (*Platanus x acerifolius*) and Dutch Elms (*Ulmus x hollandica*). The Plane Trees are sited on the median separating the main traffic flow from the service land, and the Dutch Elms on the outer, footpath median. Both rows of trees are mature and relatively intact. Each shows signs of severe lopping over their life span, from with they have recovered well, and some interplanting with inappropriate species has occurred, principally Desert Ash (*Fraxinus oxycarpa*).

Removal of basalt rock edge on central medians or basalt gutter and curbing on outer medians in favour of concrete. Further introduction of inappropriate species, which erodes the heritage character and general impact of the double avenue. Unnecessary pruning due to aerial cabling.

Installation of Aerial Bundle Cables (ABCs) to minimise the need for pruning of trees, particularly on the northern side of Queens Parade. Preparation of a detailed maintenance and replacement policy for the avenue which would outline regular maintenance procedures for the trees to ensure a long amenity life is attained. It should also outline appropriate measures for the replacement of senescent specimens with the same species to ensure the uniformity of the avenue is maintained. The policy should outline strategies for the replacement of the Dutch Elms in the event of the Dutch Elm Disease (Ceratocystis ulmi) becoming established in Australia. These should be included within an overall tree management policy for significant trees within the City of Yarra.
