House 101 Kilgour Street

City of Geelong Urban Conservation Study
Significant Sites

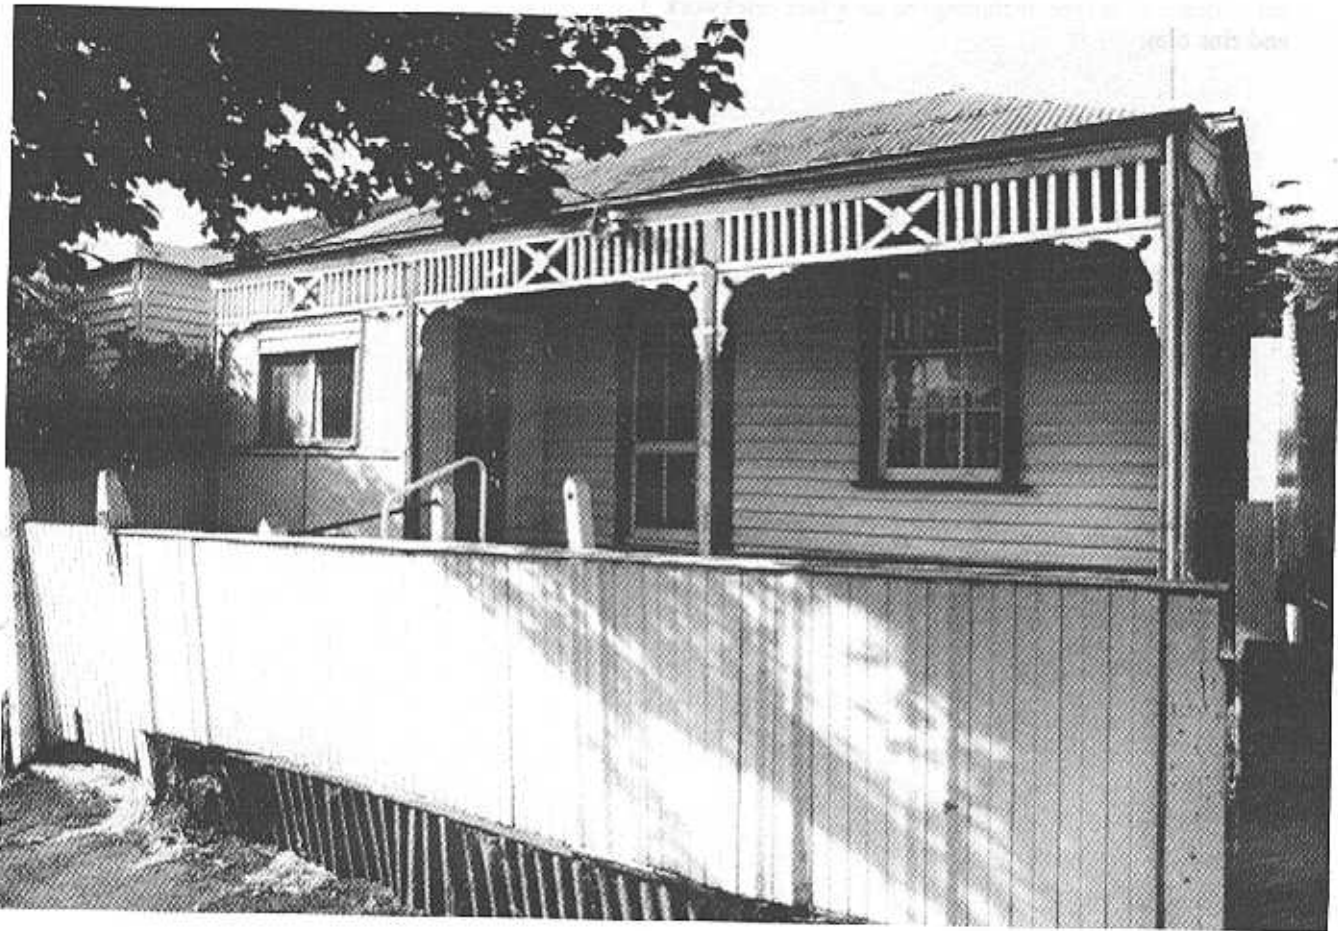
At first appearing to be similar to other Geelong houses of the 1850s, with its simply pitched roof, multi-pane glazing, beaded boarding and slim opening architraves, the house is distinguished by its side and rear-wall construction which consists of wide, dressed posts, with equally wide horizontal boards housed in vertical slots let into each post. Inside, the walls are lined with wide butted boards which served as a base for hessian and wallpaper.

The verandah has been replaced in the Edwardian period and presumably part enclosed since. The fence appears to be part Edwardian or later.
