BELLARINE HERITAGE STUDY RECORD SHEET

Site No.	Street/Site Name	Town / Suburb	Postcode	Record No.
Address 580	Wallington Rd	Wallington	3221	272
Site Name	residence			Page No. 1 of 4

Key Dates: Original **c1910s** Major Changes

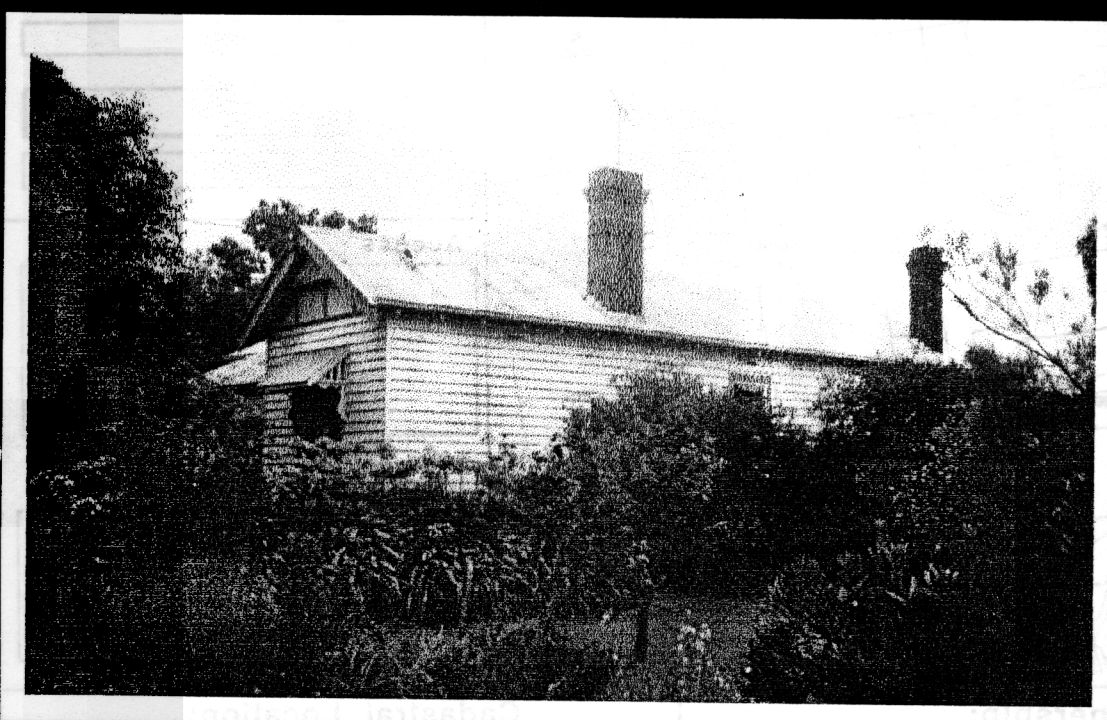
Neg. No.
14/30-2

A corrugated iron, weatherboard Federation house with a front projecting gable. The gable has a corrugated iron roof window hood with timber brackets and 'stucco' style strutwork decoration. The two red brick chimneys are on the south side and the rafters project from under the eaves. The corrugated iron roof verandah has timber posts and fretwork decoration. There is a domed concrete well with the inscription 'AD 1915 W L'. The rendered concrete is peeling off the small red brick outbuilding which has a corrugated iron roof. The significant architectural features are the original roof form and finish, the original materials, doors and windows, the intact verandah decoration and structure and the gable decoration.

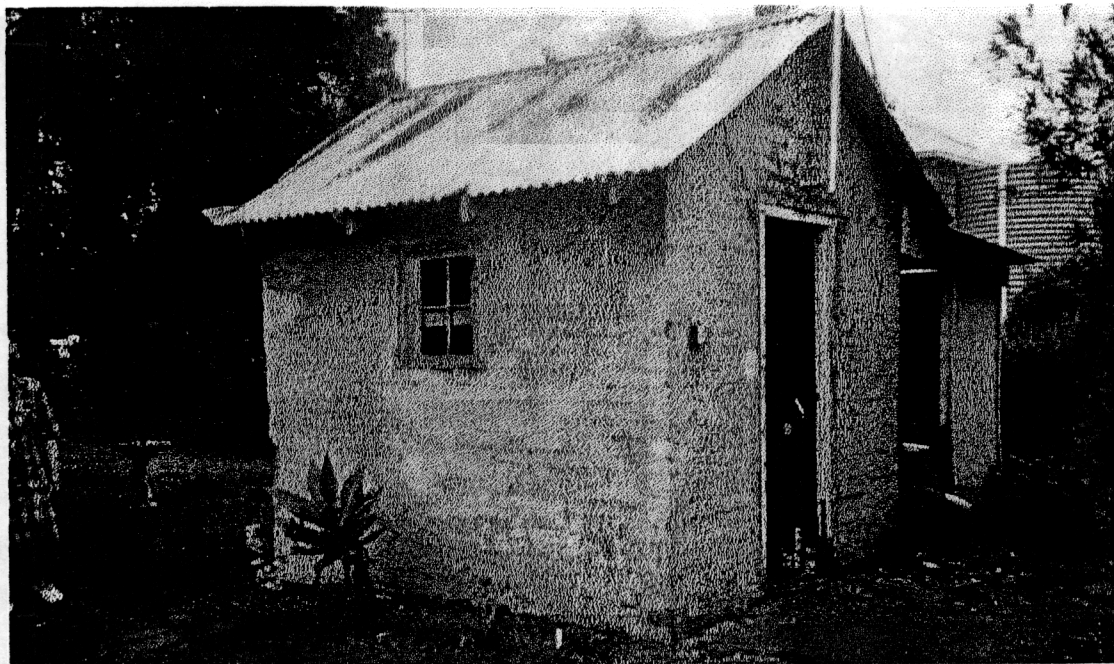
The small brick outbuilding contained a separator and was a dairy until 1957/58. The 100 acre property was originally owned by Connie Cook's Uncle. The present owners have been there since 1939.
