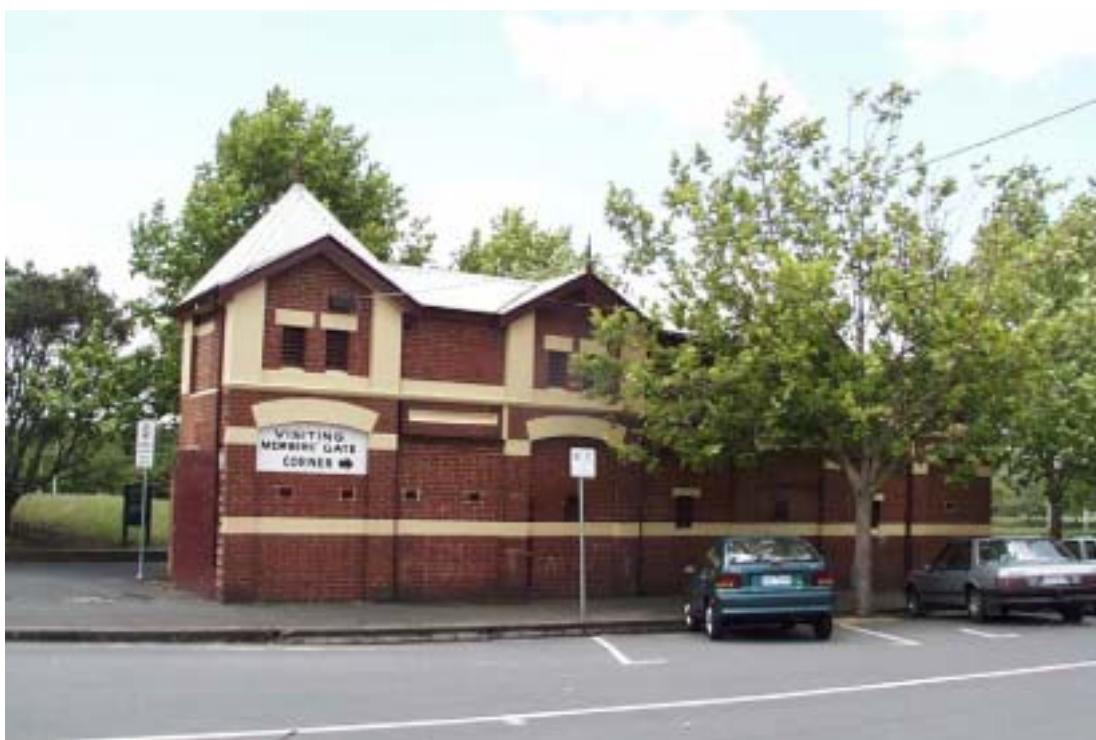
Figure 25 Southern entrance to the Oval

The former entrance gatehouse comprises a double storey red-brick building on a narrow rectangular plan. The building has a corrugated galvanised steel clad roof with distinctive pyramidal roofs to either end, surmounted by turned timber finials. Eaves have a beaded tongue and groove board lining with a carved timber valance to the north elevation only. The south elevation is divided into seven regular articulated bays, four of which are gabled. The walls are articulated by brick pilasters and contain a continuous band of render along the ground floor and a moulded string-course at the first floor level. The four gabled bays have a rendered segmented arch at the ground floor and paired timber louvres at the first floor. Alternating bays are square-headed and finished with a dog-tooth brick course surmounted by a rendered panel. Two of the bays contain small louvred vents with rendered lintels and chamfered sills. The ground floor bay to the western end contains a painted sign which reads: 'VISITING MEMBERS' GATE CORNER'.

The east elevation contains a recessed brick panel at the ground floor with a rendered segmented-arched head and non-original double-leaf flush panel door. At the first floor is a blank recessed brick panel. The west elevation is similarly detailed, although there is an infilled window/door opening at the first floor. The ground floor has been overpainted while the south-west corner displays evidence of the removed boundary wall. Abutting the centre of the north elevation is a recent timber-framed stair providing access to the first floor. The first floor has a weatherboard infill and contains a non-original flush panel door and tripartite timber-framed, double-hung sash windows fitted with metal security bars. A double-leaf flush panel door is located to the centre of the ground floor. At the western end is a small red brick addition with a flat concrete roof, presumably an infilled toilet entrance.

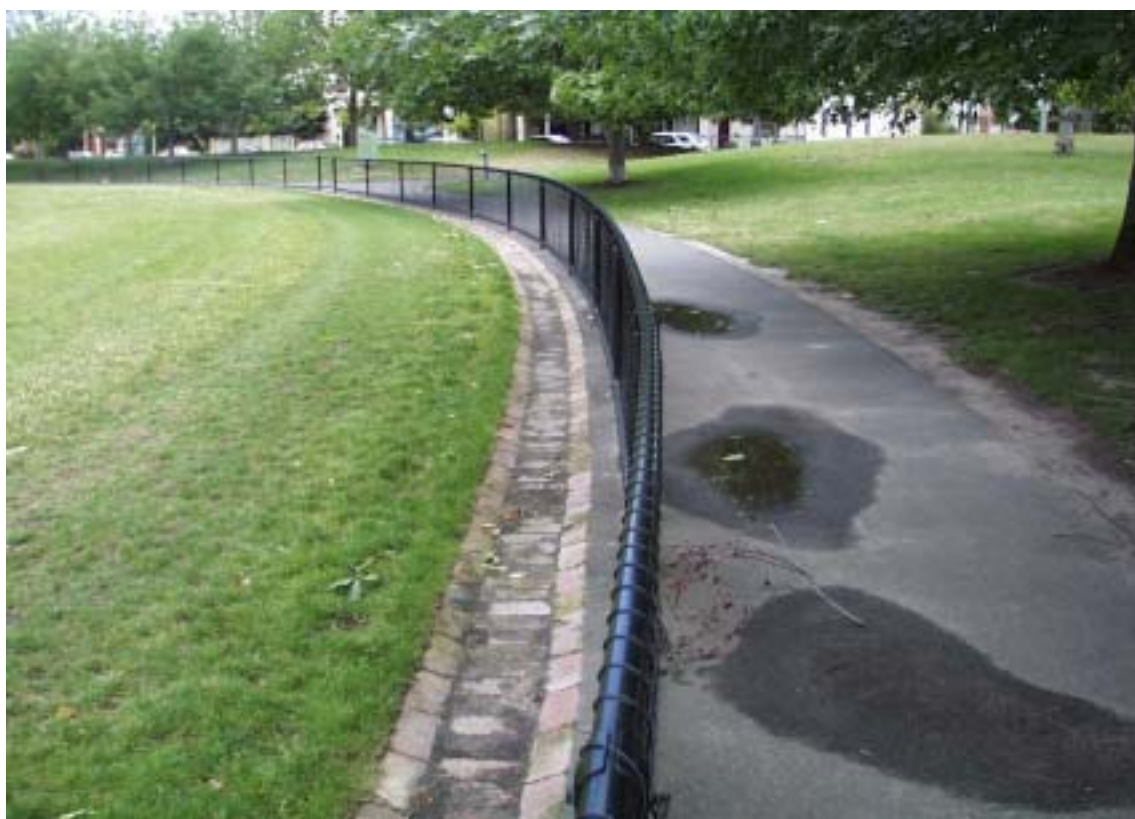
Figure 26 *Drain, Fence and Path to perimeter of Oval*

The perimeter of the oval is edged by an open drain, which is lined with red brick, and fenced by a non-original steel-framed Cyclone wire fence with powdercoated finish. The oval is encircled by a path with asphalt finish.

The drain, fence and path to perimeter of oval are of little or no significance in their fabric.

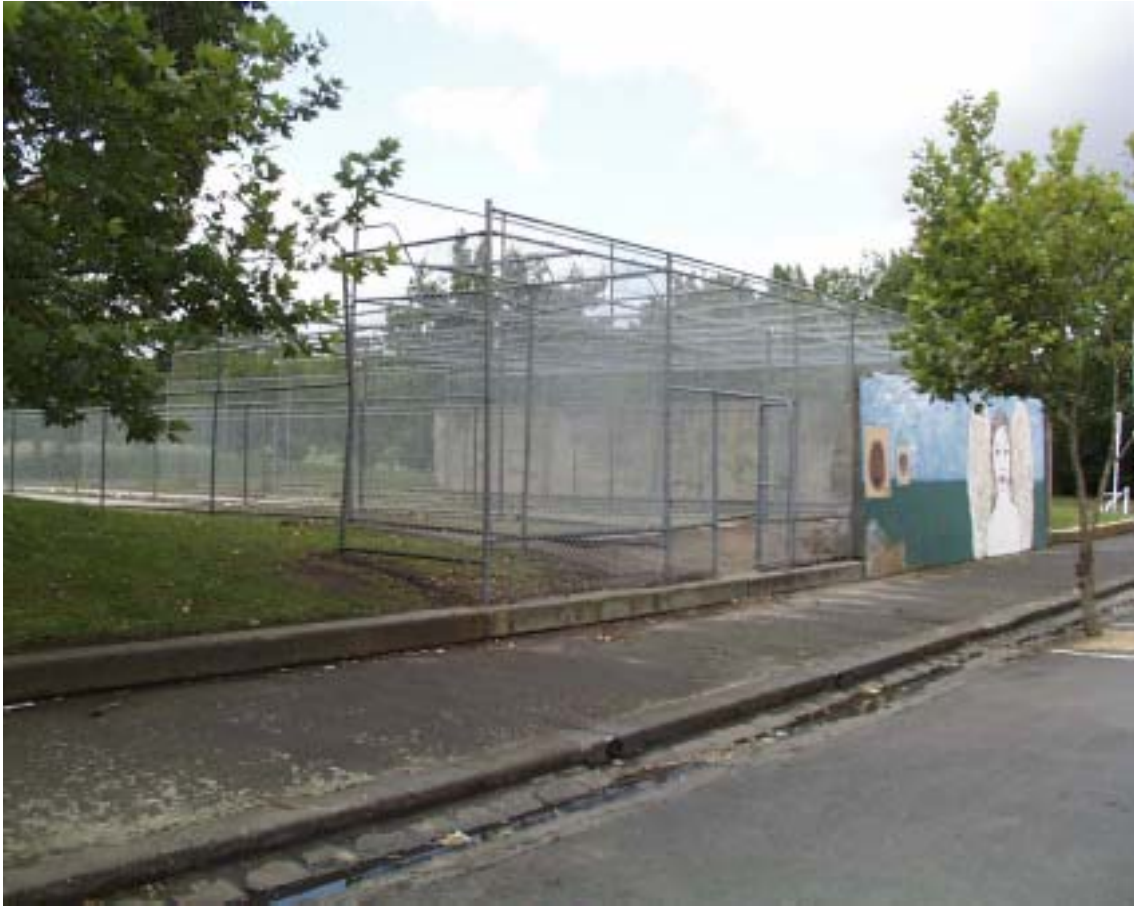
Figure 27 Cricket Practice Nets

The cricket practice nets comprise four concrete and artificial turf wickets with a galvanised pipe and cyclone wire enclosure.

The nets also incorporate a remnant of the concrete boundary wall, featuring a painted mural, which formerly ran along the boundary of the cricket/football ground.

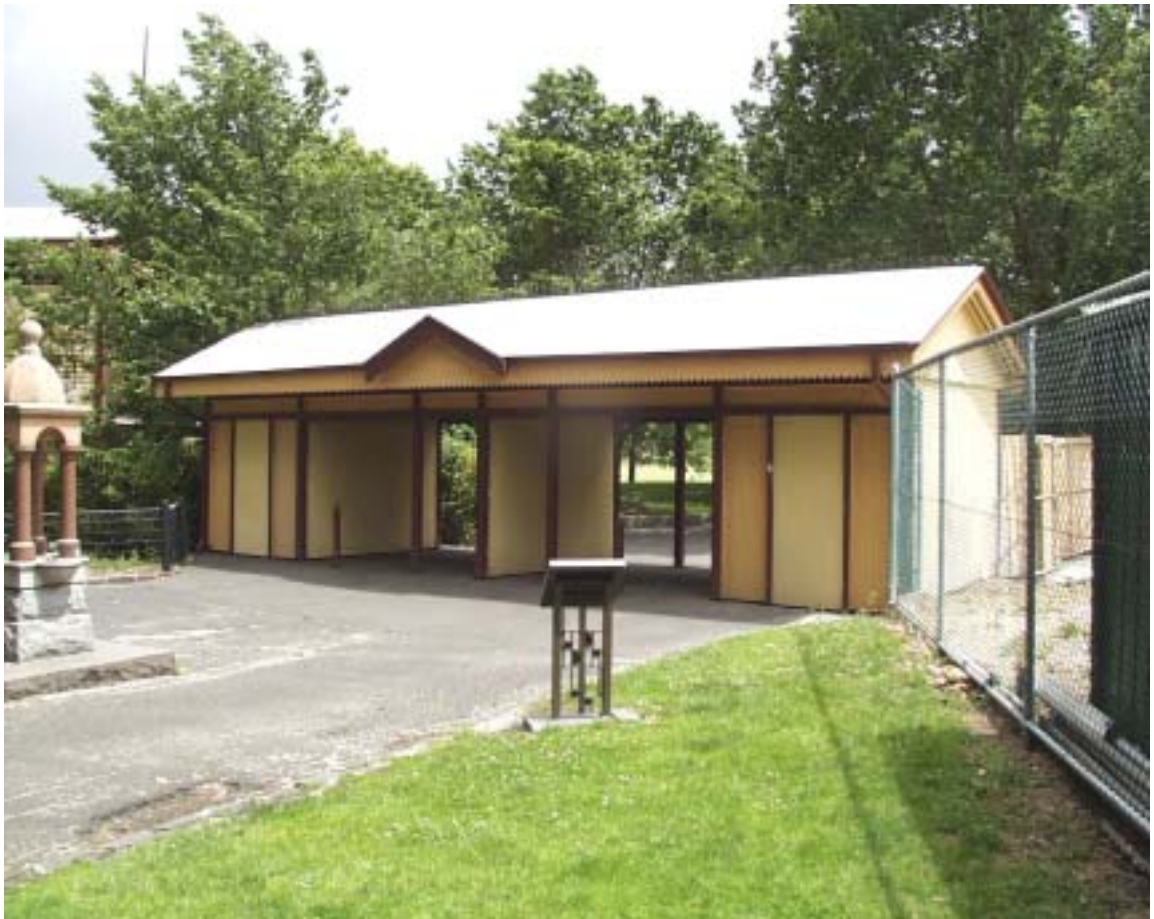
Figure 28 Timber entrance pavilion, viewed from the north-east

The entrance pavilion is a utilitarian, timber-framed building on a narrow, rectangular plan. It has a framework of stop-chamfered timber posts and beams with V-jointed board cladding. Passing through the centre of the pavilion, are two wide openings fitted with V-jointed board gates and surmounted by panels of diagonal boarding. The openings are flanked at either end by bays fitted with narrow V-jointed board doors.

The gabled roof is clad in corrugated galvanised steel with cast iron cresting and a central gablet to either side. The eaves are battened and feature a carved timber valance.

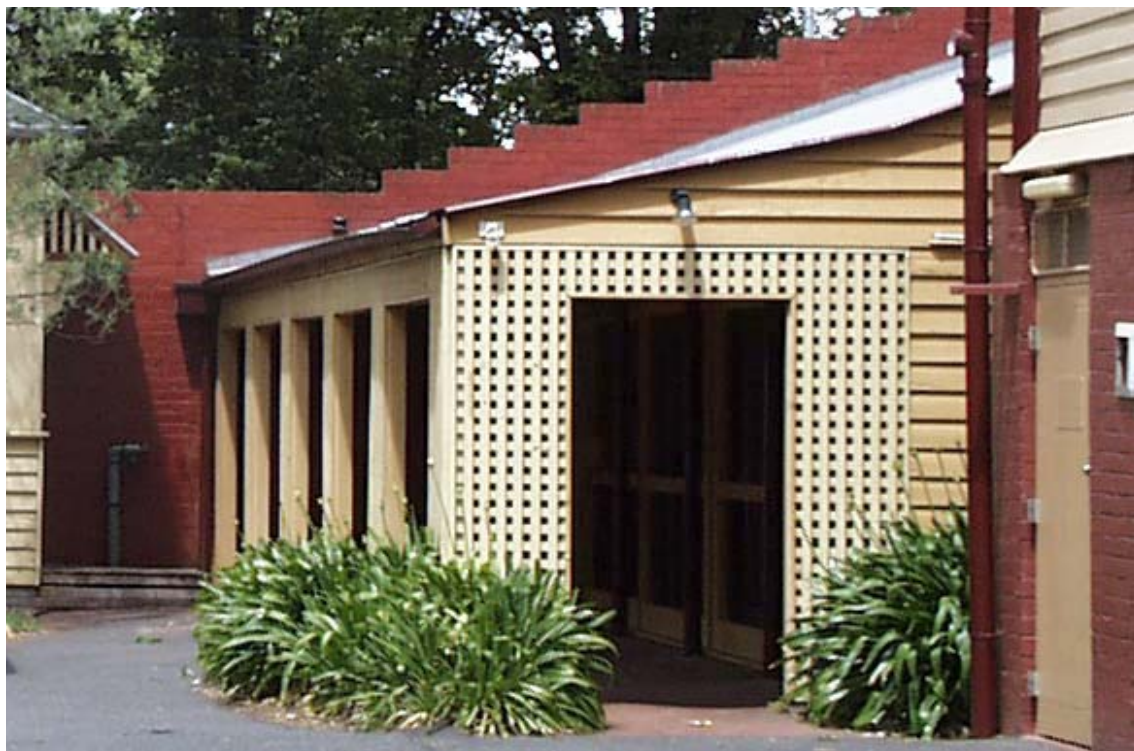
Figure 29 Community Hall (right)

Located to the east side of the grandstand, the community hall is a steel and timber-framed building with a gabled roof clad in corrugated galvanised steel. The east elevation comprises a brick wall with a stepped parapet, arched at the apex. Extending across the north of the building is a verandah with timber lattice screens while both the north and south elevations contain large, timber-framed glazed sliding doors.

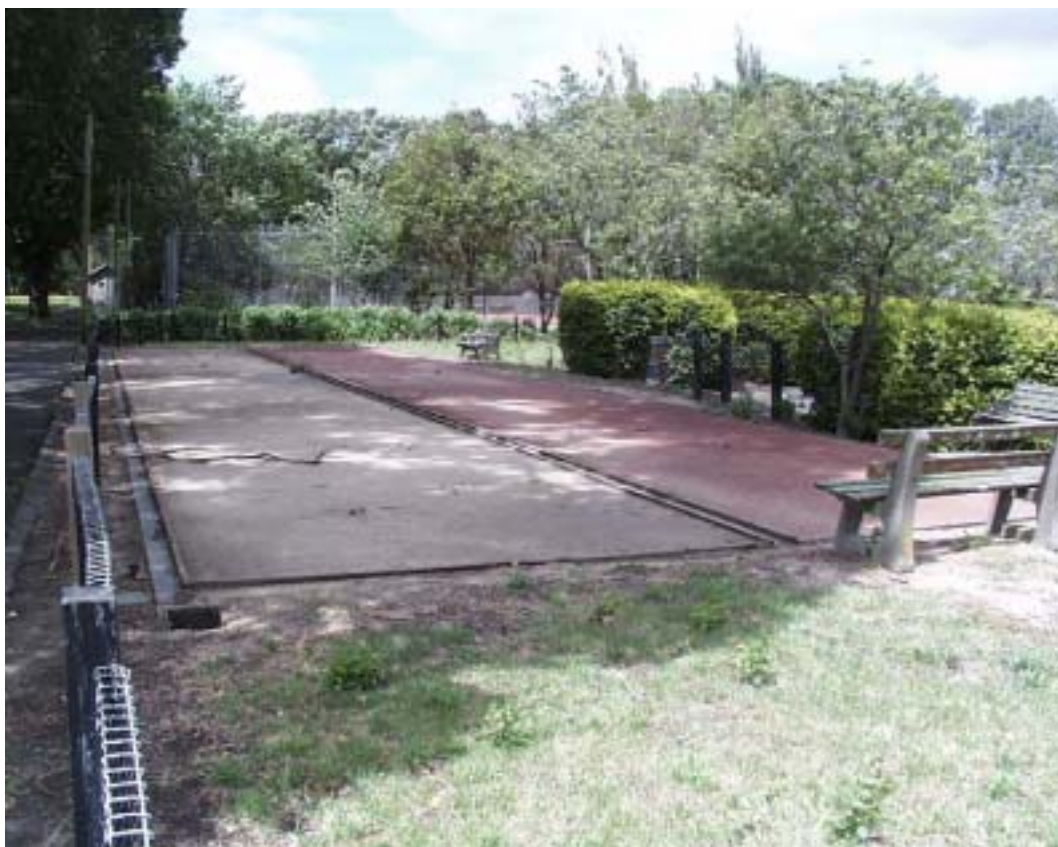
Figure 33 Bocce Court

Two gravel bocce courts with timber edging, located to the north of the grandstand. The site is enclosed by a recent steel mesh fence with a low hedge to the south side.

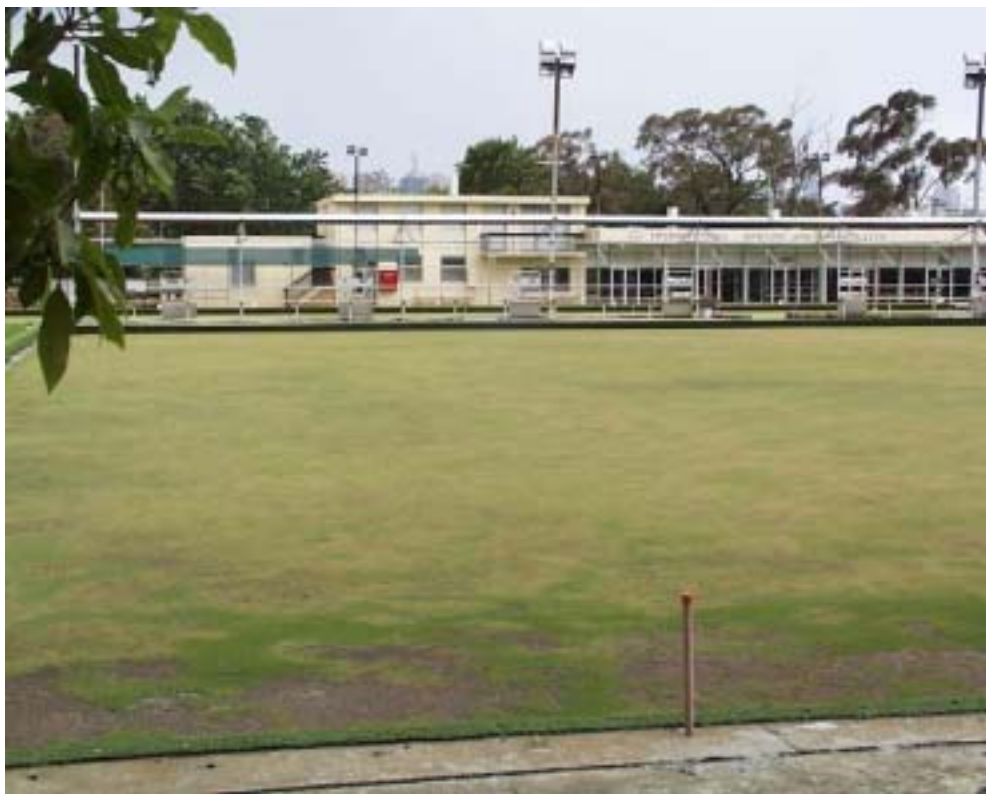
Figure 37 *Fitzroy Bowling Club & Green*

The Fitzroy Bowling Club comprises a clubhouse, greens and various ancillary structures. The clubhouse is a single and double-storey utilitarian brick building on a long rectangular plan. It has a flat roof with an aluminium fascia and walls with a bagged render finish and aluminium-framed windows. There is one ten-rink synthetic green and one seven-rink Tidrawf grass green, with a central stone retaining wall and rose bushes planted around the perimeters. The site is enclosed by a chain mesh and galvanised steel pipe fence with the main entrance from Brunswick Street through a wrought iron memorial gate with red and brown brick piers. Other structures on the site include recent timber lattice shelters, prefabricated aluminium sheds, and earlier steel-framed shelters to the centre of the green with canvas awnings.

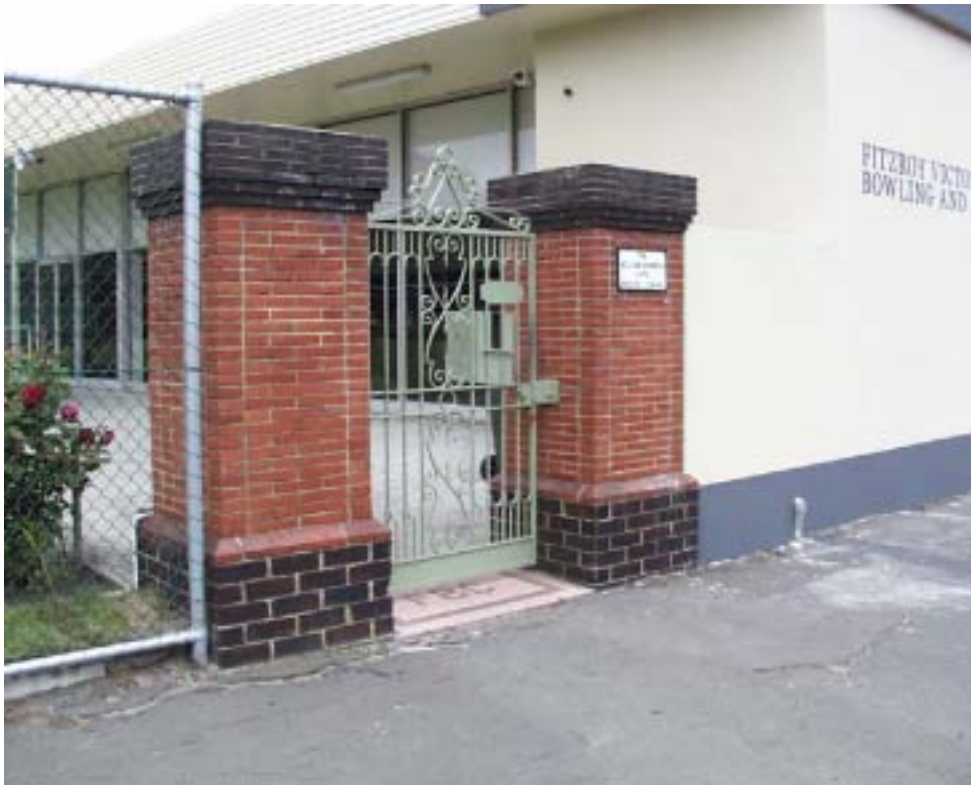
Figure 38 Hannah memorial gates at the entrance to the Bowling Club

A memorial gate was erected on 17 September 1943 in honour of Mr W Hannah, President of the Club from 1936 to 1942. During the 1947-48 season a memorial fountain was erected in memory of T S Rowe, secretary of the club for 16 years, and an additional fountain was placed between the two greens to honour the 1946-47 champion fours.¹⁶

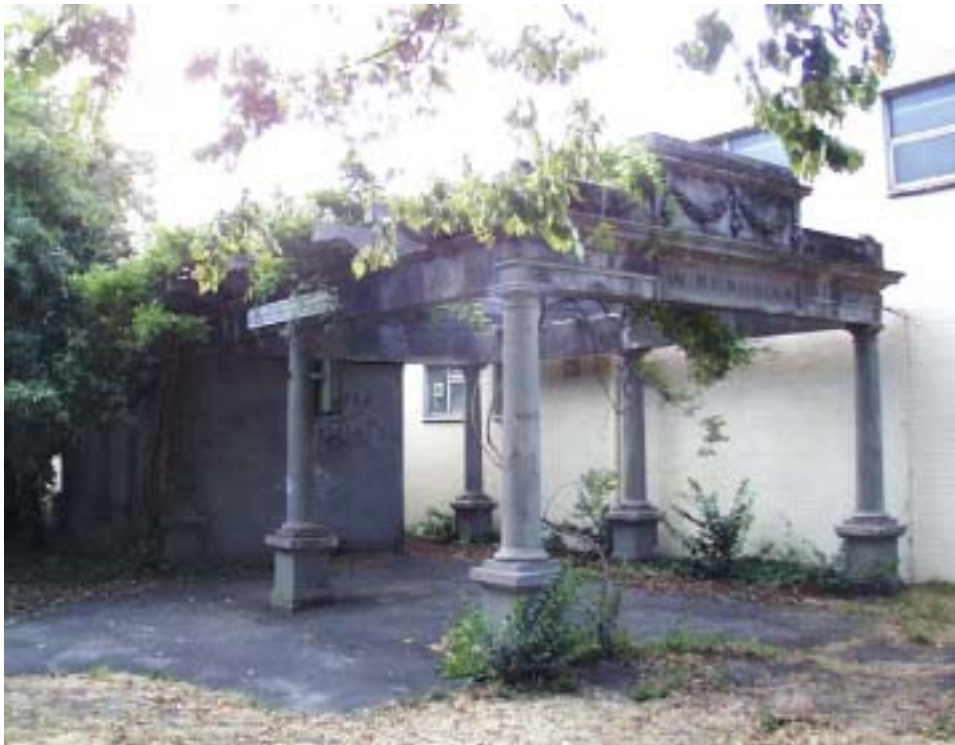
Figure 40 War Memorial Arbour

A concrete arbour supported by six Tuscan order columns resting on pedestals with simple moulded caps. The perimeter beams have a textured rendered frieze and a moulded cornice and support a series of parallel rafters carrying Wisteria. The beam to the east elevation contains a central pediment with pressed cement swags surmounted by a moulded cornice. Below the pediment is a recessed panel with the inscription 'IN MEMORIAM' in incised lettering. Urn finials, originally located at either end of the east beam, are missing (Figure 39). On the south elevation, the beam contains a marble plaque which reads: 'THIS MEMORIAL HAS BEEN ERECTED BY THE FITZROY CRICKET, FOOTBALL, BOWLING, BASEBALL AND TENNIS CLUBS TO PERPETUATE THE MEMBERS WHO FELL IN THE GREAT WAR 1914-1919'. The plaque originally appears to have been fixed to the panel on the east elevation. A steel-framed cabinet for the display of wreaths is fixed to one of the columns and is in poor condition with all of its glass broken.

A concrete substation now abuts the west end of the arbour and the joist ends along the north side have been cut short to accommodate the bowling clubhouse. The substation has been partly detailed to match the arbour.

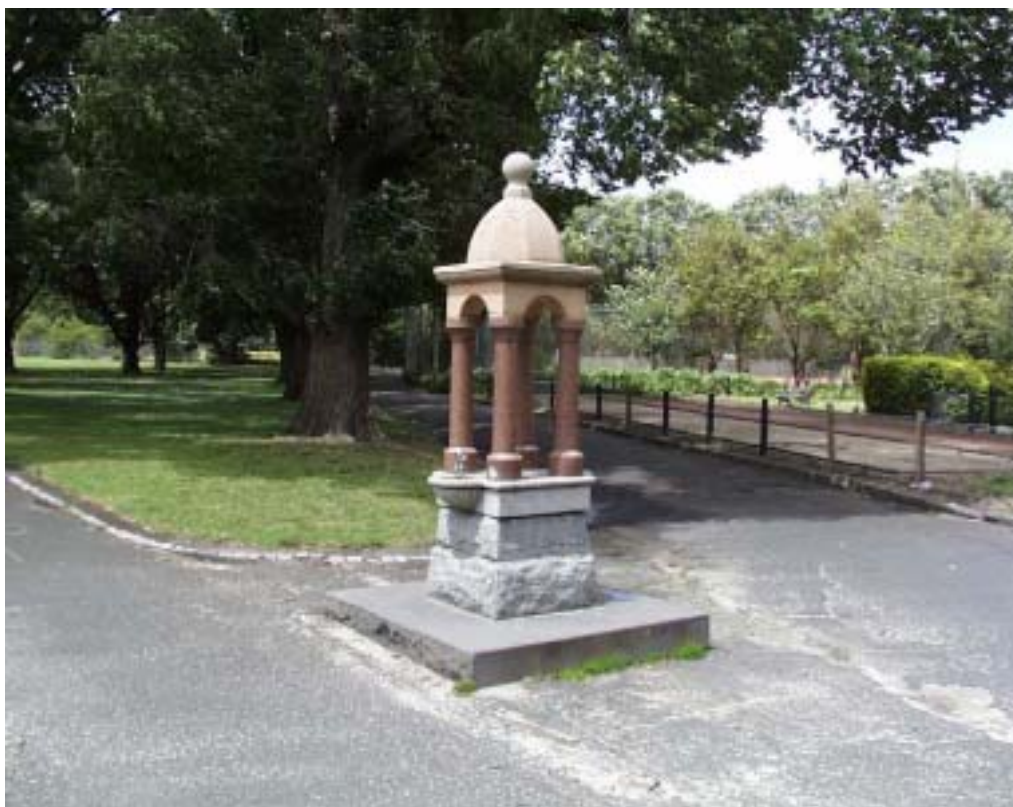
Figure 41 Chandler Drinking Fountain

Located on a path intersection, to the north of the ticket booth/entrance gate, it is square-plan, with polished granite basin on a plinth of rock-faced Harcourt granite. Two semi-circular bowls extend outwards from the sides of the fountain and are fitted with non-original bubblers. Surmounting the fountain, is a small four-sided 'temple' form with arched openings between polished granite columns and a domed top with an orb finial. The whole of the fountain rests on a bluestone plinth.

An engraved inscription on the side of the fountain reads: 'PRESENTED TO THE CITY OF FITZROY BY COUNCILLOR D J CHANDLER JULY 1926'.

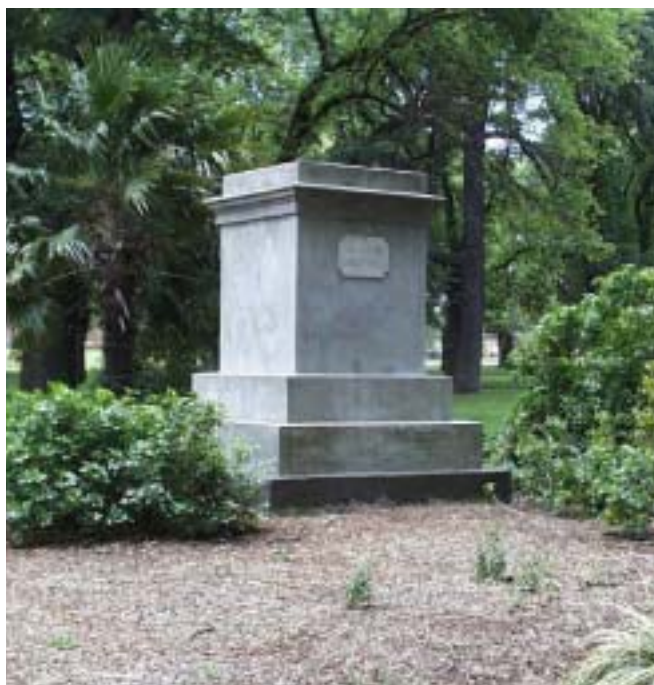
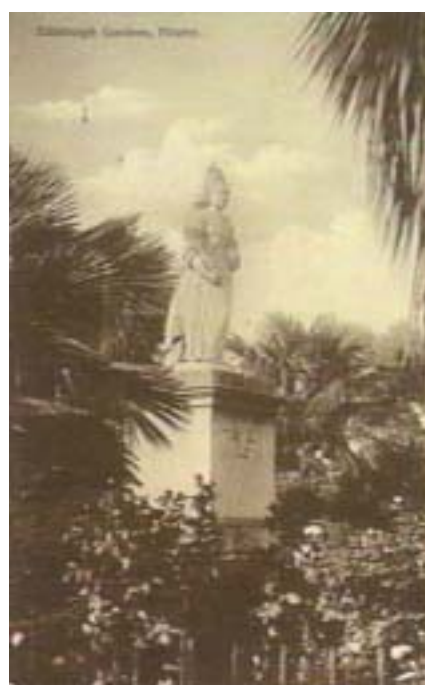
Figure 43 Queen Victoria Statue Pedestal (left) and original statue c.1910 (right).
Source: State Library of Victoria

The circular shrub bed is much neglected and large sections of planting are missing; the form of the planting scheme has been all-but obliterated. All that remains of the original planting are Chinese Windmill Palm specimen (*Trachycarpus fortunei*), some Mexican Orange Blossom (*Choisya ternata*), and various grass species.

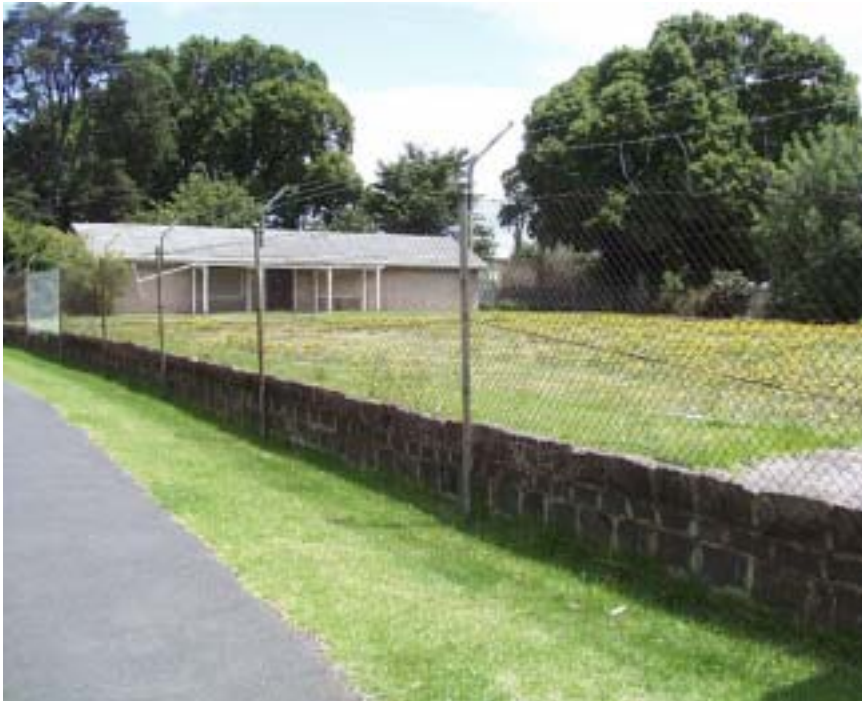
Figure 44 The Ladies Bowling Club

The clubhouse is a utilitarian, rectangular plan building, located at the southern end of the bowling green. It has a gabled roof, re-clad in metal tiles, with exposed rafters at the eaves. External walls, presumably originally weatherboard, have been reclad in *faux* brick cladding.

The building is entered through a wrought iron gate located under a timber-framed pergola on the north elevation. Flanking either side of the gate, are windows fitted with steel roller shutters, while the side elevations contain timber-framed louvred windows. The site perimeter has bluestone pitch edging and is enclosed by a wire mesh and galvanised steel pipe fence surmounted by strands of barbed wire. Two small brick shelters and a prefabricated aluminium shed are located at the northern end of the now overgrown green.

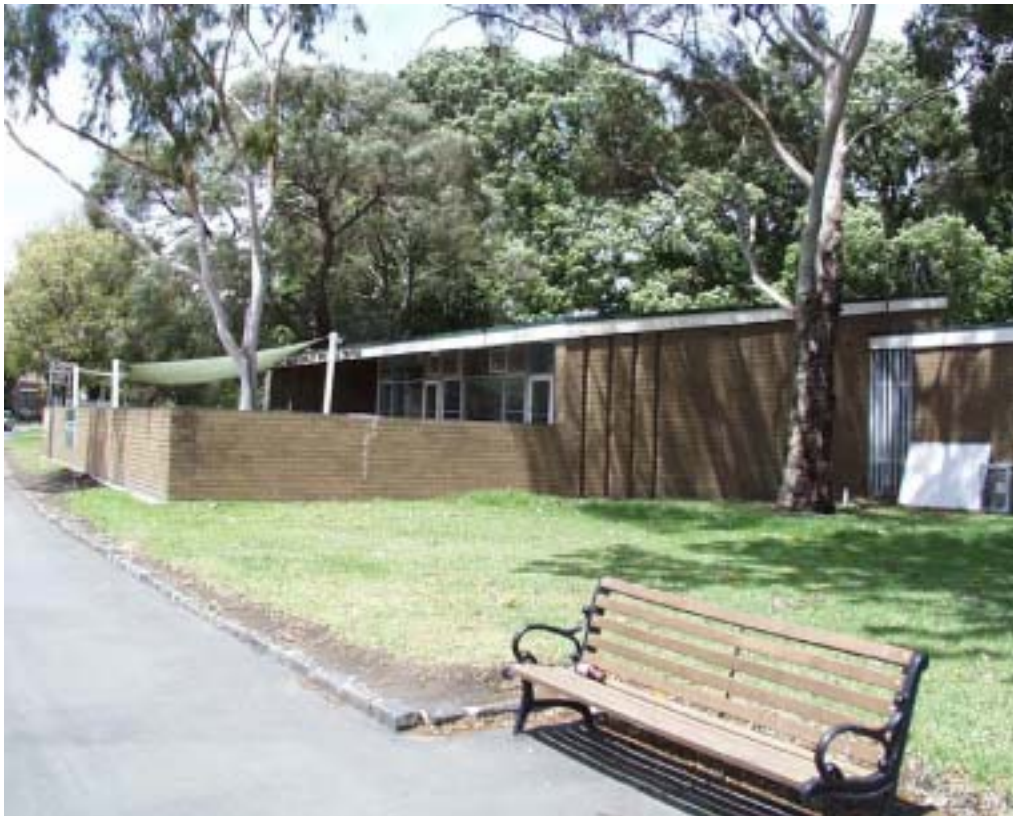
Figure 45 Emily Baker Infant Welfare Centre

The infant welfare centre is an undistinguished, single-storey, tan-brick building with aluminium-framed windows and a skillion roof clad in metal tray deck. A brick wall with tile coping extends outwards from the side elevations, enclosing the front of the building.

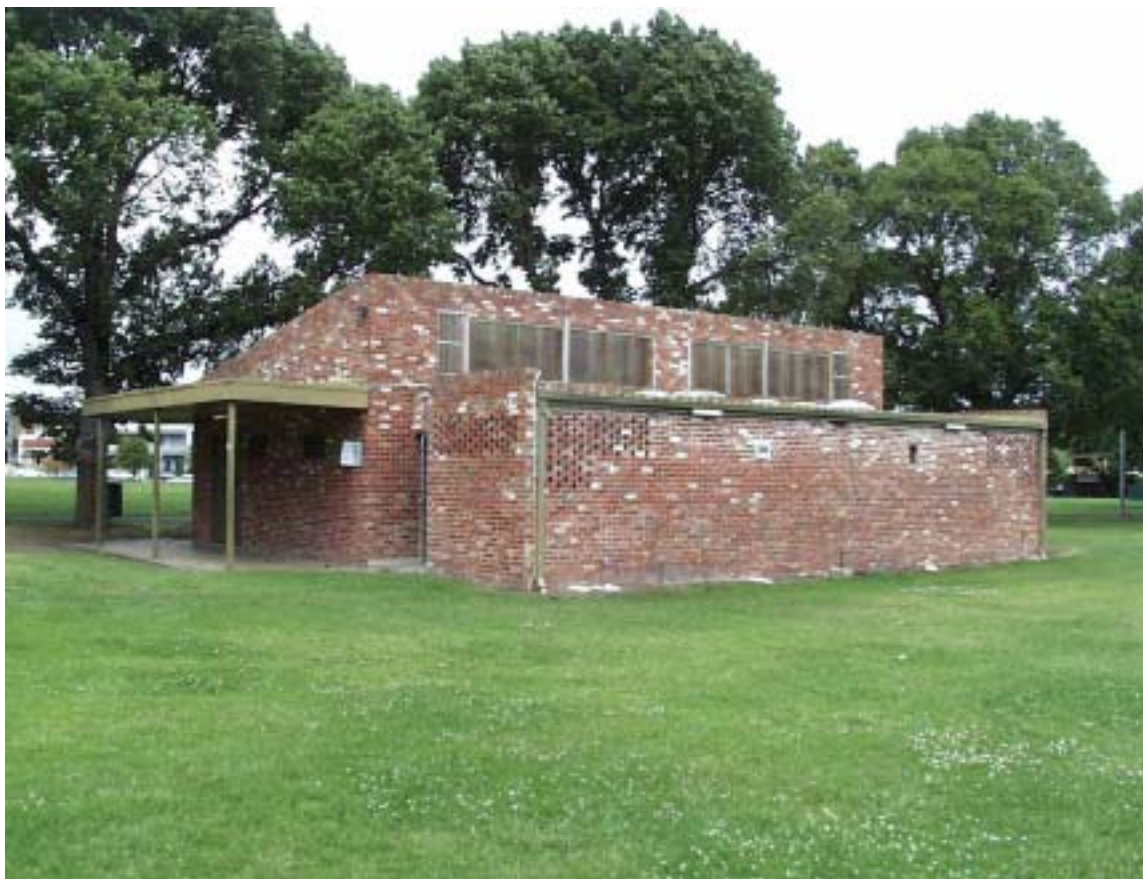
Figure 48 Centenary Pavilion

The Centenary Pavilion is a single-storey building with walls of recycled brick and a parapeted skillion main roof clad in metal tray decking. A steel-framed verandah with an aluminium fascia extends along the east and side elevations.

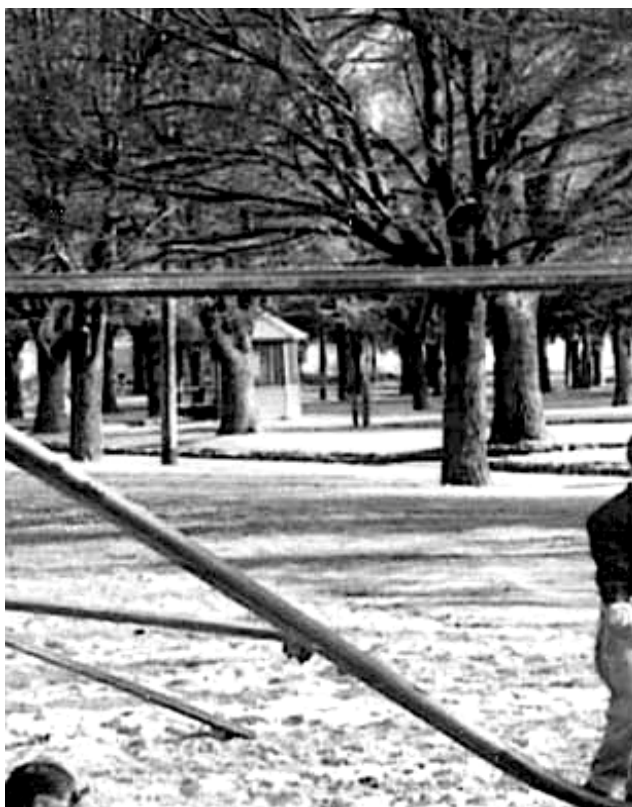
Figure 55 *Detail of a 1965 photograph of the Gardens showing the original timber gazebo.*
Source: Fitzroy Local History Collection

The shelter was constructed in 1972, replacing a Victorian, timber lattice gazebo which had a slate-roof (Figure 56).³⁴

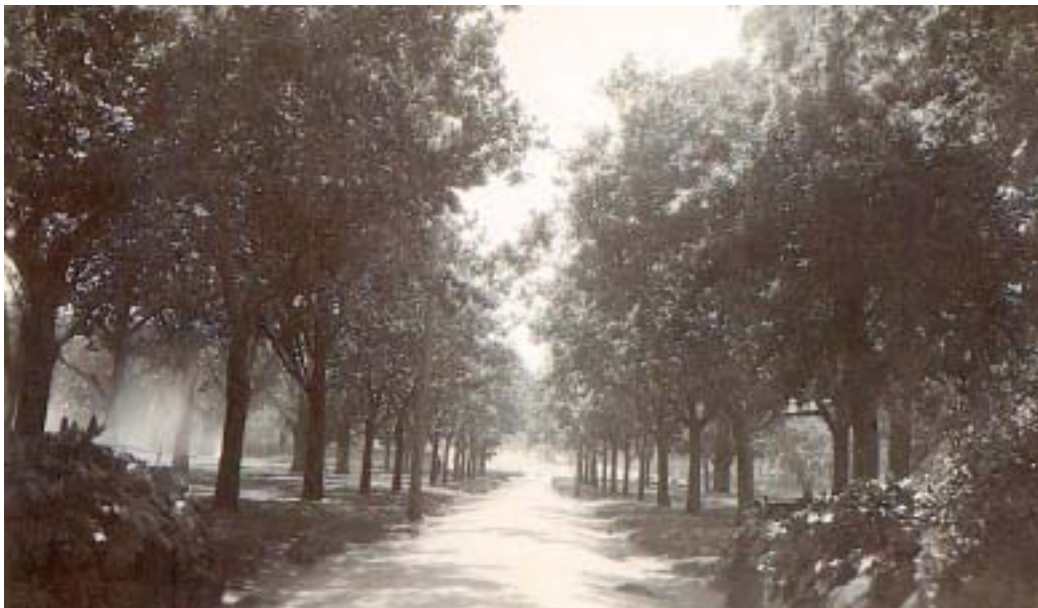
Figure 57 View along a path in the gardens, c.1927.

Paths within the Edinburgh Gardens were originally surfaced with gravel.³⁵ *Annual Reports* prepared by the Committee of Management from 1897-1899 record expenditure on 'ashes' for the paths, while MMBW plans dated c. 1901 show most paths to have been asphalted by this time. The bluestone rock edging is possibly an early feature of the gardens, however the original nature of the path edging has not yet been established. Similar edge treatment was a feature of many of Melbourne's parks and gardens in the late nineteenth and early twentieth centuries. A photograph of the gardens dated c.1927 shows garden beds with bluestone rock edging (Figure 57). Sections of lawn alongside the path, however, appear to be without edging.

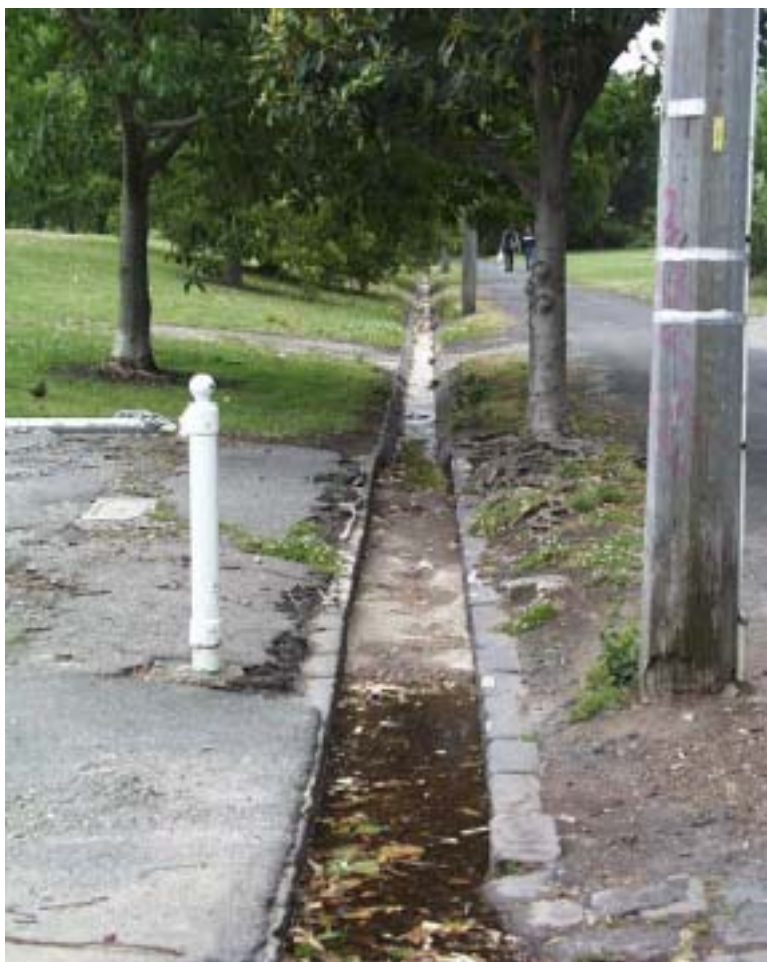
Figure 60 Open drain lined with bluestone pitchers

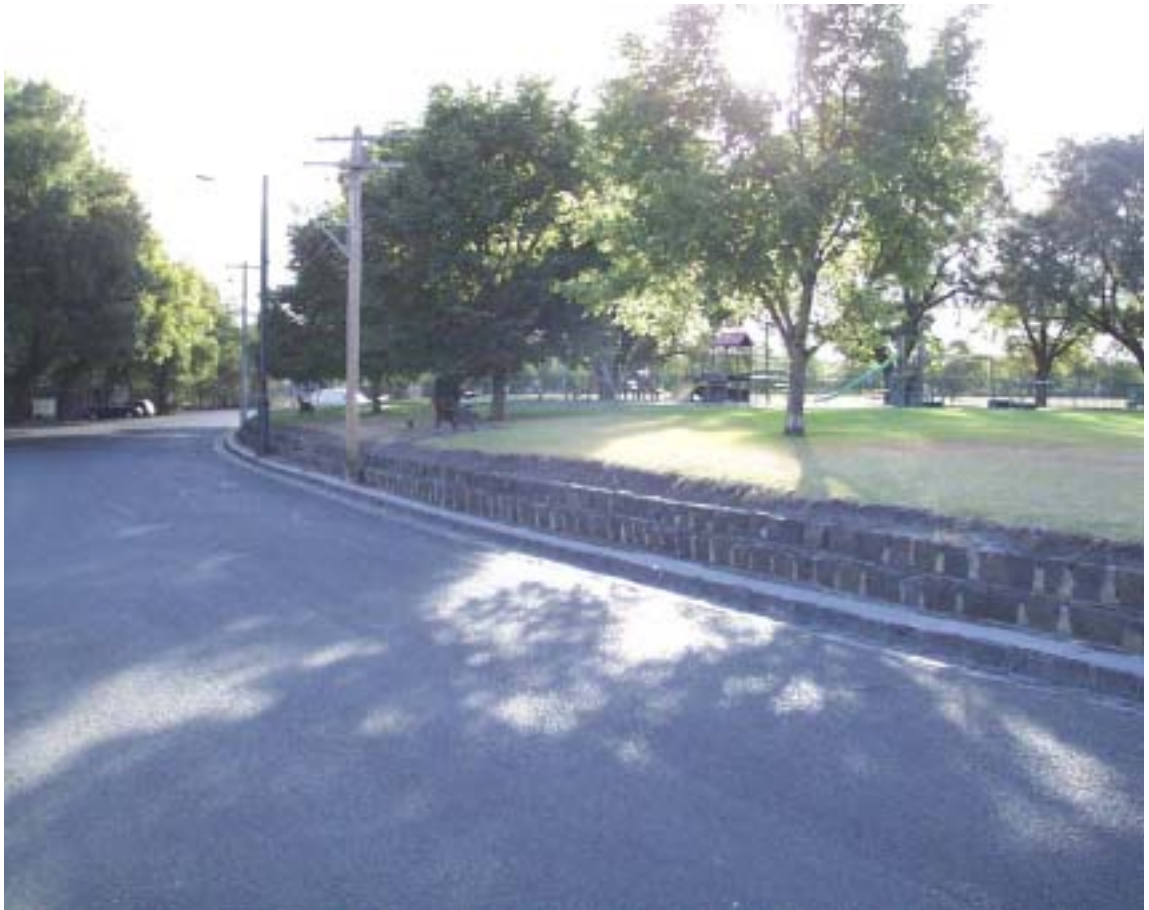
Figure 61 Bluestone retaining wall along Alfred Crescent

The retaining wall is of little or no historic or architectural significance.

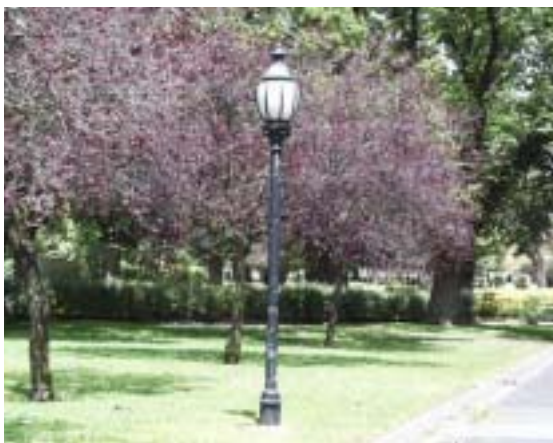
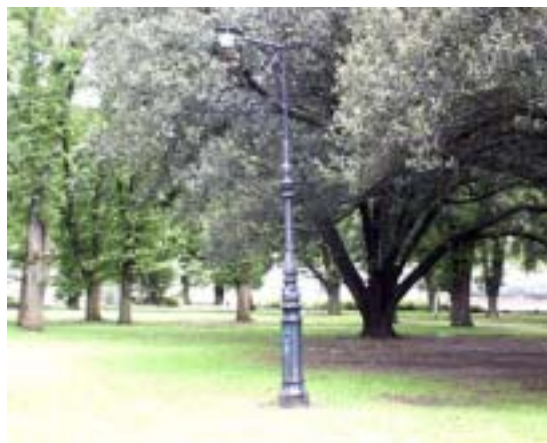
Figure 63 Reproduction aluminium standard (left) and early cast iron standard (right)

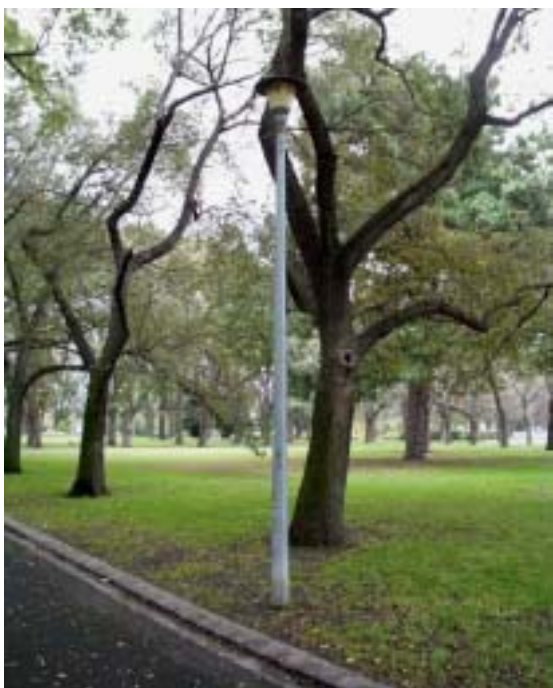
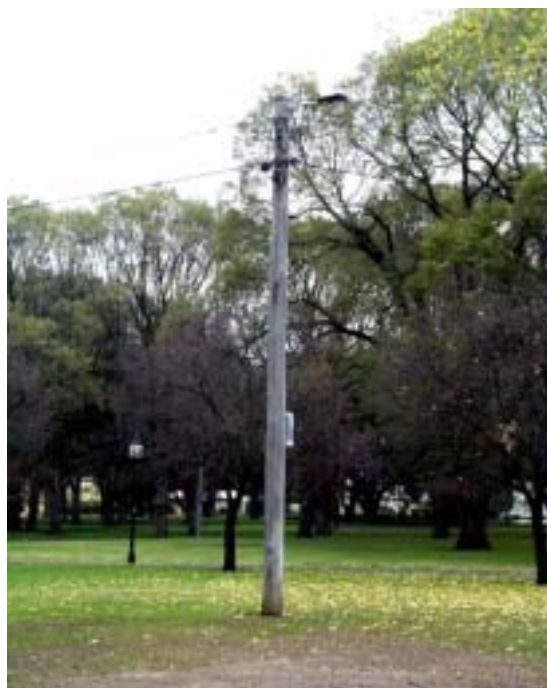
Figure 64 Contemporary steel standard (left) and combined power pole and light (right)

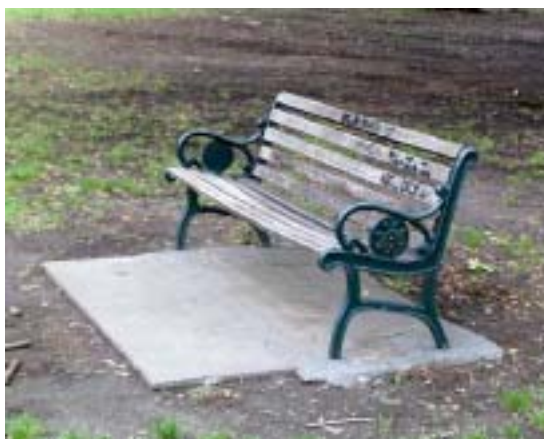
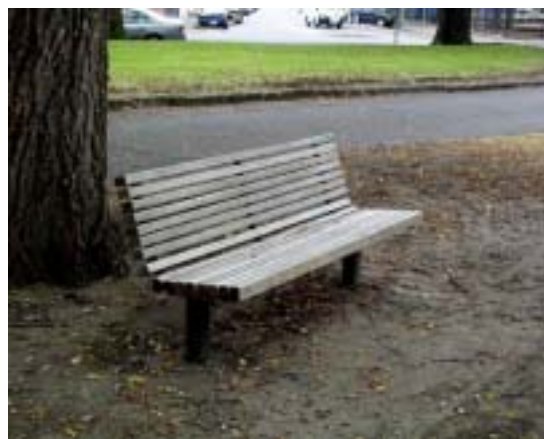
Figure 65 Reproduction seat (left) and contemporary steel and timber seat (right)

Seating within the gardens largely consists of reproduction Victorian seats with stained timber battens and painted cast iron frames fixed to a concrete slab. Two frame designs are evident: the first is an elaborate Victorian pattern while the second is simpler with curvilinear, Art Nouveau inspired detailing. In the vicinity of the community oval and the northern playground the seating types are of various contemporary designs comprising stained timber battens on painted wrought iron frames. In addition there is a timber picnic table and seats and a small number of concrete-framed timber seats.

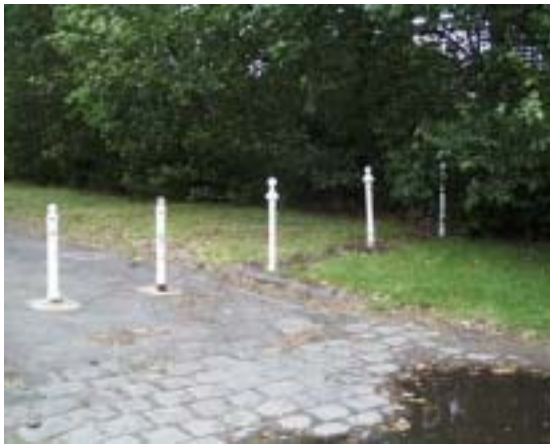
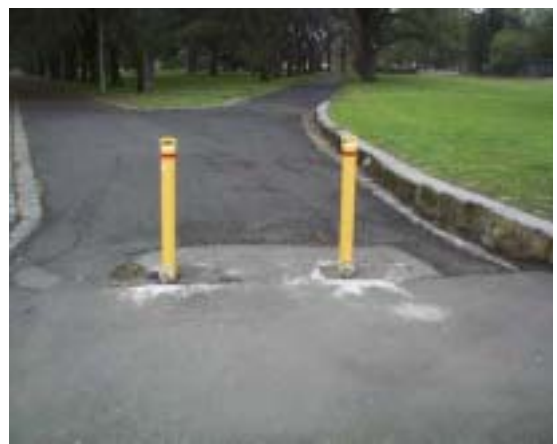
Figure 68 Early cast iron bollards (left) and later steel bollards (right)

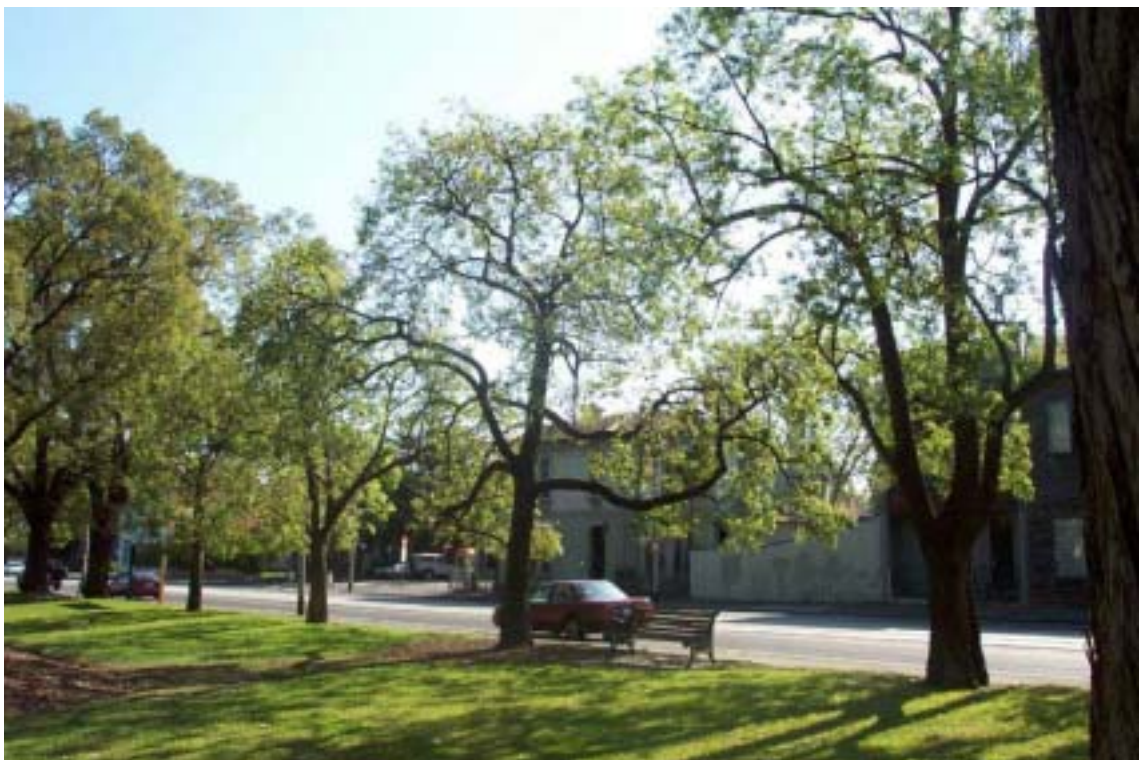
Figure 71 Kurrajong (*Brachychiton populneus*), St Georges Road

Given the size and apparent age of many of the Kurrajong (*Brachychiton populneus*) specimens in this location it is thought that the existing row is the same planting evident in the aerial photos of 1945 and 1966. Some of the specimens in the 1945 photograph have moderately developed canopies, suggesting a planting time before 1940, possibly in the 1920s or 1930s. Such a planting time would be consistent with the heightened sense of national identity and sentiment following World War I which was expressed in several parks through the use of Australian species, such as a plantation of Red Flowering Gum (*Corymbia ficifolia*) in the Domain, and Kurrajongs in Central Park, East Malvern.

There is considerable variation in the size of the trees with some responding to site conditions markedly better than others. The row includes a number of exceptionally good examples of the species within the Melbourne context, particularly those at the northern end.

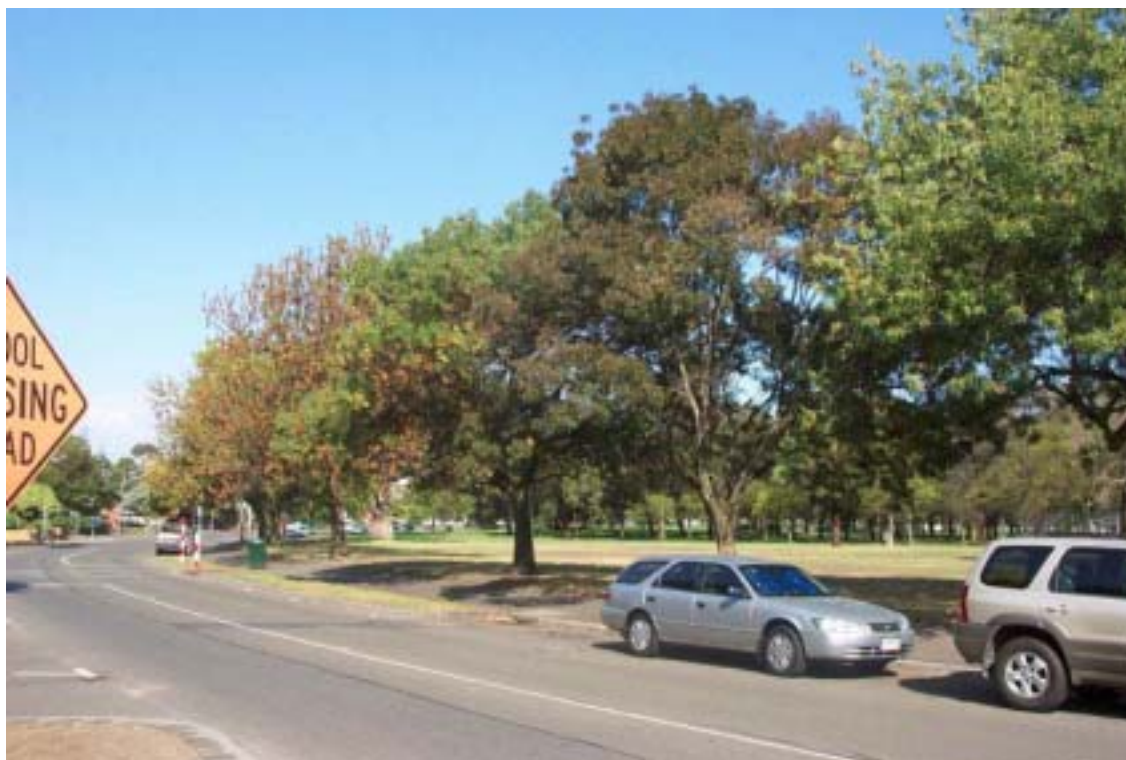
Figure 72 Desert Ash (Fraxinus angustifolia) Alfred Crescent

A short row of nine Desert Ash (*Fraxinus angustifolia*) and one Claret Ash (*Fraxinus angustifolia* 'Raywood') is planted along the northern frontage of the Gardens to Alfred Crescent opposite the Primary School. The trees are mature and in fair to good condition.
