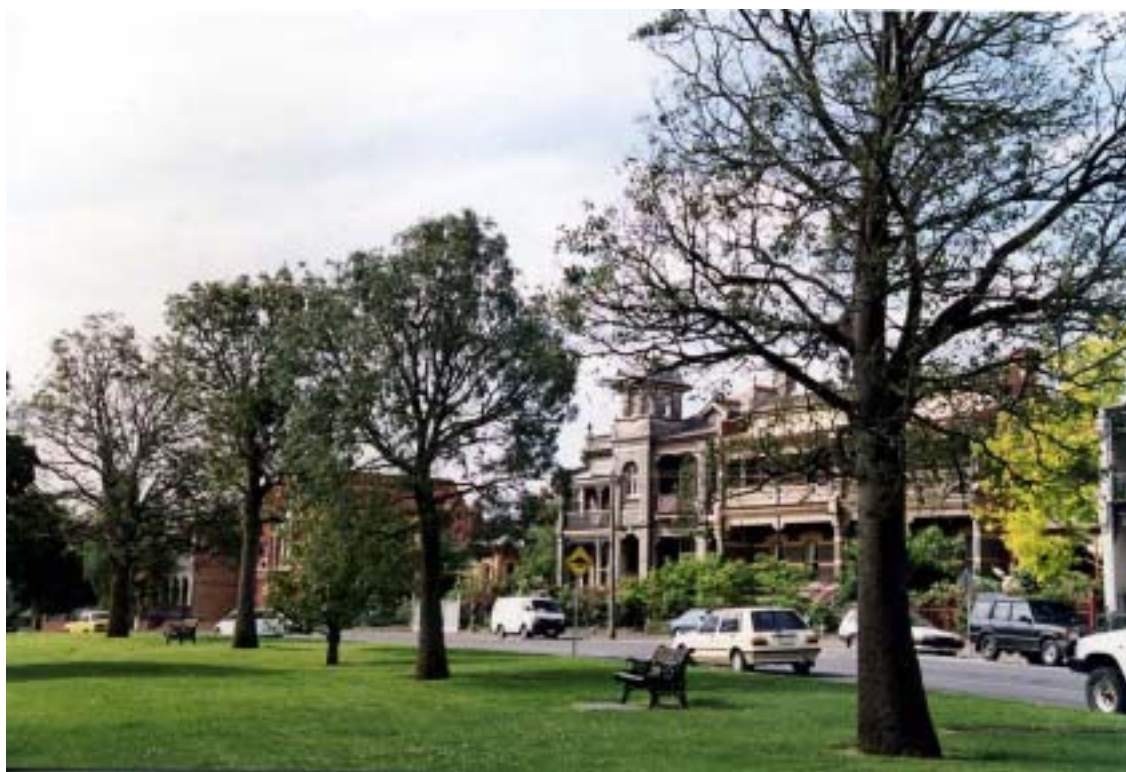
Figure 73 Kurrajong (Brachychiton populneus) Tree Row Alfred Crescent

A row of Kurrajong (*Brachychiton populneus*) and Illawarra Flame Tree (*B. acerifolia*) is established along the north-eastern frontage of the Gardens extending from the Falconer Street entrance to the vicinity of Grant Street. The planting consists of some fourteen Kurrajongs which are generally larger in size and dominate the northern end of the row. However, a number of the Kurrajongs are not large, particularly toward the south, suggesting more inhospitable conditions in this vicinity.

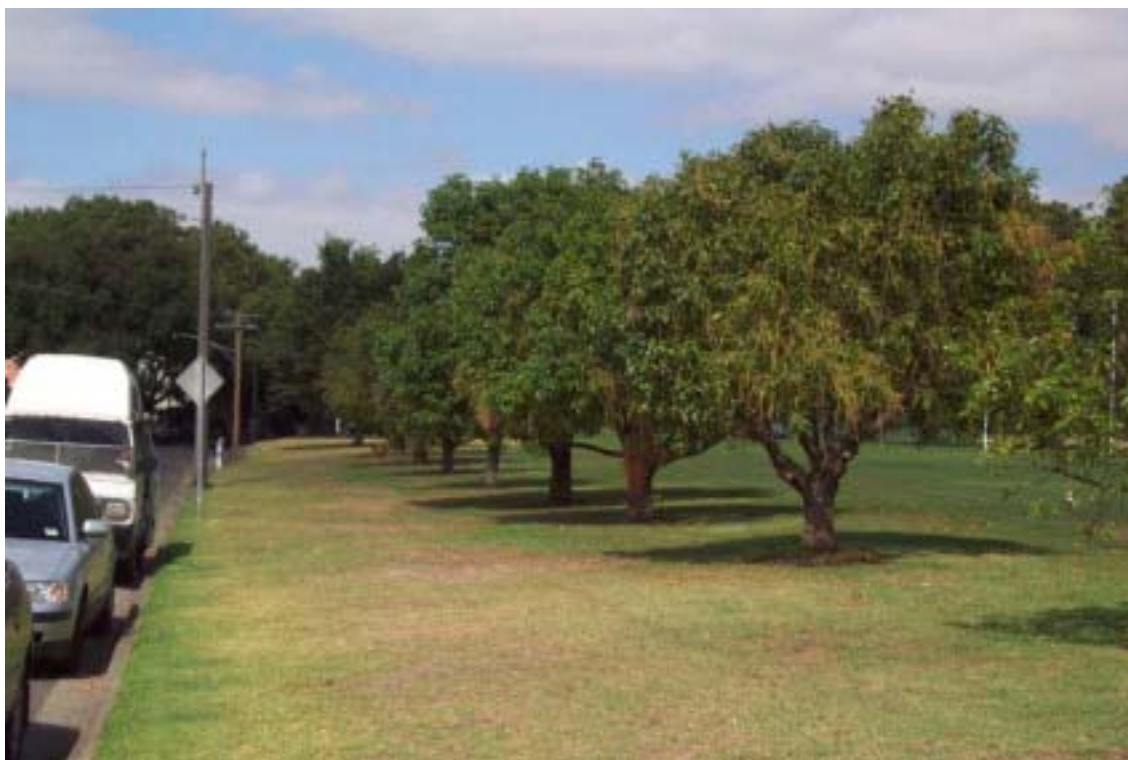
Figure 74 Illawarra Flame Tree (Brachychiton acerifolia) interplanted with Kurrajong (Brachychiton populneus) along eastern sectors of Alfred Crescent

The Illawarra Flame Tree plantings consist of about seventeen specimens interplanted with the Kurrajongs. These are predominantly located south of the Rowe Street entrance. They are generally significantly smaller than the Kurrajongs although this could be expected given the relatively recent planting, their slow growth habit, and the fact that they are still young. Both species are in good to fair condition.

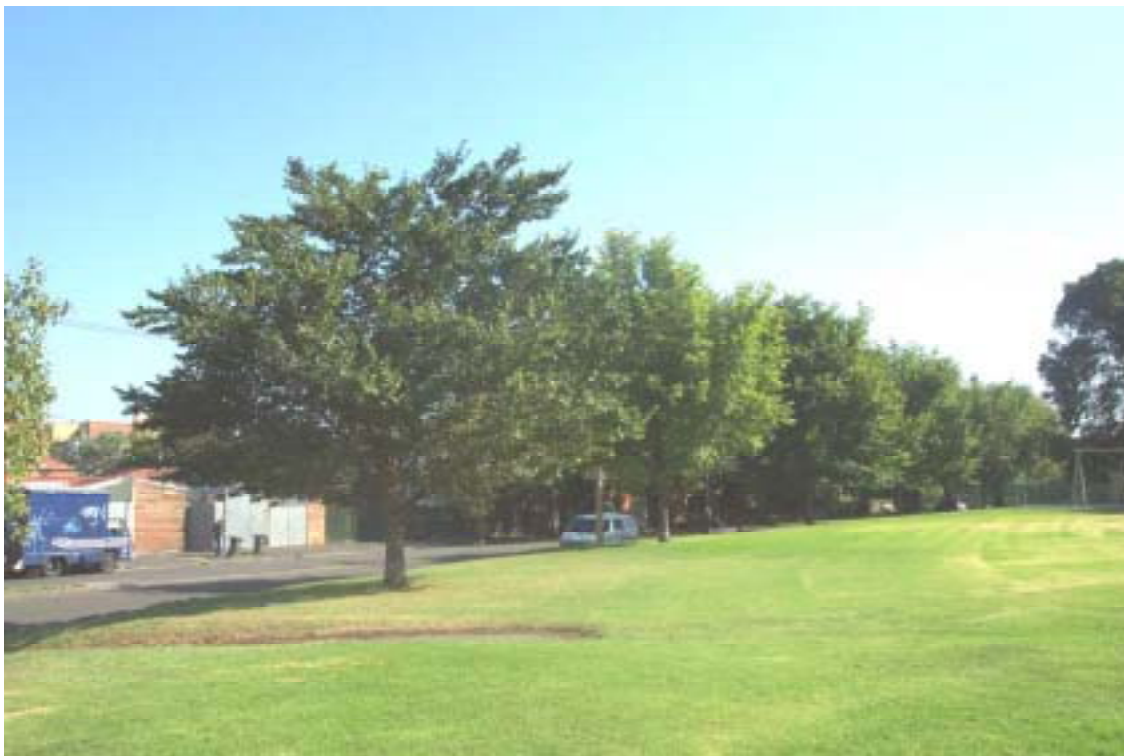
Figure 75 Dutch Elm (Ulmus x hollandica) Alfred Crescent South

Four semi-mature specimens of Dutch Elm (*Ulmus x hollandica*) are planted along Alfred Crescent between Grant Street and Jamieson Street. The trees are in fair to good condition.

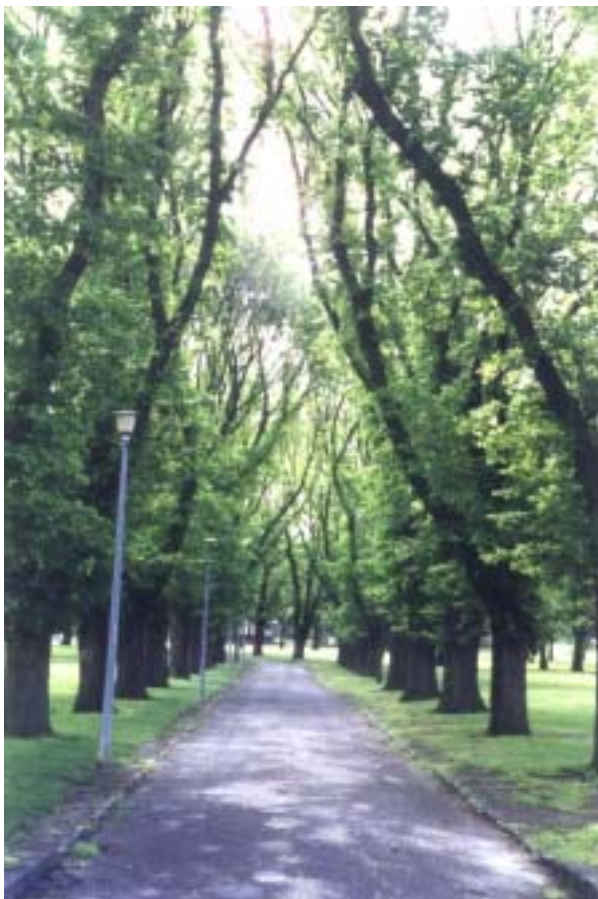
Figure 76 Avenues of Dutch Elm (Ulmus x hollandica) lining the main path system.

Although the avenues do not represent the full extent of the historical plantings, the original scheme is still largely intact. Some sections, as noted above, have been removed, while in other avenues occasional specimens may be missing.

The remaining trees are generally in fair to good condition, although there is evidence of some deadwood in upper canopies. At the time of writing, thin canopy growth was frequent, reflecting severe elm leaf beetle attack and possum browsing. The prevailing drought conditions may also be aggravating the situation although most of the Gardens are irrigated.

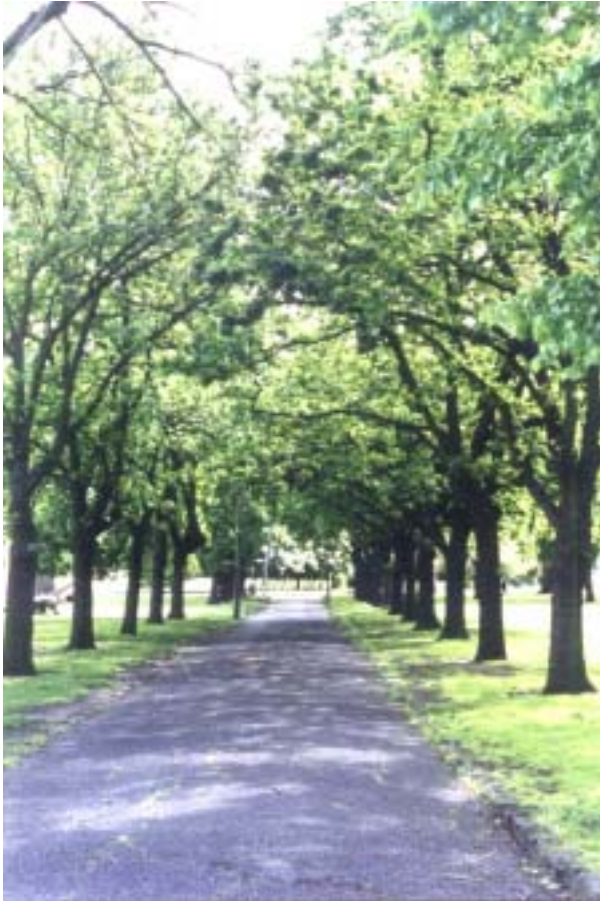
Figure 77 *Avenue of English Oak (Quercus robur)*

The southern fork of the path opposite Rowe Street is planted with an avenue of English Oak. Two specimens are missing mid-way along the southern row.

The trees are well-established but have not thrived in the conditions and are somewhat small. They are in fair to good condition although there is evidence of deadwood in the upper canopy of a number of specimens, and some appear to have been subject to possum browsing.

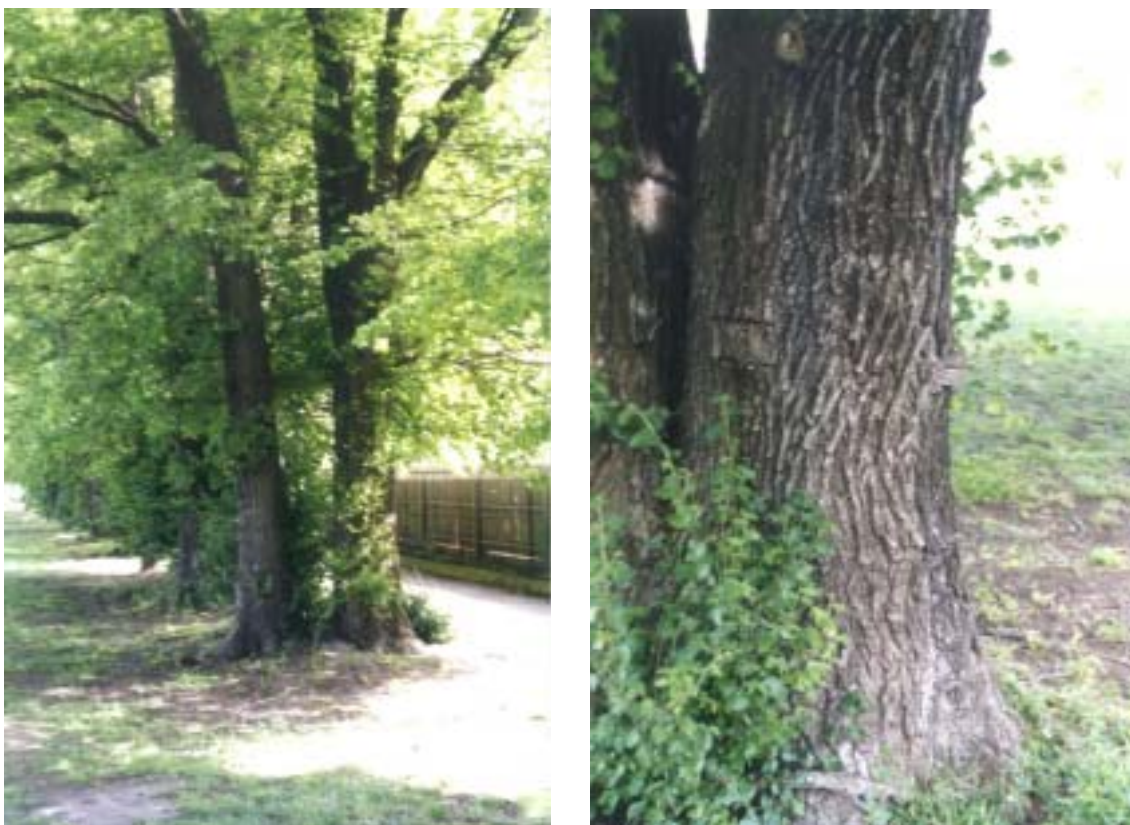
Figure 78 Self seeded row of Dutch Elm (*Ulmus x hollandica*) (left) and detail of old fence rails showing through trunks

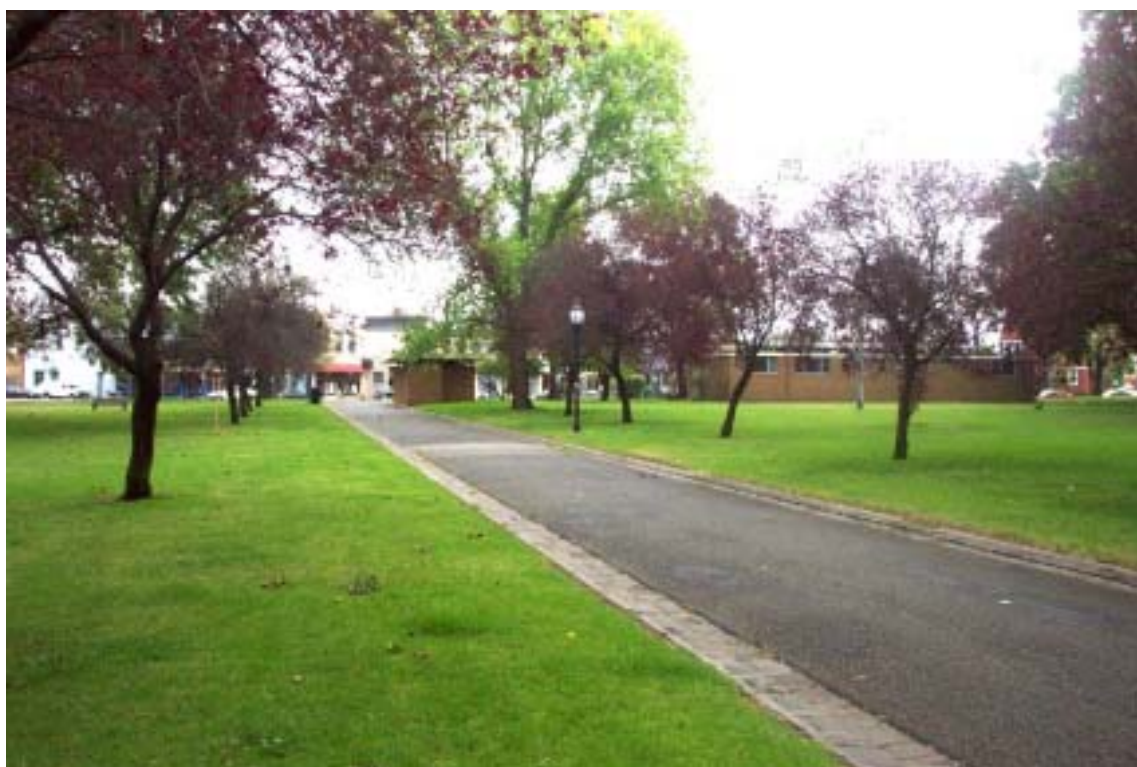
Figure 79 *Avenue of Purple Leafed Plum (Prunus x blieriana)*

An avenue of Purple Leafed Plum (*Prunus x blieriana*) is established on the diagonal path leading from the intersection of St Georges Road and Alfred Crescent. The trees are small and with foliage colour which does not sit harmoniously with the stately scale and character of the avenues of Dutch Elm which dominate the Gardens. A number of the specimens are missing so that the avenue form is diminished and weak. The trees are in fair condition and are approaching the end of their effective horticultural value.

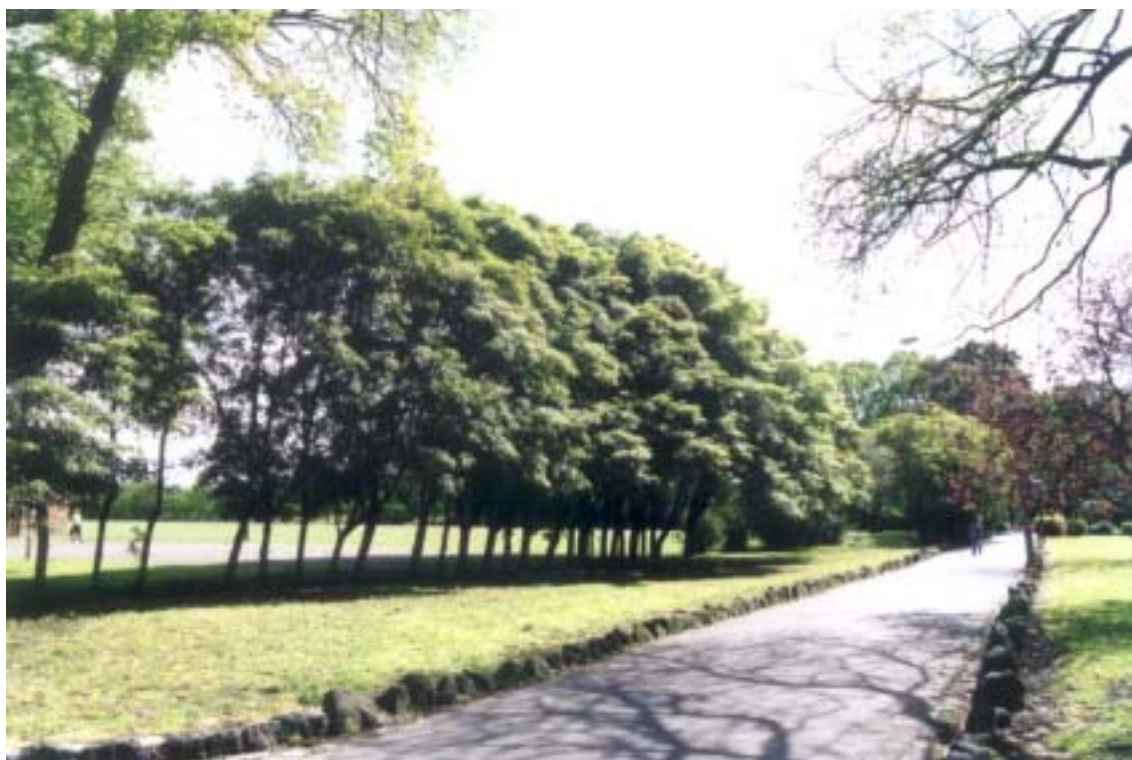
Figure 80 *Off set rows of Sweet Pittosporum (*Pittosporum undulata*) and Oleander (*Nerium oleander*) on the south side of the central east west path.*

The section of path where the Sweet Pittosporum (*Pittosporum undulatum*) and Oleander (*Nerium oleander*) are now located, is shown on the 1883 plan and was possibly first planted as part of the 1884 works which established the main elm avenues along the network of paths. However, the integrity of this planting would have been short-lived with the excision of the railway land in 1888 which cut a swathe across the path. The 1905 plan indicates a gap in the avenue planting along the sections of path adjacent to the railway land, although the trees along the eastern end of this section of the path are still intact.
