Heritage Overlay No: 013
Citation No.: 002
Place: Lynuilg Homestead, 477-569
Bensons Road

Other Names of Place: N/A
Location: 477 - 569 Benson Road, Toolern Vale
Critical Dates: Present house built c.1916.
Existing Heritage Listings: None
Recommended Level of Significance: LOCAL

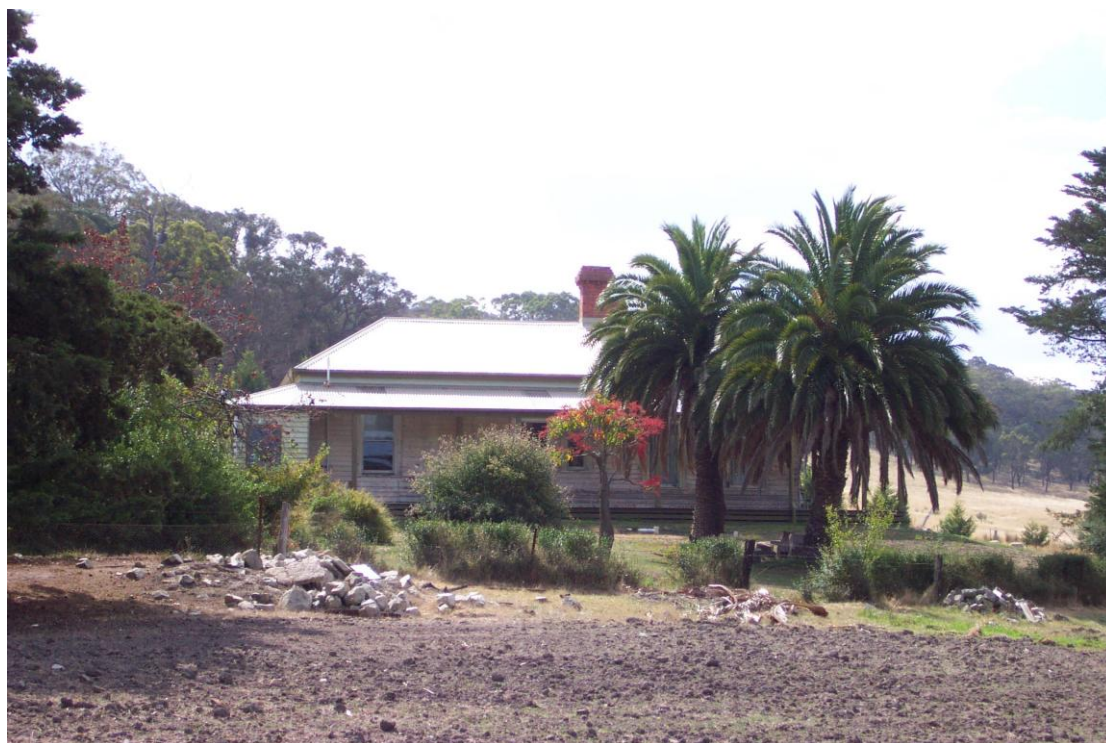
Lynuulg Homestead, 477-569 Benson Road, Toolern Vale, has a rural setting on the rise of the hill. It consists of the main timber house with a house garden setting to one side and a complex of outbuildings and structures set further up the sloping ground.

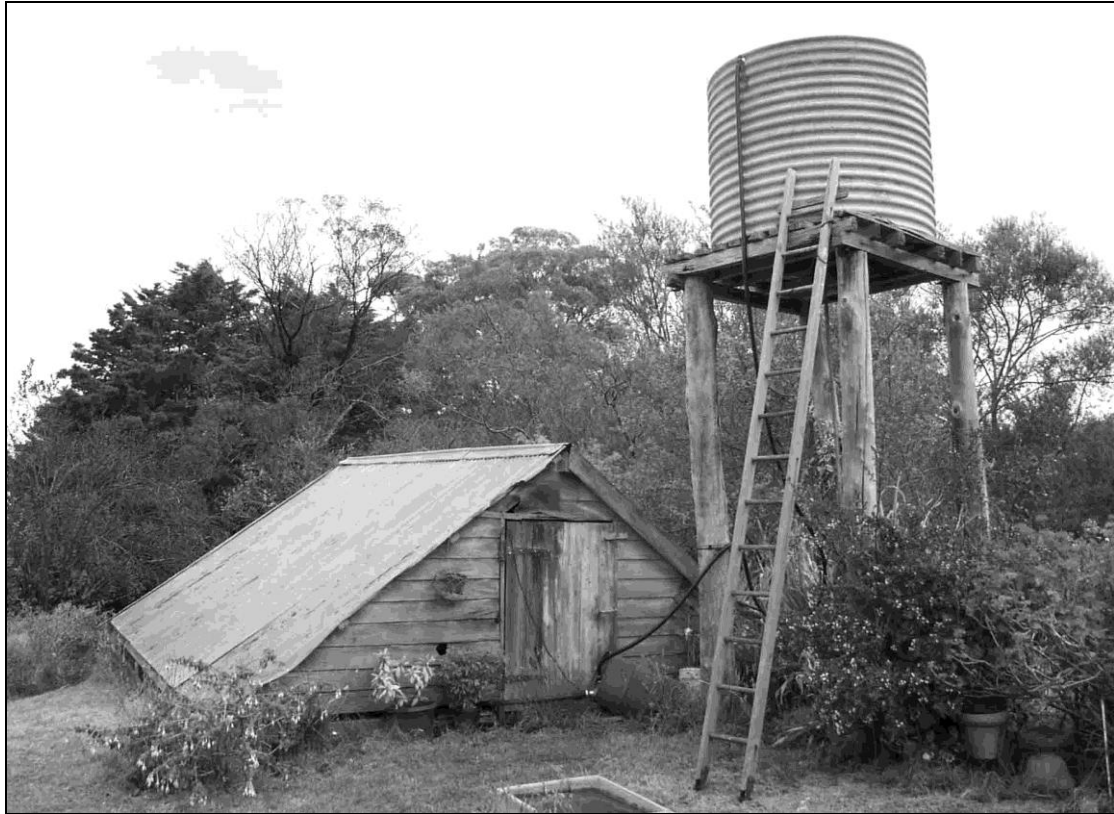
Immediately behind the main house is a large underground tank, presumably without a domed cover. It has a gabled roof clad in galvanised corrugated steel and horizontal timber weatherboard gable infill. The corrugated steel roof has been replaced quite recently. A small vertical timber boarded door is situated at one end.

Beside the underground tank is an early round galvanised corrugated steel header tank on a timber log stand. The owner advises that this was demolished in 2003.

Underground water tank covered with gable roof, and adjacent corrugated steel header tank. The steel header tank was demolished in 2003.
