Heritage Overlay No.: 054
Citation No.: 117
Place: Bridge over Kororoit Creek, Melton Highway

Other Names of Place: N/A
Location: Melton Highway crossing of Kororoit Creek (at 37 km post), Plumpton.
Critical Dates: Likely c.1859-60 (original arch span); 1870-71 (girder span); 1955 & 1968 (new deck).
Existing Heritage Listings: None
Recommended Level of Significance: LOCAL

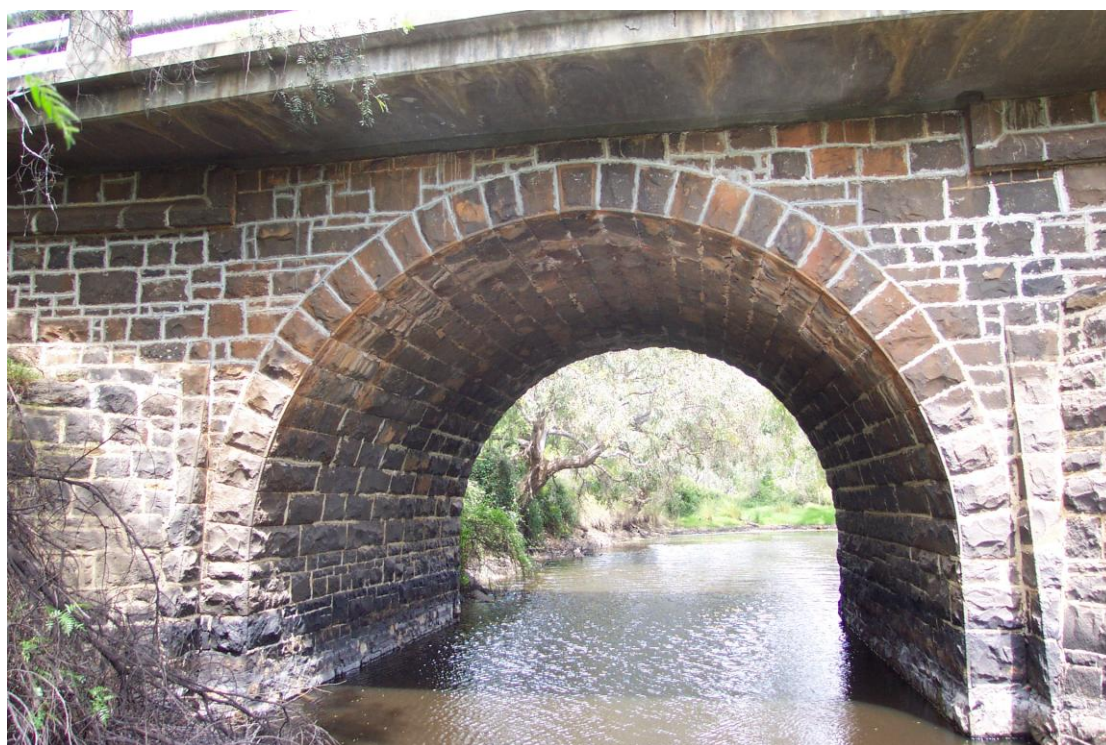
The bridge over the Kororoit Creek, Melton Highway, Melton, has a large round arched (barrel vault) and side opening that was formerly spanned by a timber superstructure. The bridge is constructed of coursed random rubble bluestone and has an introduced concrete superstructure. Other early features include the projecting bluestone corbels that support the superstructure above, large bluestone cutwater wall, and cobbled bluestone creek floor.

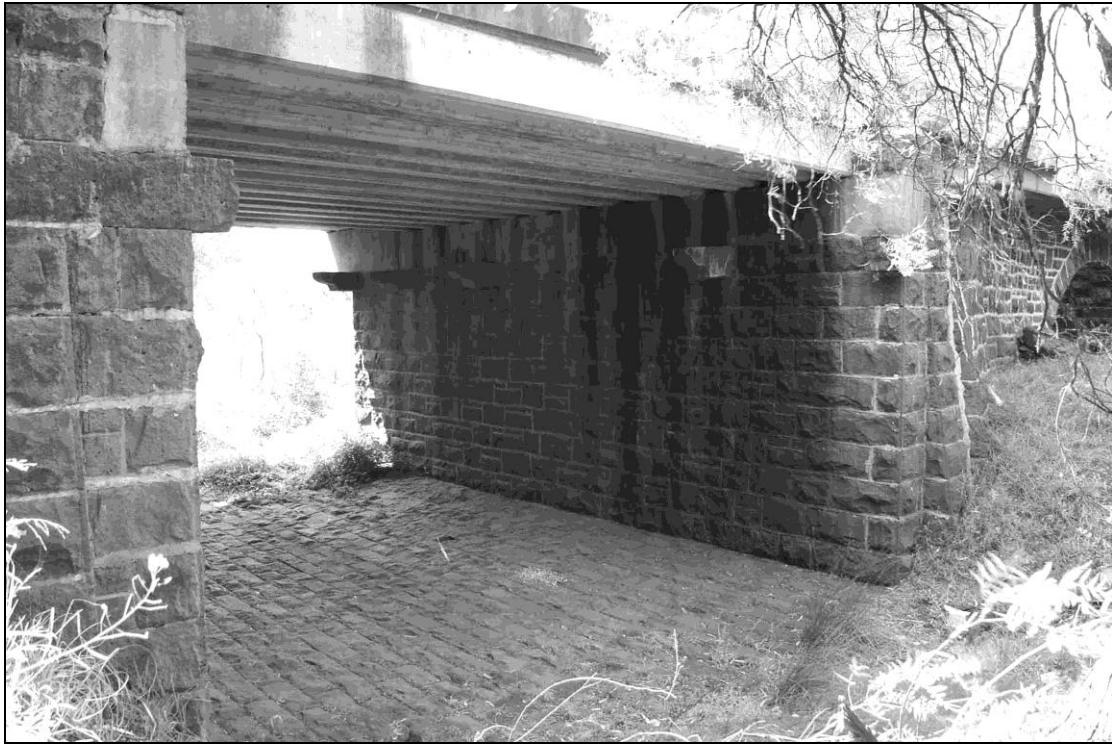
The girder span, showing the shaped bluestone corbels, bluestone paved bed. Concrete girders have replaced the original timber ones. The round arch span is adjacent.
